Grounding of *Lysblink Seaways*

Kilchoan, West Scotland

18 February 2015

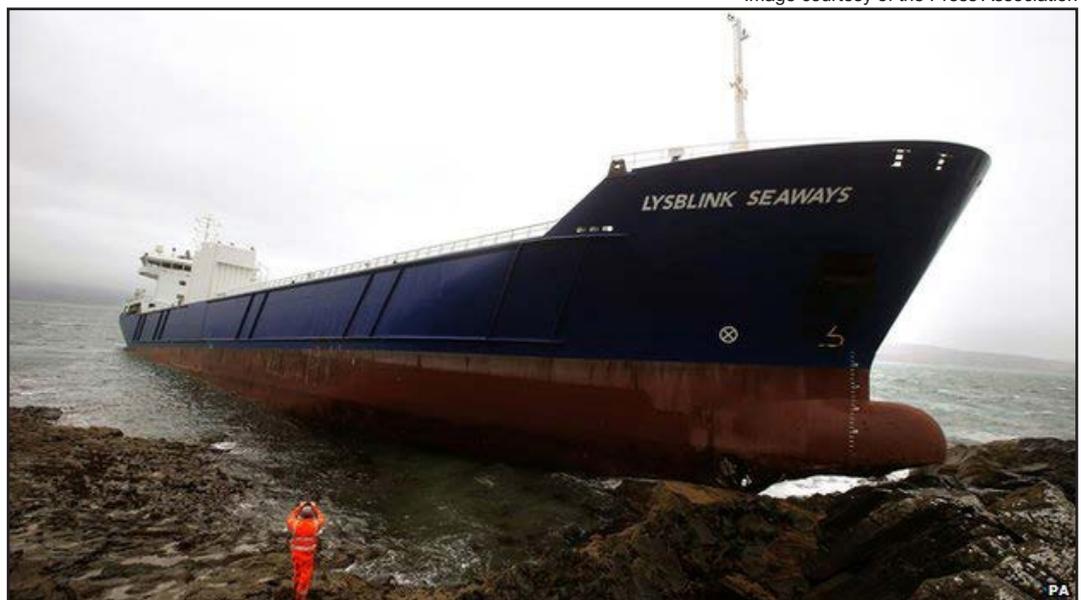
At 0232 (UTC¹+1) on 18 February 2015, while on passage from Belfast to Skogn, Norway the general cargo vessel *Lysblink Seaways* ran aground at full speed, near Kilchoan, Ardnamurchan peninsula, West Scotland (**Figure 1**).

The vessel remained aground for almost 2 days and, due to adverse weather conditions, was pounded heavily onto the rocky foreshore. This caused material damage to its hull and breaching of the double bottom, including some fuel tanks, resulting in 25 tonnes of marine gas oil entering the water.

Figure 1: Vessel aground

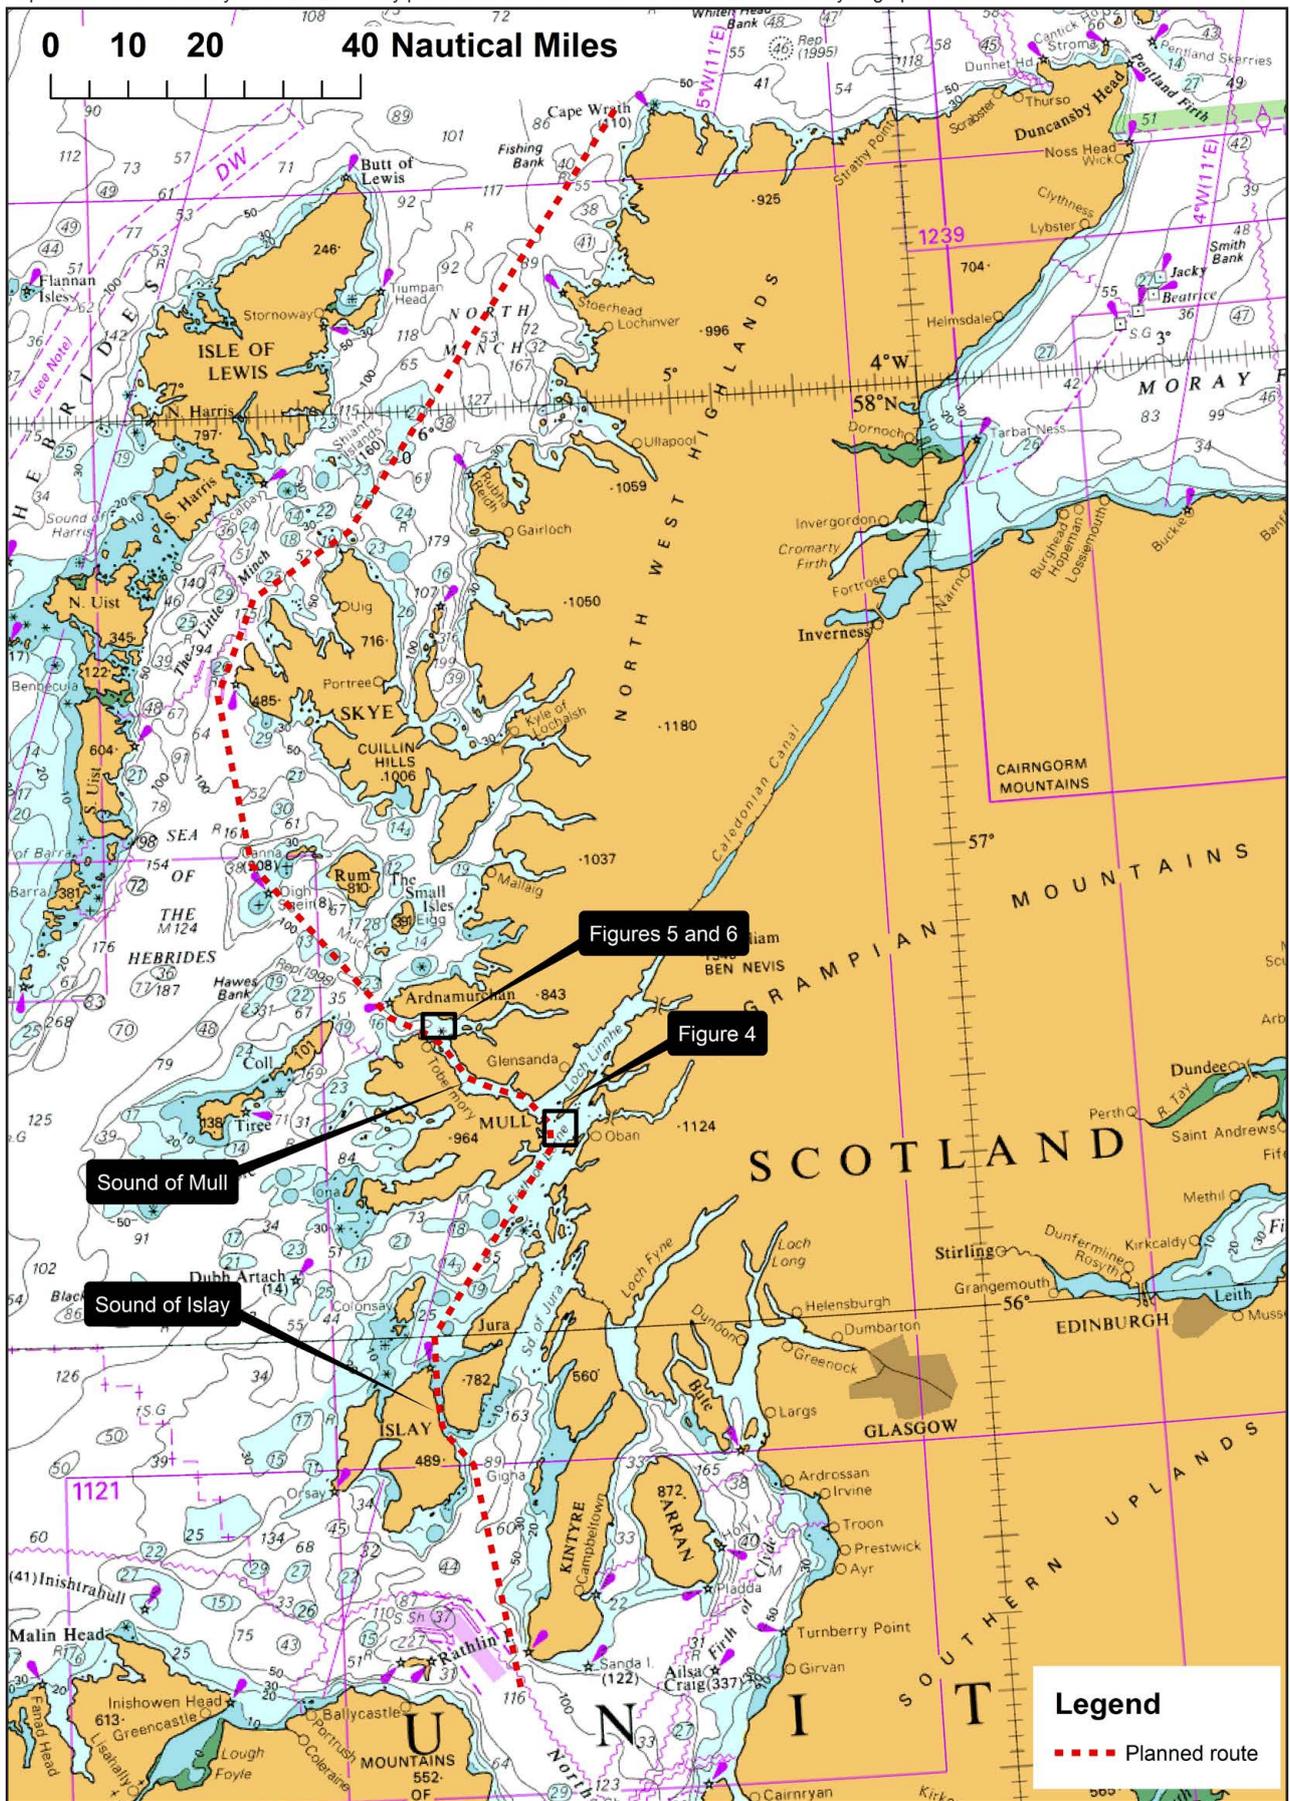
At 0200 on 17 February 2015 the 7409gt³ general cargo vessel *Lysblink Seaways* arrived in Belfast to discharge its cargo of paper reels. While in port the second officer prepared the passage plan for the vessel's next voyage from Belfast to Skogn, Norway. The master decided, due to forecast adverse weather, that the vessel would take an inshore route along the west coast of Scotland via the Sounds of Islay and Mull (**Figure 2**).

Figure 2: Lysblink Seaways' planned route

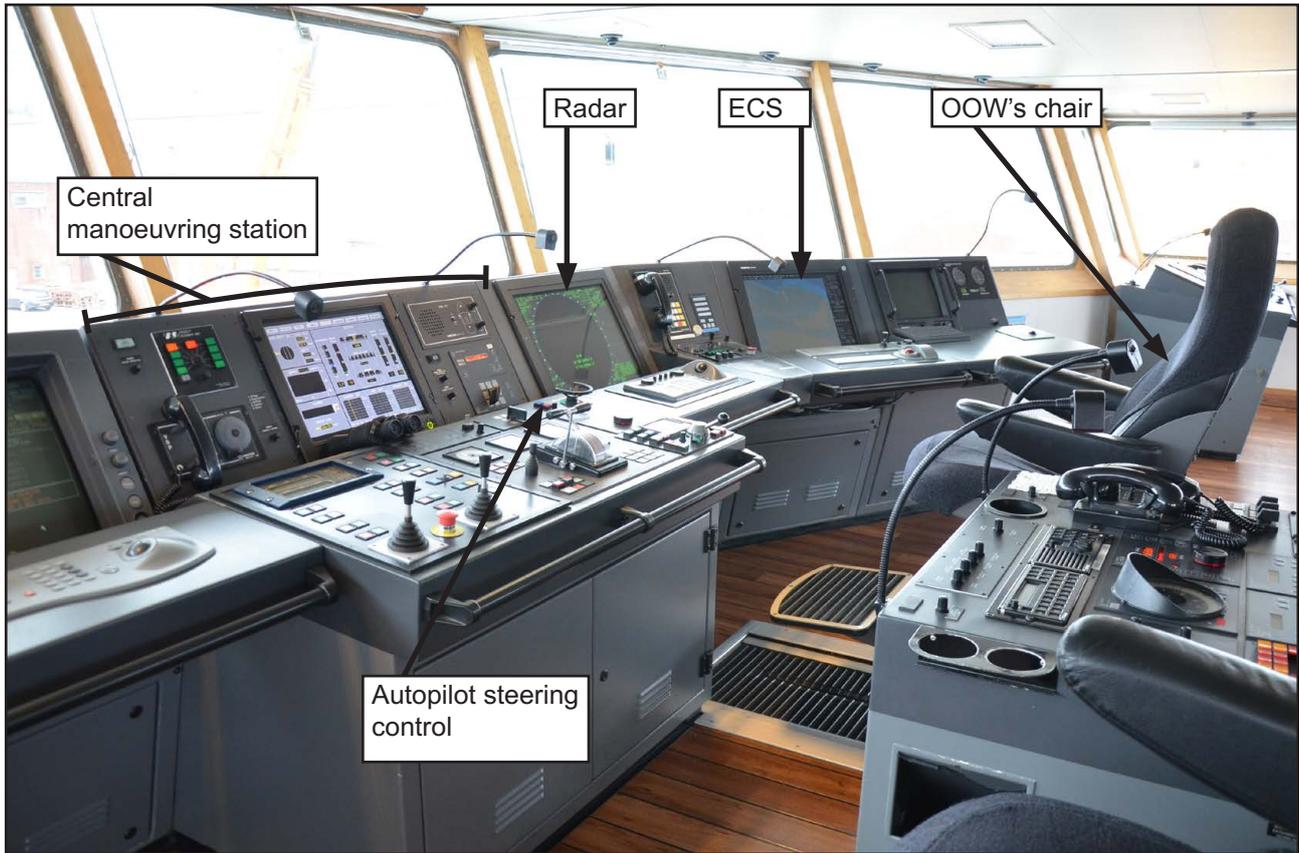
At midnight the chief officer took over as OOW from the second officer. The chief officer then sat in a chair, located to starboard of the central manoeuvring station (**Figure 3**), from where he monitored the ECS and the starboard radar display. The vessel's steering was in autopilot mode, the control for which could be reached from the chair, which he had positioned fully forwards.

Figure 3: Wheelhouse

The control for the radar watch alarm, set to sound at low volume every 6 minutes, could also be reached from the bridge chair, and this was regularly reset throughout the watch. No positions were plotted onto the vessel's charts after midnight.

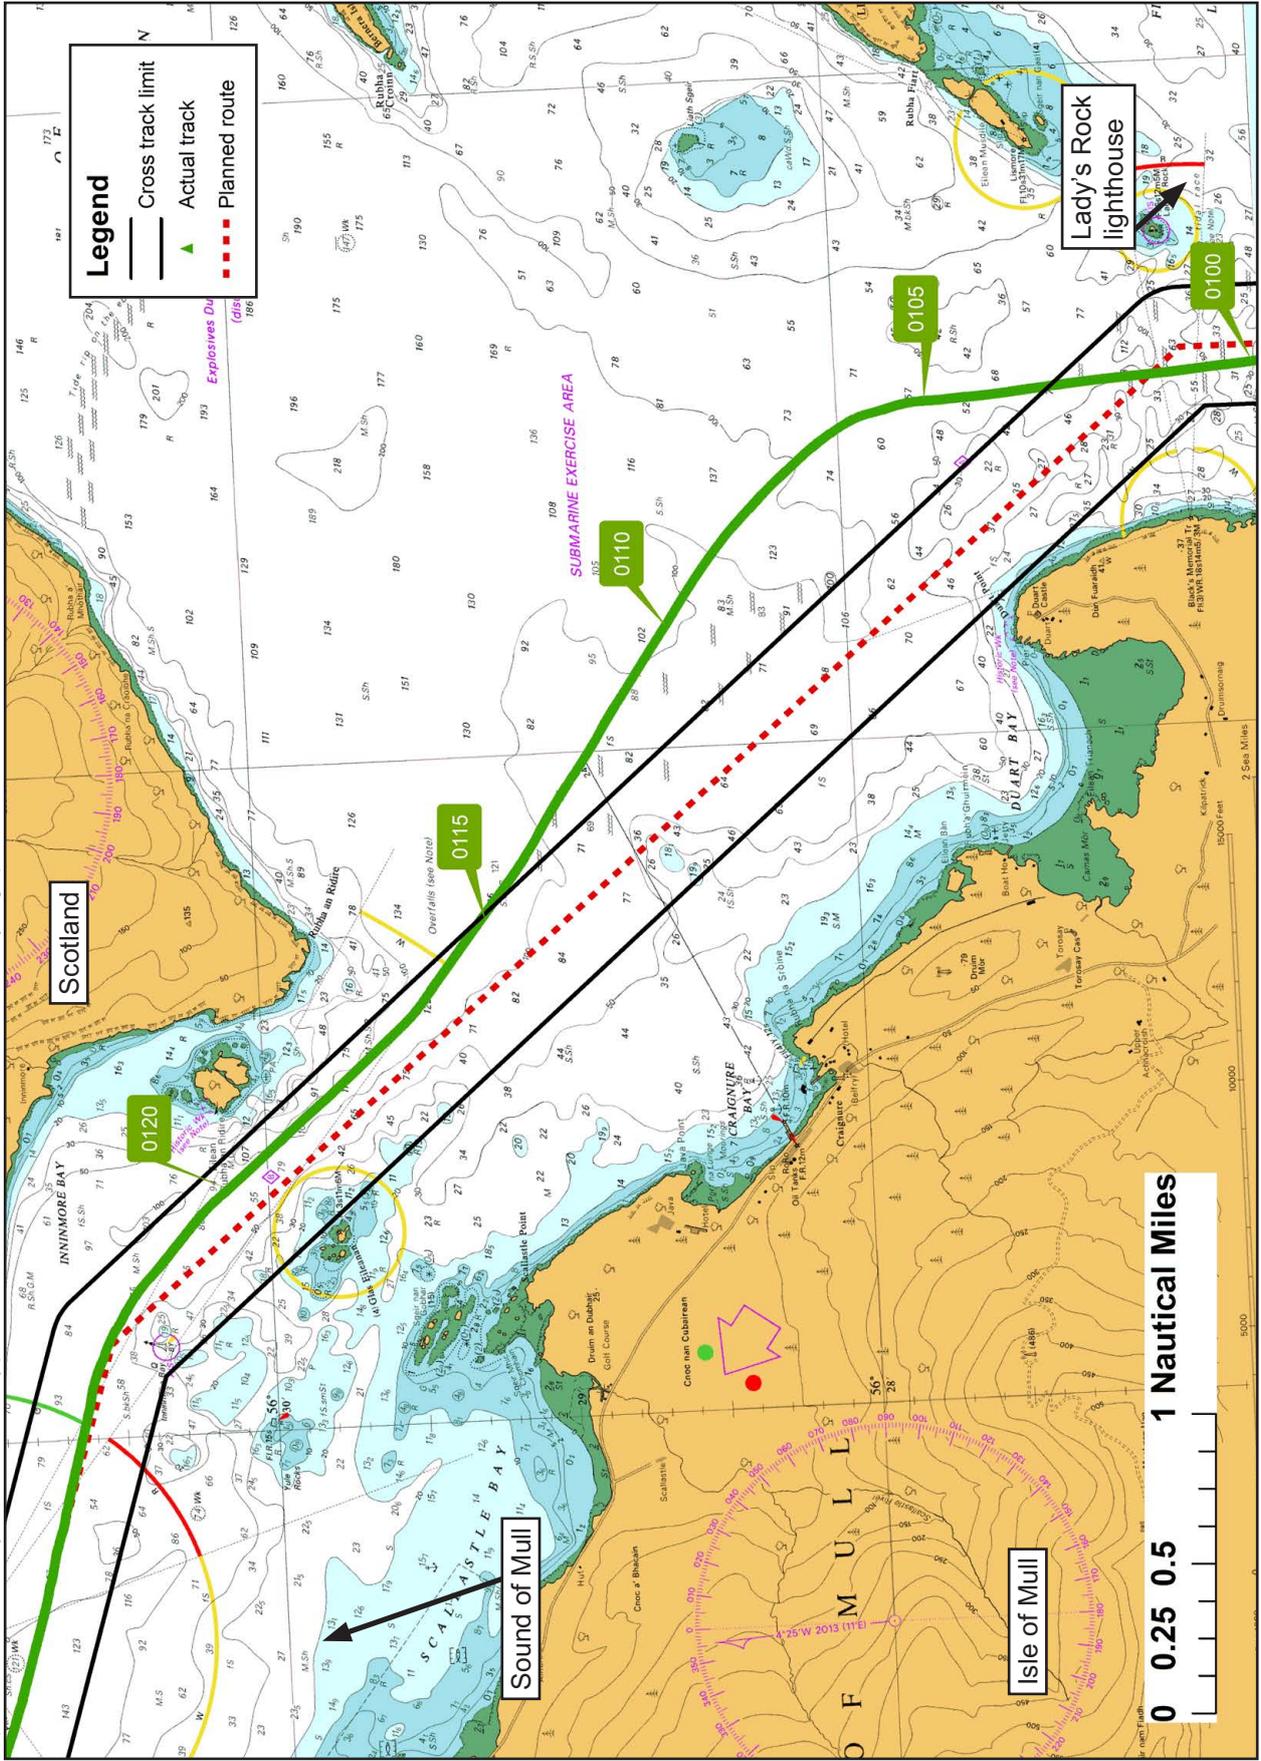
At 0100 *Lysblink Seaways* passed between the Isle of Mull and Lady Rock's lighthouse; a course alteration due at that position was not made until 0105 (**Figure 4**) just after the radar watch alarm had sounded. At this time the vessel was 0.4nm from its planned route and outside the 0.2nm cross track limit set on the ECS, the alarm for which had been silenced. No vessel traffic was visible on its radar at that time.

Figure 4: Overshooting 0100 wheelover position

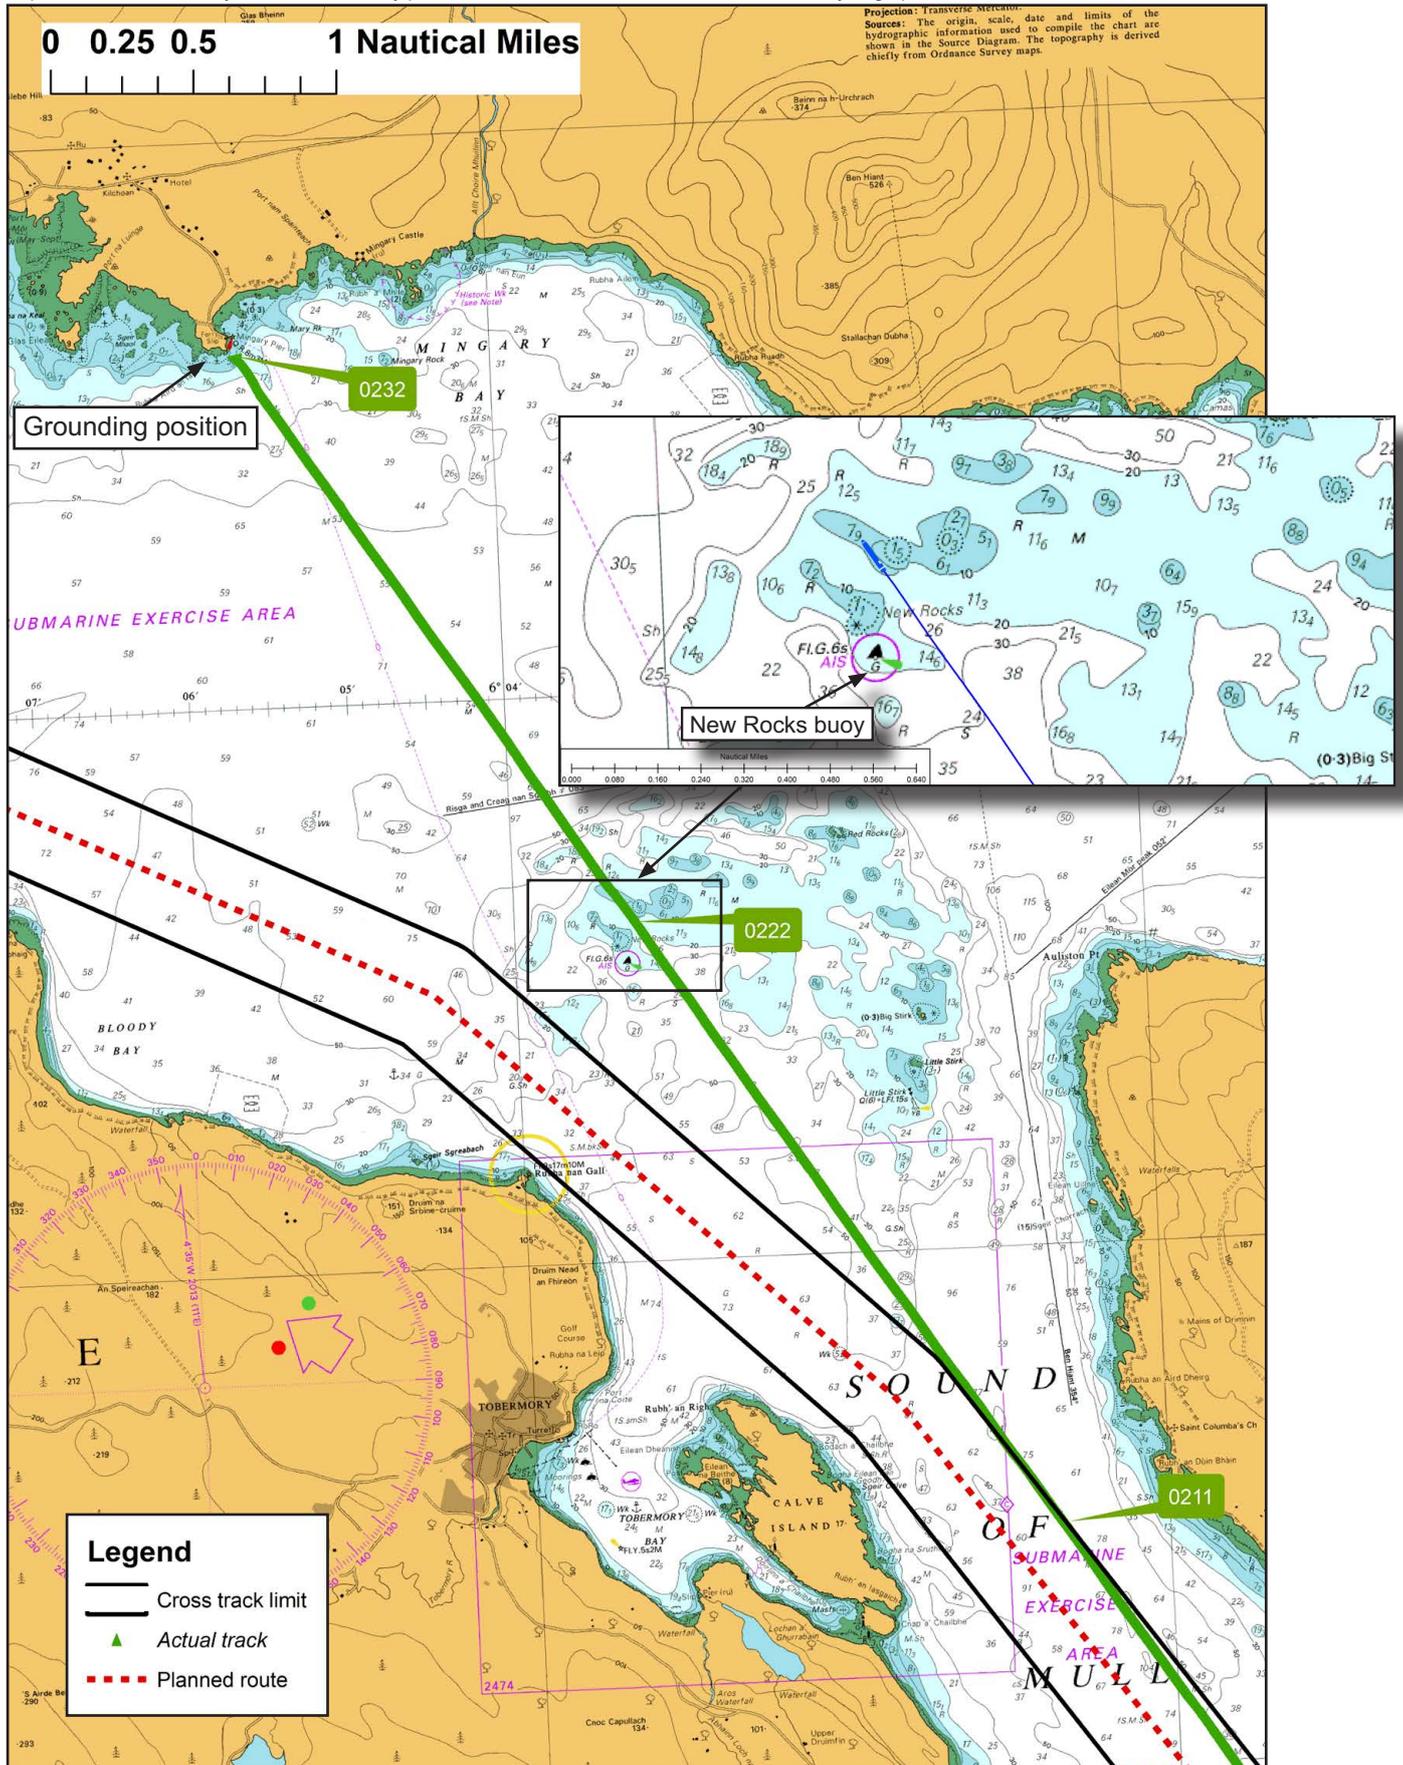
At 0211 *Lysblink Seaways'* track again passed outside of the 0.2nm cross track limit set on the ECS (**Figure 5**). At 0212 the radar watch alarm sounded and was reset, but an alteration of course onto a new heading of 315°, which should have been made at that time, was not executed.

At 0222 *Lysblink Seaways*, still heading 324°, passed the wrong side of the New Rocks starboard lateral buoy, narrowly missing the rocks (**Figure 5 inset**).

Figure 5: Deviation from planned route until grounding (inset: Vessel passes wrong side of New Rocks buoy)

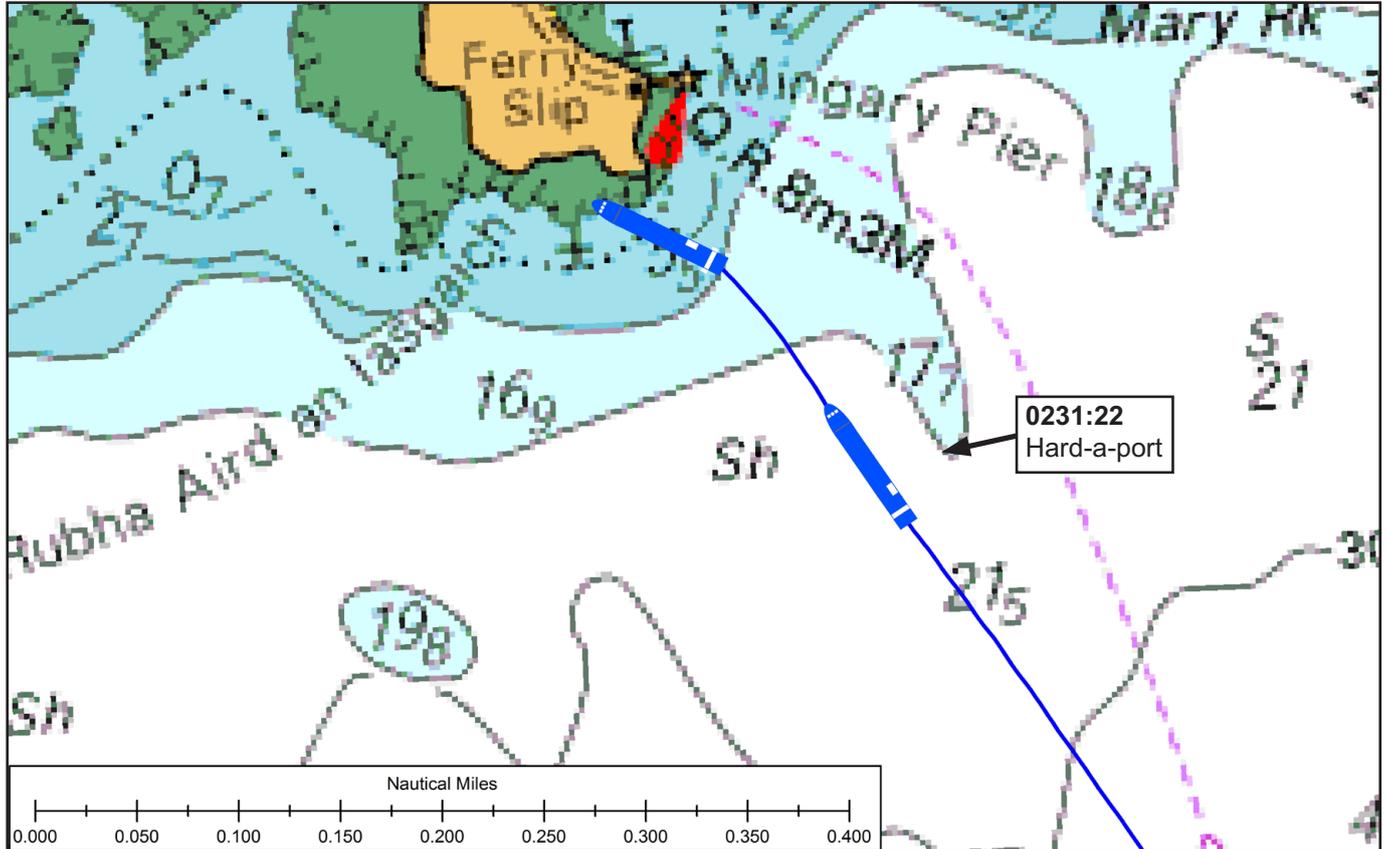
At 0231:22, shortly after the radar watch alarm had been reset, the steering mode was changed from autopilot to manual and the helm was placed hard-a-port. The vessel was 0.1nm from the shoreline and making a speed of 13.3 knots.

At 0232 *Lysblink Seaways* grounded on the rocky shoreline near Mingary pier, Kilchoan while swinging to port (**Figure 6**).

Figure 6: 0232 - vessel grounded at 13.3 knots
