### DETAILED INVESTIGATION OF ENGINE CONTROL ELECTRONICS

### DETAILED INVESTIGATION OF MECHANICAL FUEL CONTROLS

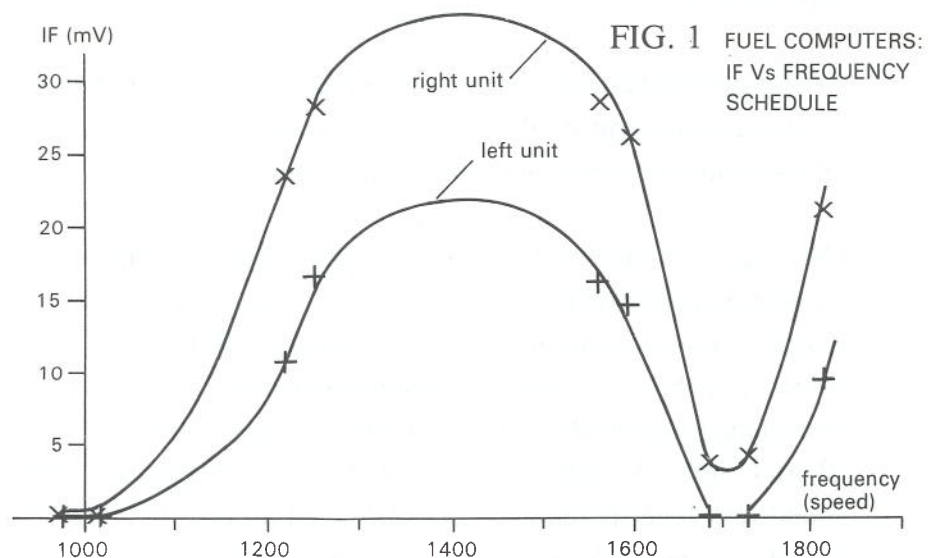
The  $I_f$  vs Speed (frequency) Schedule data displayed a significant disparity between the left and right computers. The data also appeared, at a superficial level, to indicate possible discontinuities. However, when plotted (fig.1) it became apparent that the characteristics of the left and right computers were actually very similar, but that the gain of one of the control loops was set higher in the right computer than the left, probably via the trim potentiometers.

Both units were operational and the essential characteristics of each was similar, but the left computer trim potentiometers had been adjusted to give lower  $I_f$  currents than the right computer. These lower currents translate into higher fuel flow demands from the left computer than from the right, but with both computers demanding more fuel than nominally required.

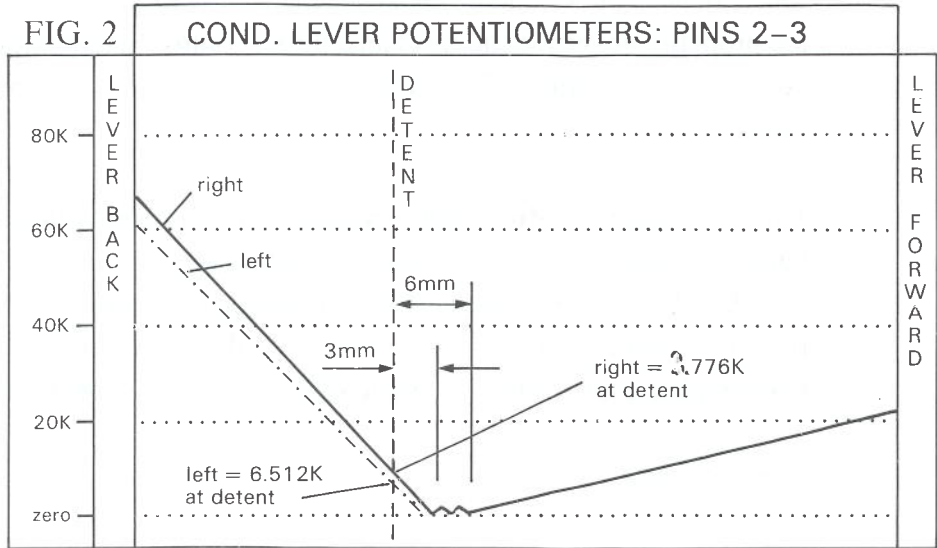
No region of open circuit or high resistance was encountered on any of the potentiometers and the resistance values fell broadly within the expected ranges except for the condition lever potentiometer values (fig.2), which were essentially correct at the cruise detent but approximately 7 times the value quoted in the maintenance manual at the take off and landing position (lever fully forward), and 3 to 4 times the quoted values at the start/taxi detent. However, since both condition lever potentiometers displayed almost identical deviations from the 'book' figures and no regions of intermittent contact were found, it is clear no sudden or recent change had occurred affecting either potentiometer.

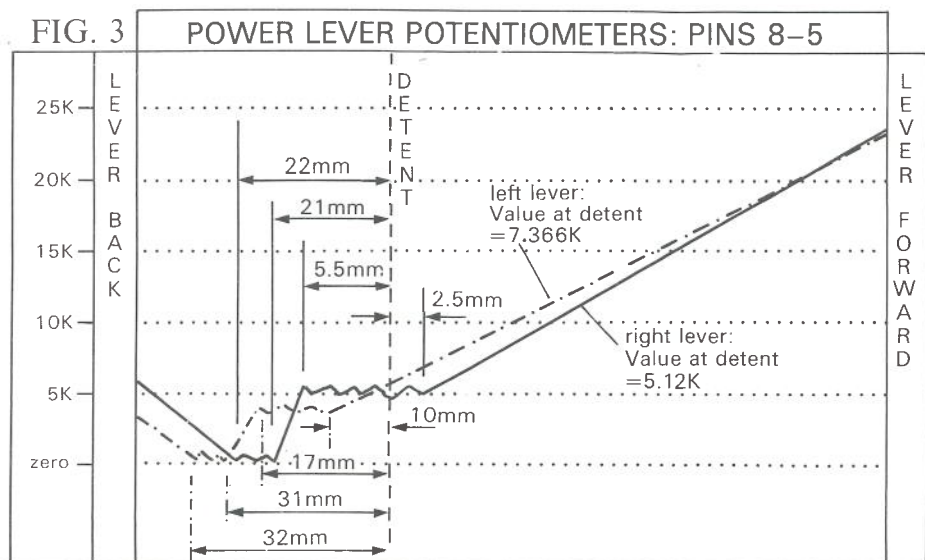
It was noted that the power lever potentiometers were adjusted such that the flat region on the potentiometer characteristic, which should be rigged to coincide with the flight idle stop, was set some 15mm aft of the correct position as specified in the Cessna maintenance manual (fig.3), whereas the flat on the right potentiometer characteristic was only 2.5mm aft of the correct position, producing an apparent power lever split. However, although the apparent split based on the setting of the "flat" section was considerable, the practical effect of the mis-rigging would have been to offset, and slightly overcompensate for, the lower resistance values of the left potentiometer, reducing the effective split at the low power end of the flight range. However, the fact the the flat region on the characteristic curve no longer coincided with the flight idle detent would have made the left engine flight idle less consistent, ie less repeatable.

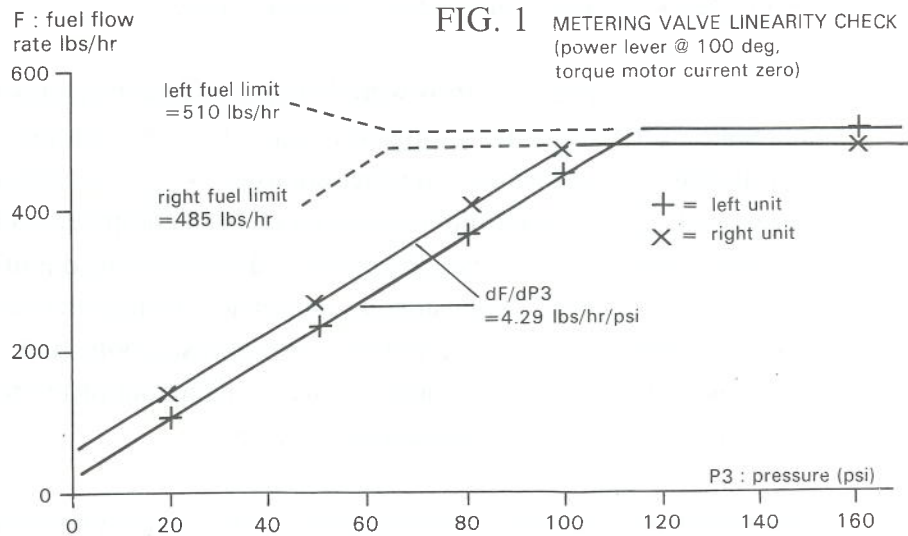
Both units displayed similar response patterns with good linearity (fig.1). There was a rich shift evident in the output of the right unit relative to the left equivalent to approximately 35 lb/hr., but the right unit topped out at a max fuel flow of 485 lb/hr compared with 510 lb/hr for the left unit.

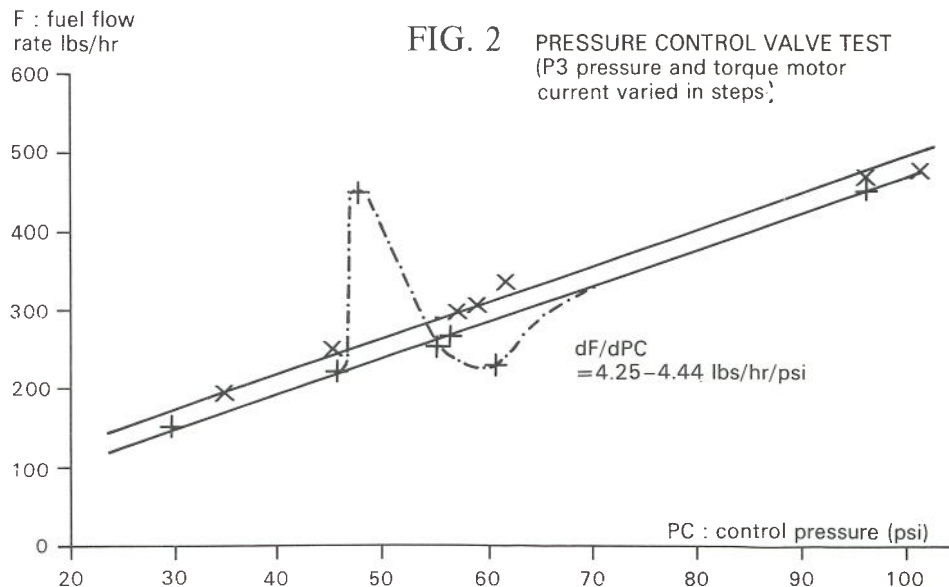
the resulting characteristics were linear and, as expected, the slopes matched closely the rates of change of fuel flow with control pressure determined from the linearity check (fig.2). However, two 'rogue' data points stood out on the left fuel control valve plot, the potential significance of which was difficult to establish.

Both points occurred together (*ie* adjacent in the test sequence) at max P3 pressure and max power lever position, but with only moderate fuel demand from the computer - conditions which might be expected to occur in the case of a torque or temperature limited climb. However, it was not possible to determine retrospectively whether these points represented actual deviations from the linear response characteristic or were the result of test instrumentation error.

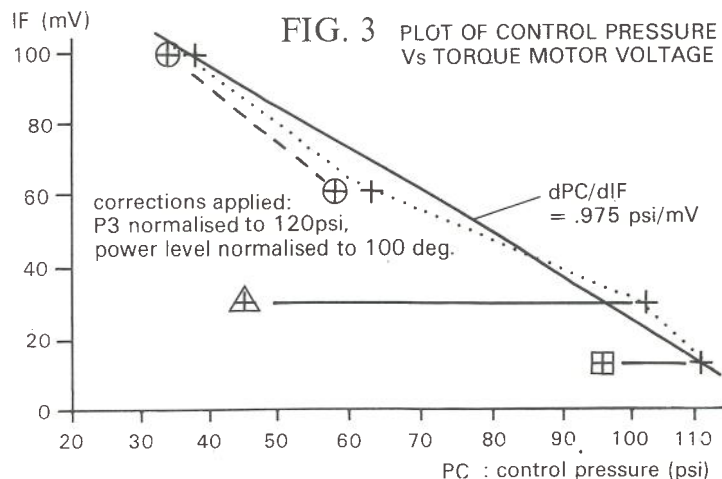
To overcome this problem, torque motor voltage was plotted against control pressure (PC), with the P3 pressures normalised to 120 psi and the power lever settings normalised to 100 deg, using the data overlap points to establish the correction offsets. The resulting plot (fig.3), although comprising only four data points (the two points used for normalisation cannot be included) did nevertheless approximate to a straight line, giving 0.975 psi/mV. Using the slope determined from the linearity test, this is equivalent to 4.181 lb/hr/mV.
