## Europa, G-BVLH

<b>AAIB Bulletin No: 7/2003</b>	<b>Ref: EW/G2003/03/05</b>	<b>Category: 1.3</b>
<b>Aircraft Type and Registration:</b>	Europa, G-BVLH	
<b>No &amp; Type of Engines:</b>	1 Rotax 912-UL piston engine	
<b>Year of Manufacture:</b>	2001	
<b>Date &amp; Time (UTC):</b>	3 March 2003 at 0920 hrs	
<b>Location:</b>	Brunton Airfield, Northumberland	
<b>Type of Flight:</b>	Private	
<b>Persons on Board:</b>	Crew - 1	Passengers - None
<b>Injuries:</b>	Crew - None	Passengers - N/A
<b>Nature of Damage:</b>	Aircraft broken into two pieces	
<b>Commander's Licence:</b>	Airline Transport Pilot's Licence	
<b>Commander's Age:</b>	54 years	
<b>Commander's Flying Experience:</b>	18,515 hours (of which 126 were on type)	
	Last 90 days - 158 hours	
	Last 28 days - 32 hours	
<b>Information Source:</b>	Aircraft Accident Report Form submitted by the pilot plus AAIB examination of rudder cables

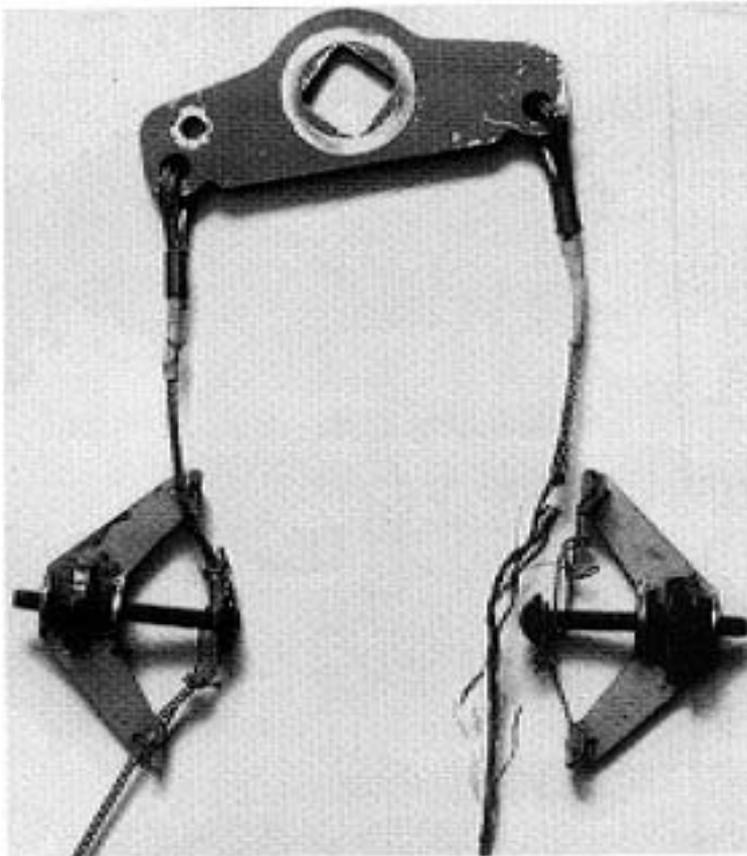
forward end. The right cable had failed completely at the cable shortener and the left cable had partially failed in a similar location.

The cables, operating arm and shorteners were sent to the AAIB for examination. The metallurgical examination showed that all the strand failures had been the result of tensile failure, consistent with mechanical overload, and all had occurred at positions related to where the cables had been in contact with the shortener.

**Rudder operating arm with cables and shorteners**

Both cables were tested for tensile strength, both with and without the shorteners in place. These tests showed that both cables had an ultimate strength greater than 460 kgf but that the presence of the cable shorteners reduced the effective strength by about 20%. The minimum strength of the wire cable, guaranteed by the manufacturer, was 380 kgf.

The shorteners used in this instance were of proprietary manufacture and had been acquired by the owner when building the aircraft. This type of shortener has the cable passing over sharp plate edges which results in a marked reduction in the effective strength of the cable. The aircraft manufacturer recommends a different type of shortener in which the cable passes round bolts rather than over sharp edges.
