ACCIDENT

Aircraft Type and Registration:	Slingsby T67M-MkII Firefly, G-BUUD	
No & Type of Engines:	1 Lycoming AEIO-320-D1B piston engine	
Year of Manufacture:	1993	
Date & Time (UTC):	16 July 2006 at 1356 hrs	
Location:	Hoxne, Suffolk (close to the Norfolk border)	
Type of Flight:	Private	
Persons on Board:	Crew - 1	Passengers - None
Injuries:	Crew - 1 (Fatal)	Passengers - N/A
Nature of Damage:	Aircraft destroyed	
Commander's Licence:	Private Pilot's Licence	
Commander's Age:	40 years	
Commander's Flying Experience:	83 hours (of which 18 were on type) Last 90 days - 8 hours Last 28 days - 2 hours	
Information Source:	AAIB Field Investigation

Synopsis

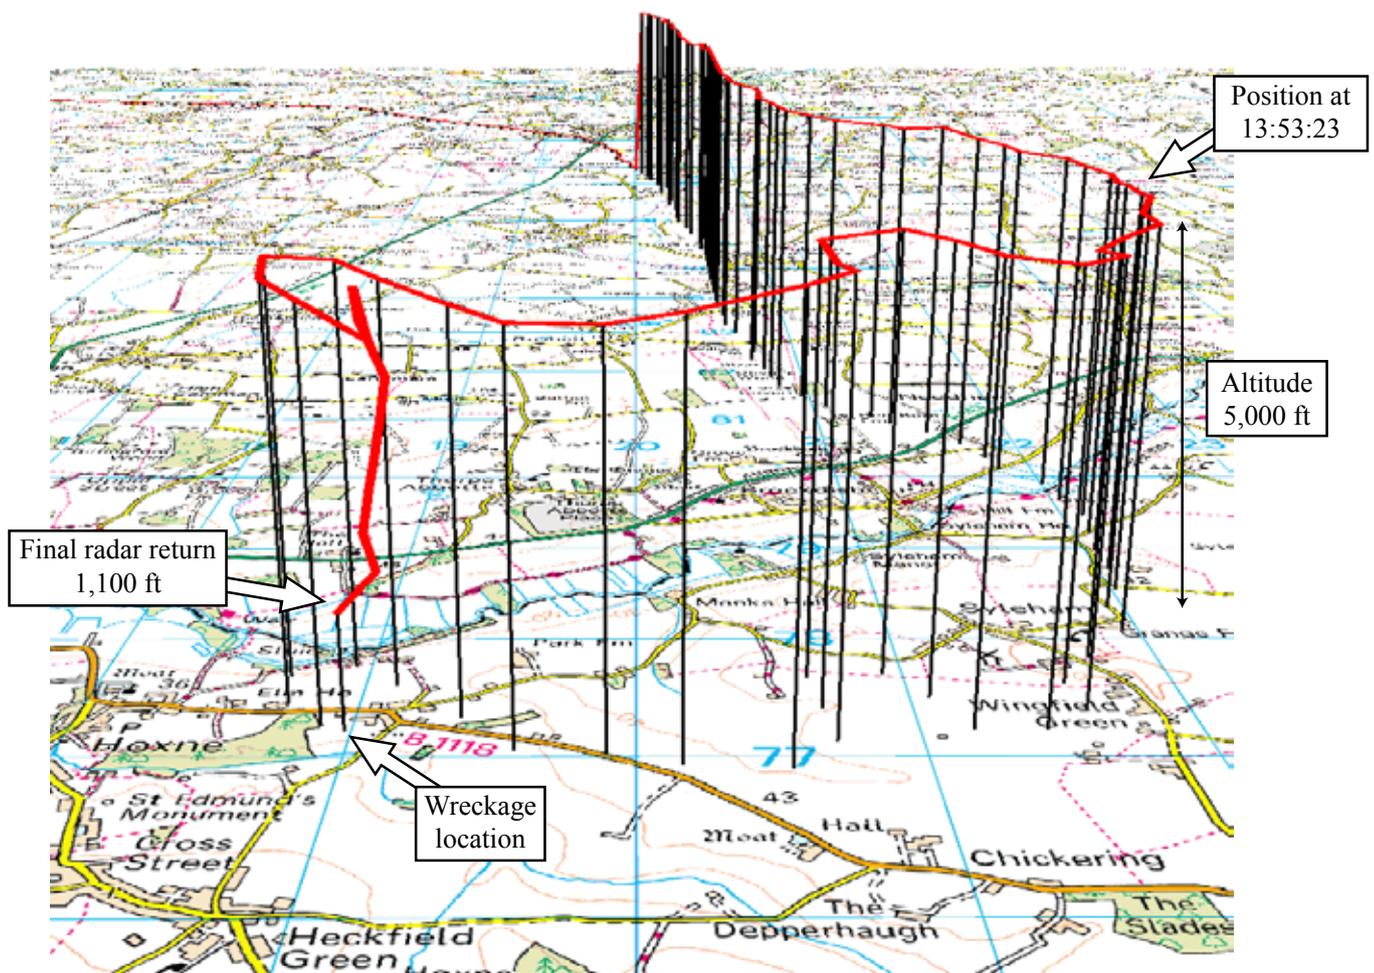
Figure 2

The data shows the aircraft continuing in the general direction of Hoxne (Figure 2), making several turns on the way whilst maintaining an altitude of about 5,000 ft. The final concentration of 10 radar returns occupy a small area, which contained G-BUUD's ground impact position, with the final radar return recording an altitude of 1,100 ft.

Isometric view of G-BUUD recorded radar
