Figure 2 Detail of No 6 Flap Track Forward End

INCIDENT TO B747 G-AWNM ON 11 SEPT 1988

SUBJECT: WINGS - TRAILING EDGE FLAPS -
REWORKED AND INTERIM PRODUCTION
FLAP TRACK FORWARD END CRACK
INSPECTION

Reason **FRACTURED TRACK NO 6 ON G-AWNM**

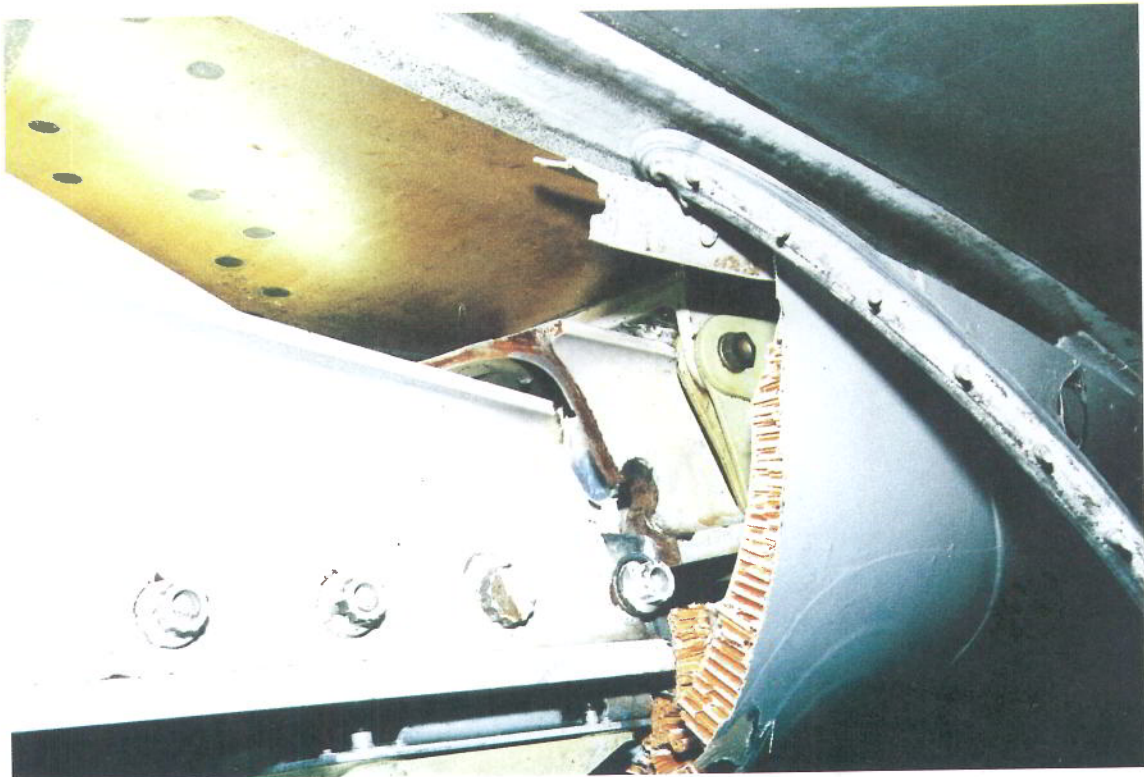
3. View of general damage to no. 6 flap track fairing.

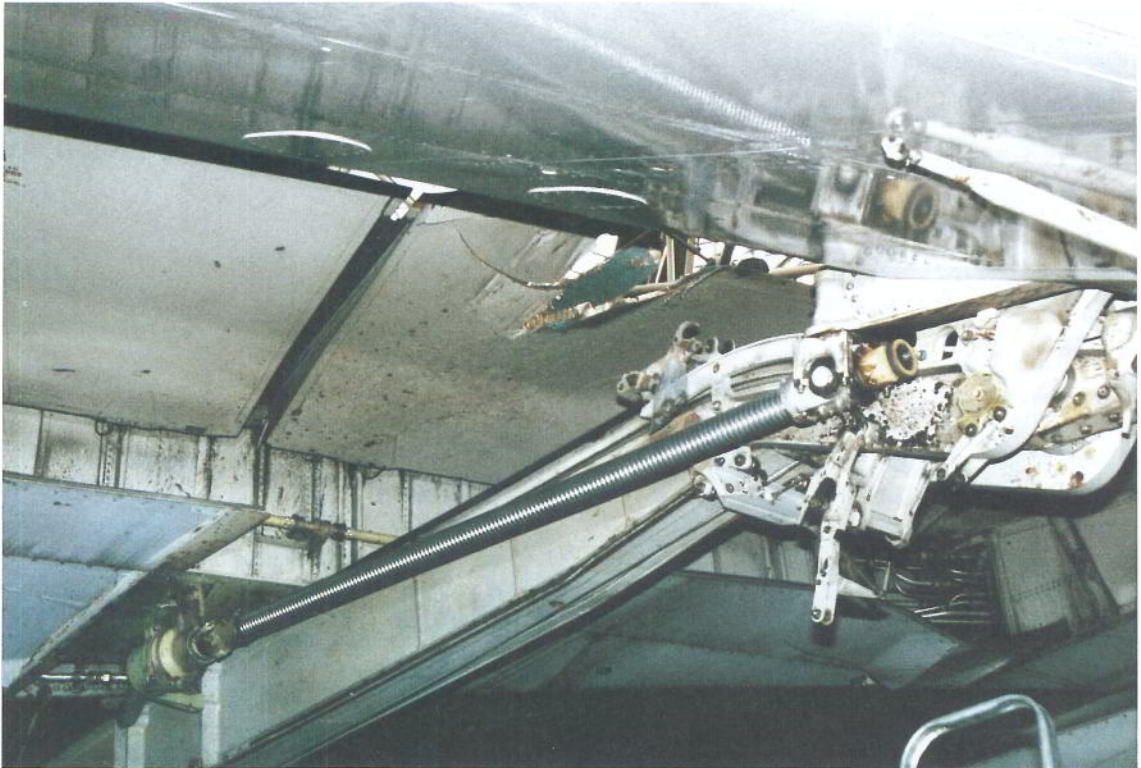
6. Showing secondary damage to spoiler caused by upwards displacement of No. 6 flap track and sequence carriage

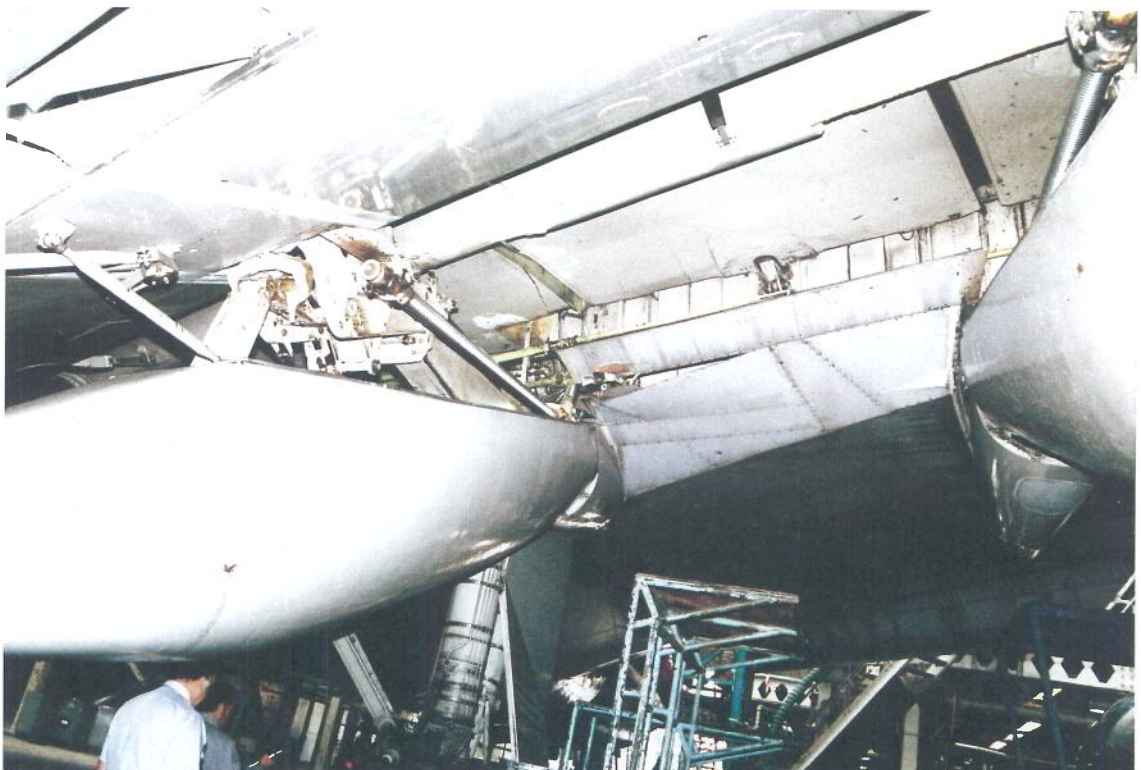
7. View of lower side of damaged spoiler

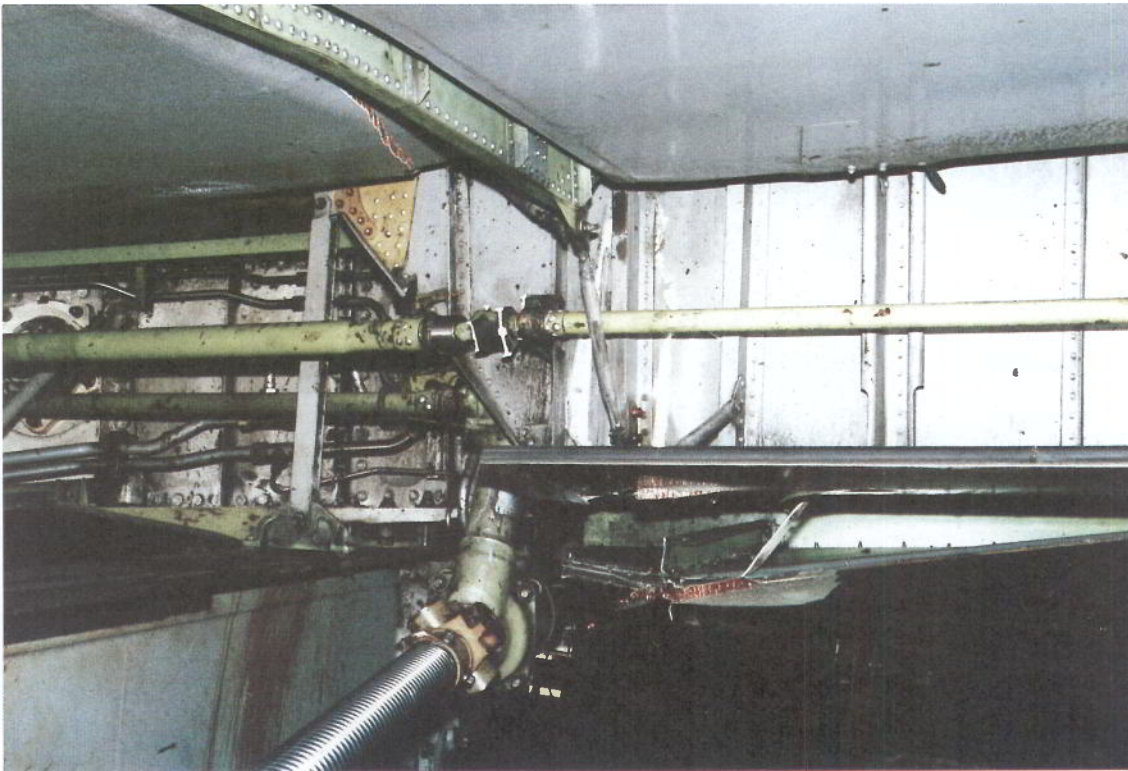
8. Showing damage to lower wing structure below spoiler support beam, adjacent no. 5 flap track

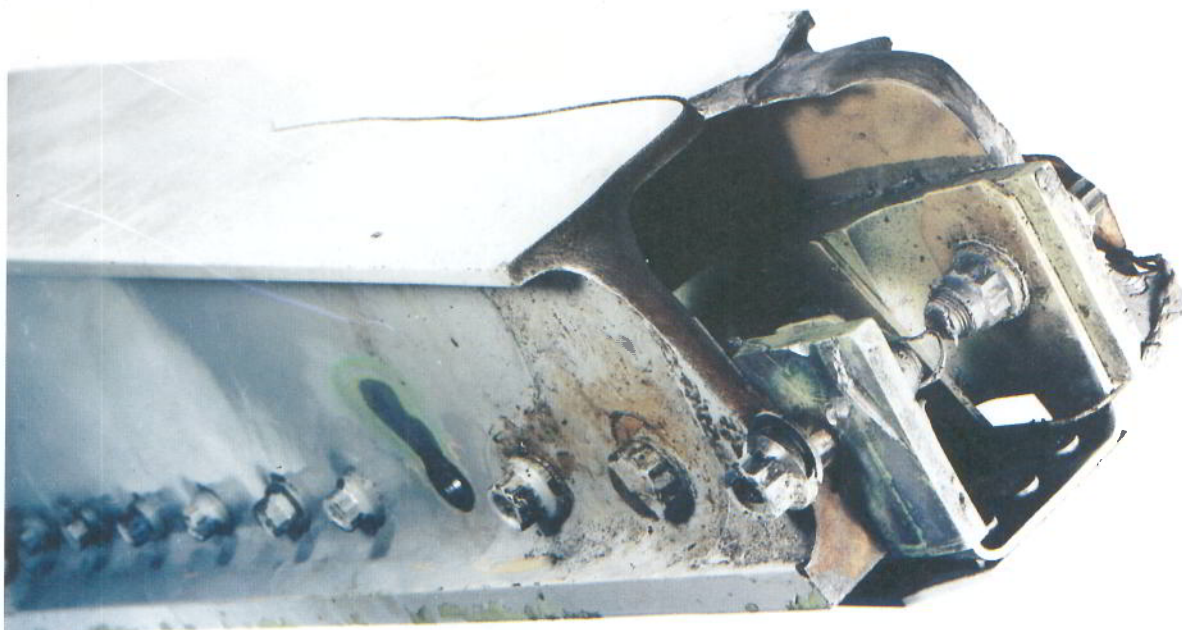
11. Separated forward end of flap track.

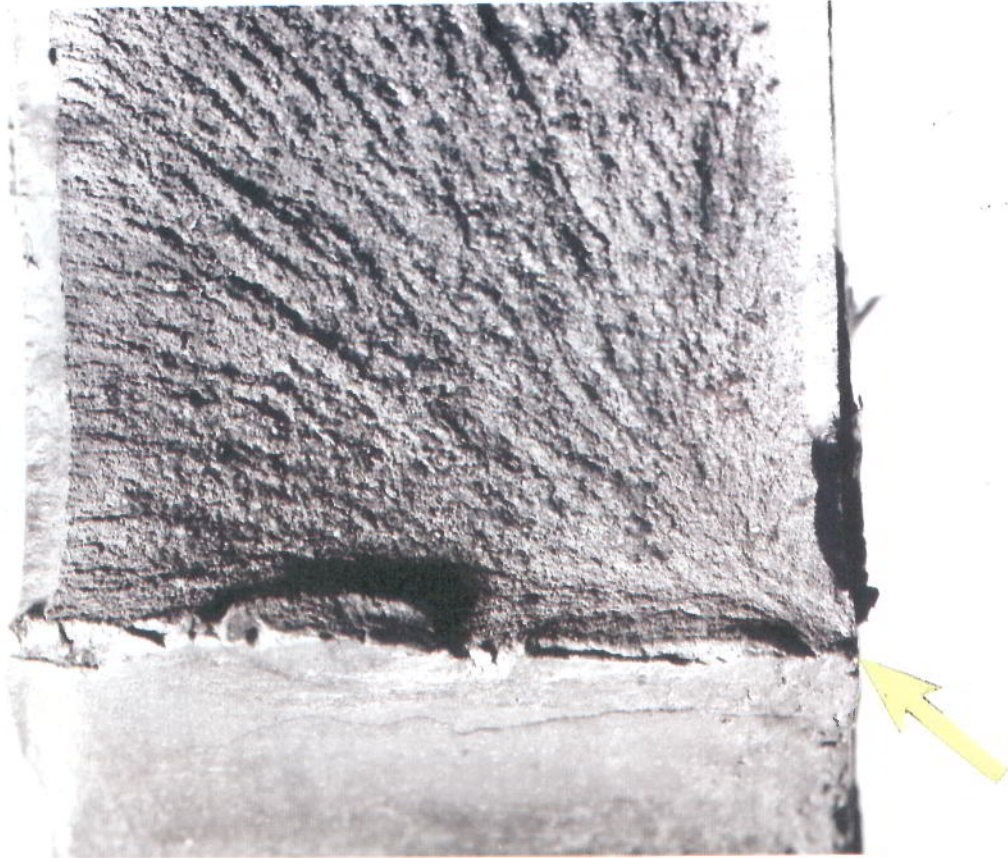
12. Showing corrosion on outboard web fracture, crack extension back along upper section and staining around crack at No.4 bolt hole.

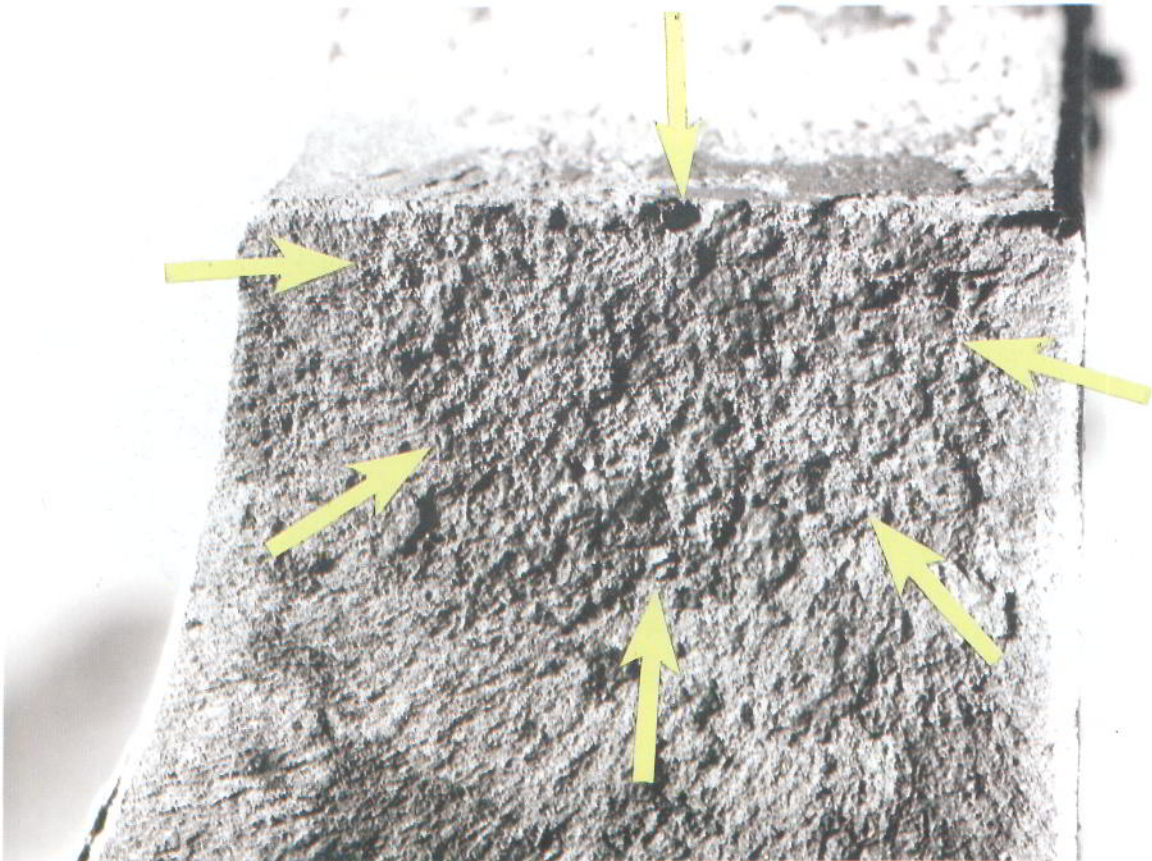
13. Showing fracture surface above outboard bolt hole, with origin arrowed.

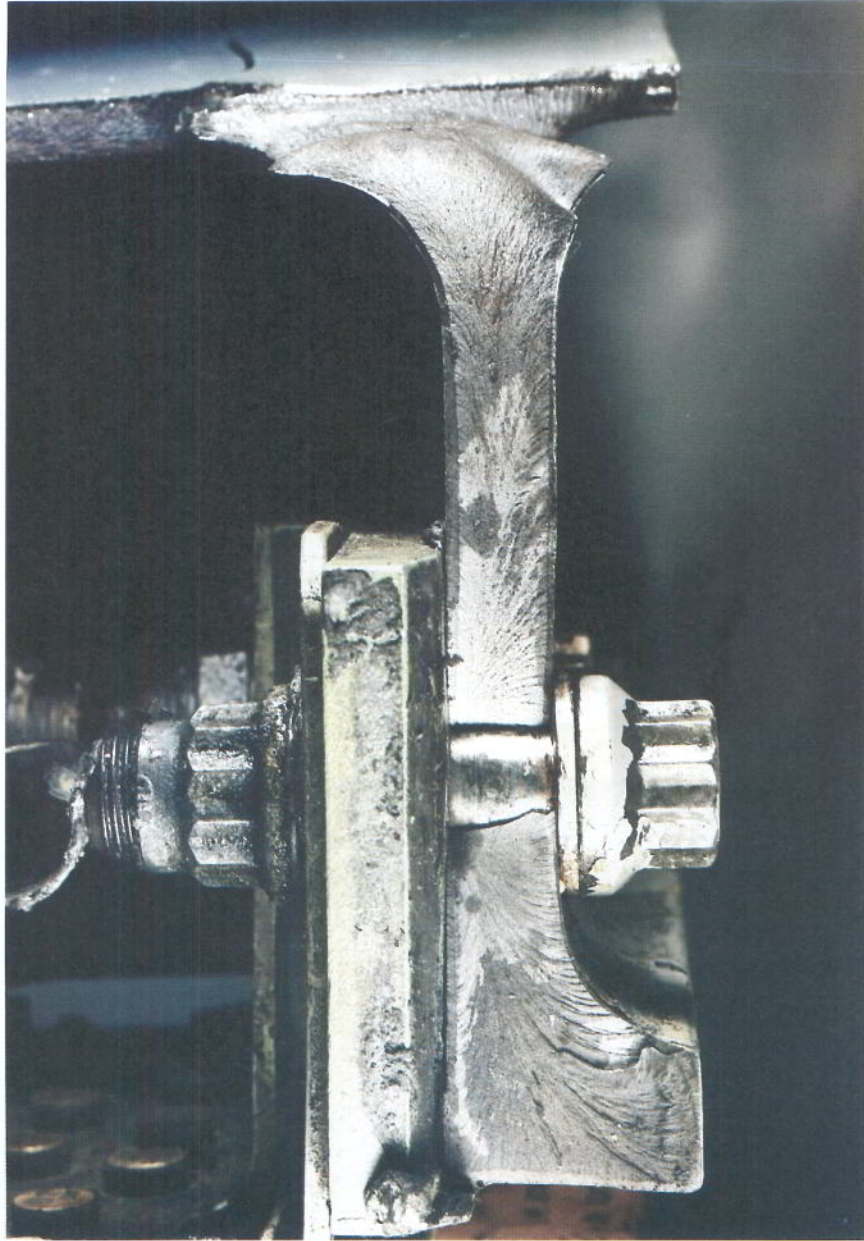
14. Showing fracture surface below outboard bolt hole, with corrosion pit and extent of intergranular crack arrowed.

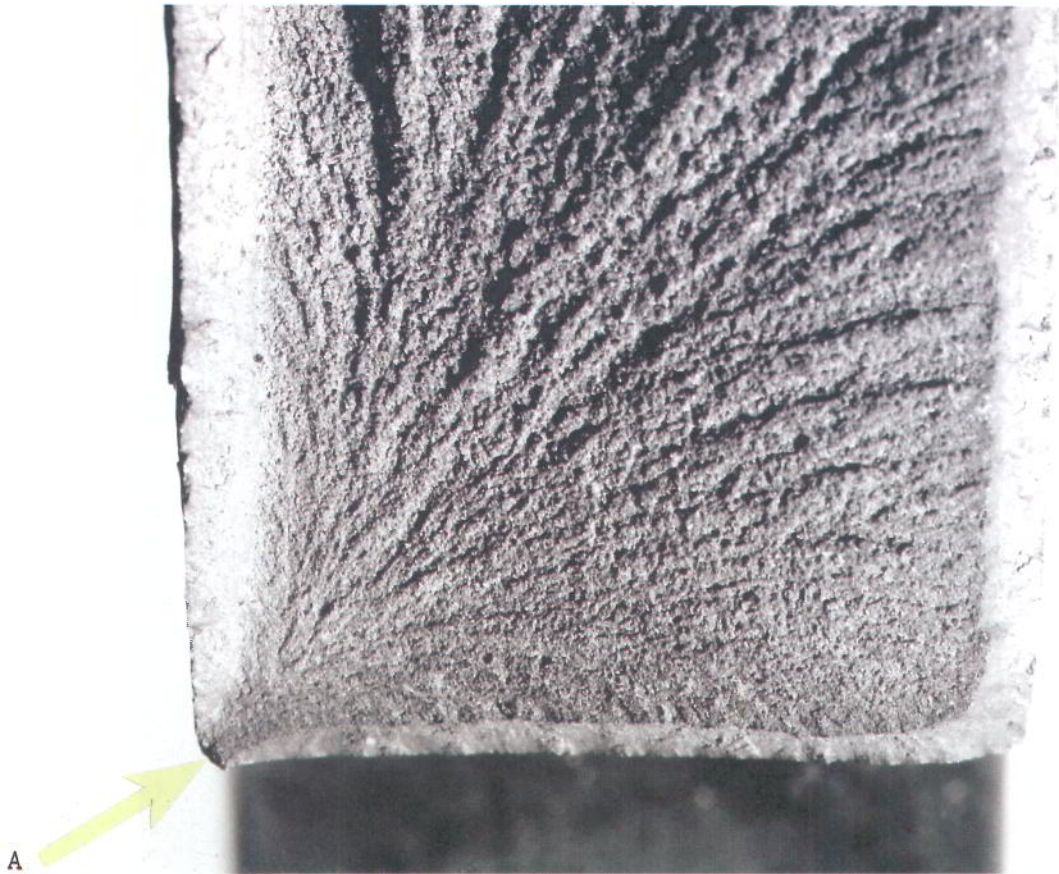
15. Showing fracture face on inboard web.

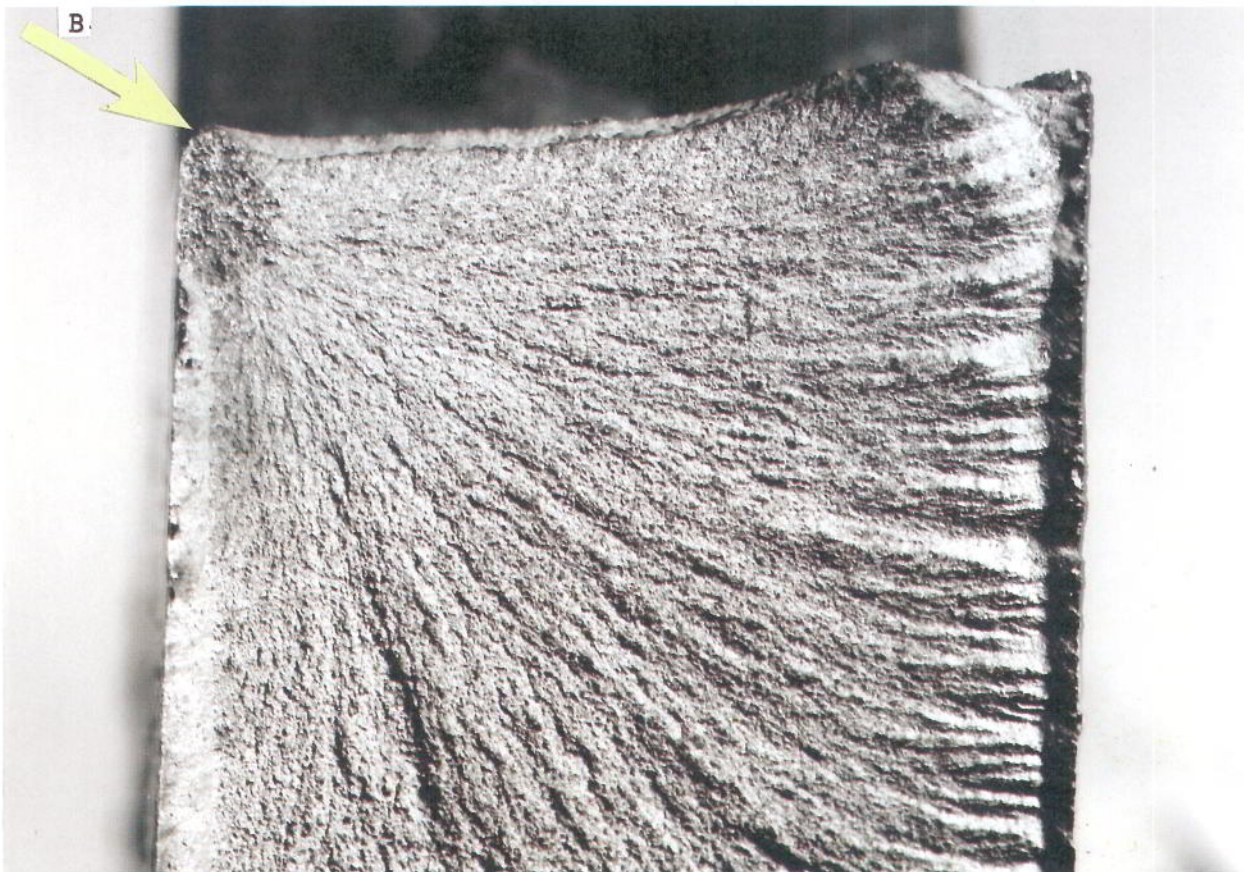
16. Showing fracture surface above inboard bolt hole with origin arrowed A.

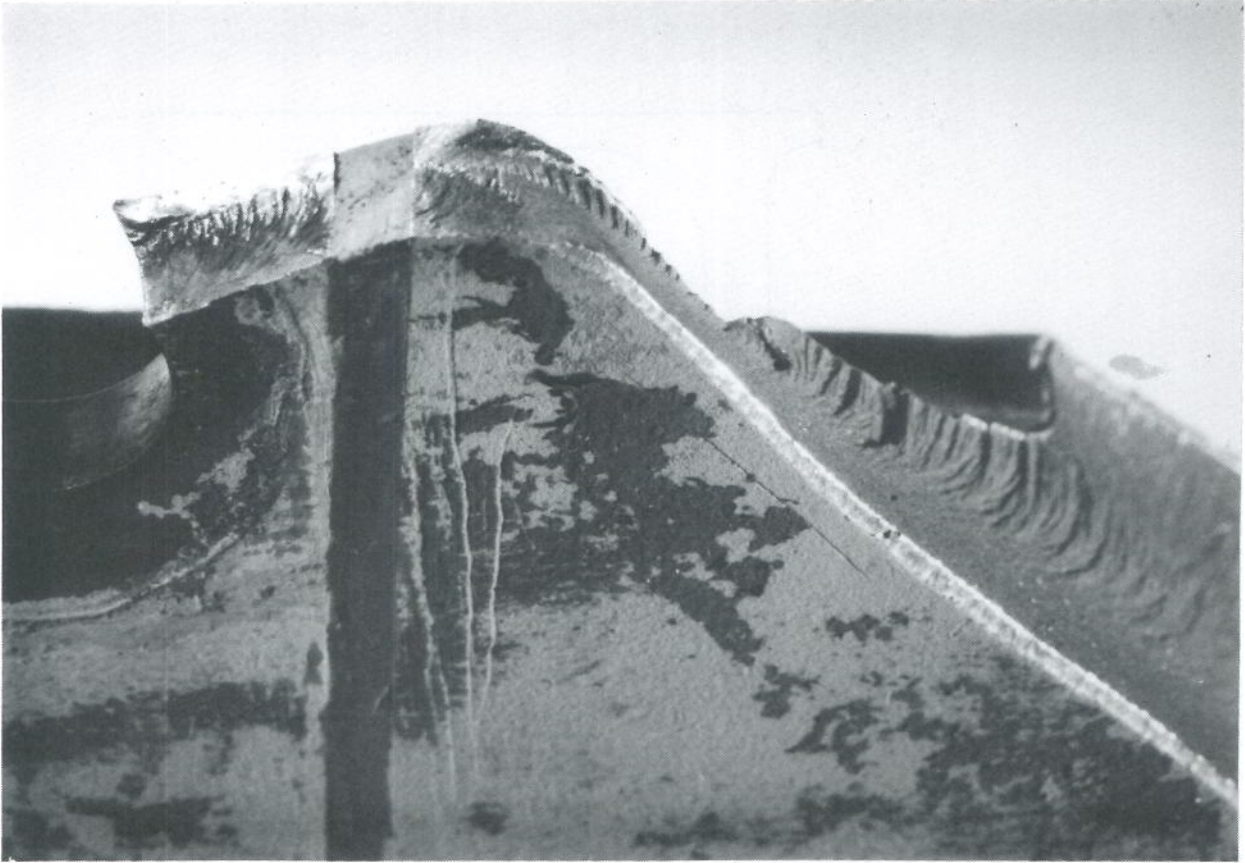
17. Showing fracture surface below inboard bolt hole with crack origin arrowed B.

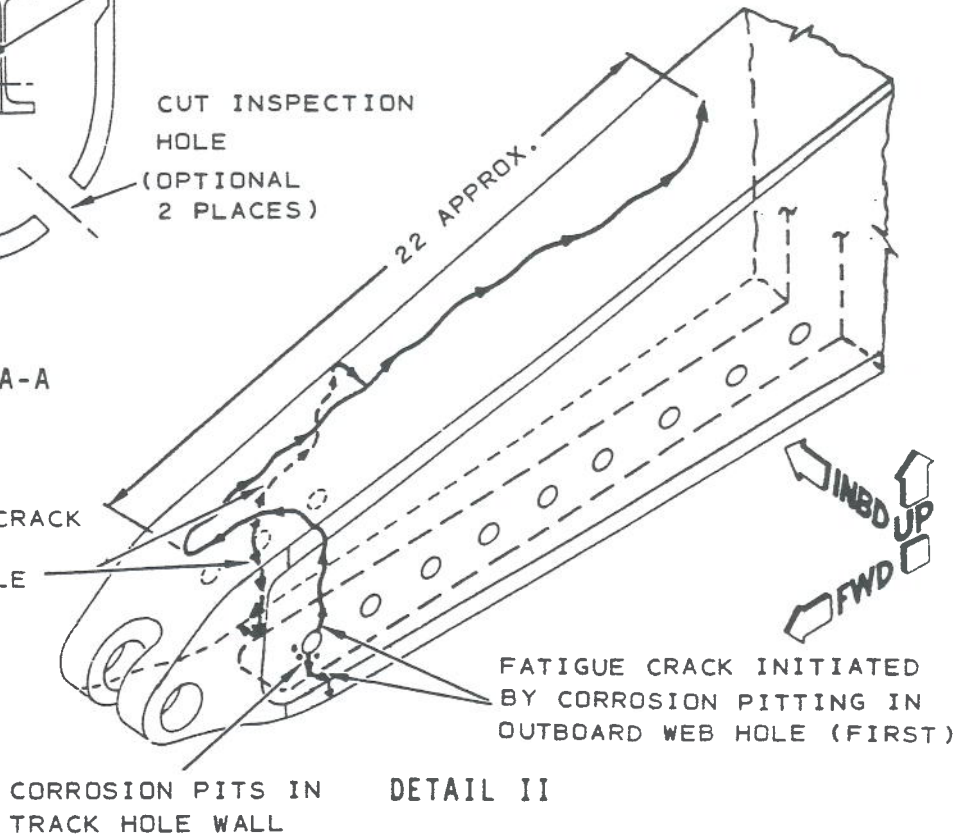
STRESS CORROSION CRACK INITIATED AT INBOARD WEB HOLE (SECOND)

REPORTED BROKEN REWORKED TRACK 3 AT 45,436 FLIGHT-HOURS AND 12,106 FLIGHT-CYCLES

The track broke five inches aft of the forward fuse pin. A crack initiated by corrosion pitting on the wall of the forward outboard failsafe bar hole, and propagated by fatigue. Later, another crack was initiated by stress corrosion on the faying surface near the second inboard failsafe bar hole, and also propagated by fatigue. The two cracks intersected in the inboard upper flange, upon rapid final track fracture.

If any cracks are found, replace the cracked track with a new track before further flight.
