**No: 2/91**

**Ref: EW/C1176**

Hughes 369 HS, G-OAIM

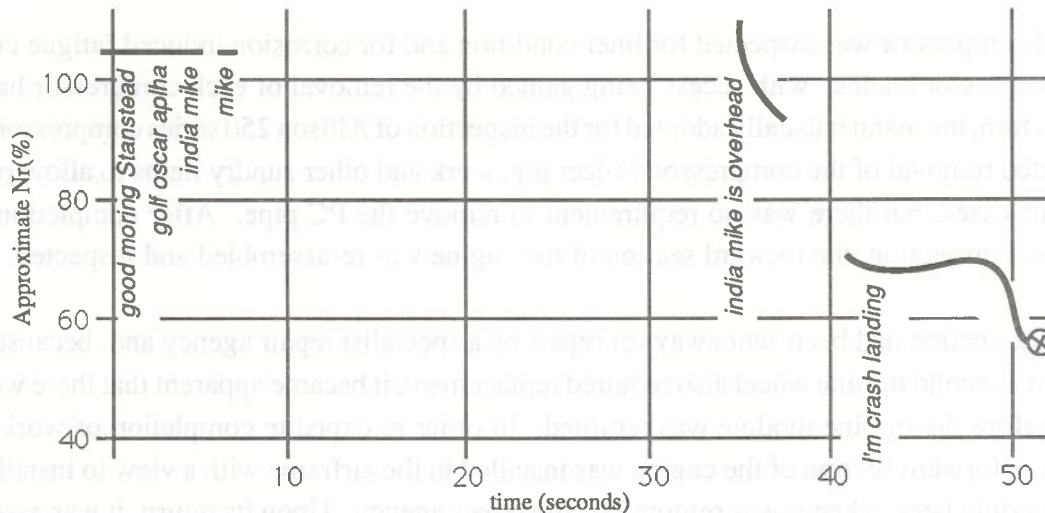
From the spectral analysis it was possible to identify frequencies which it is believed were consistent with the rotational speed of the main transmission input shaft, though a measure of uncertainty existed regarding the exact value of rotor RPM (%Nr) because of possible variations in the speeds of the recorder tape transport mechanism. The analysis nevertheless provided valuable indications of rotor RPM trends during the three periods of ATC transmission made during accident flight, together with approximate values of rotor RPM. In fig1 the variation in rotor RPM, expressed as percentage Nr, is plotted against an arbitrary time base in seconds, together with speech transcripts. The nominal value of main rotor RPM during the initial transmission, when there was apparently no problem, was steady at a (nominal) value of about 104% (data uncorrected for tape transport errors). However, at the start of the second transmission, RPM is decaying rapidly from an initial value of approximately 109% Nr to a value of approximately 96% at the time that this transmission terminates some 2-3 seconds later. When the transmission resumes, some 4 seconds later, RPM has decayed to approximately 70% Nr, and thereafter appears to stabilise for about 9 seconds at values between 66% Nr and 70% Nr, before falling rapidly to about 56% immediately prior to the end of the transmission.

The indications of very low rotor RPM were consistent with both the heavy blade coning observed on all main rotor blades and with the very high rate of descent at impact, and clearly indicated that the main rotors were not being driven under significant power at any time during the descent.

**Fig 1. G-OAIM Hughes 369 Helicopter**  
Main rotor RPM trends derived from ATC recording  
(transmissions from G-OAIM in italics)

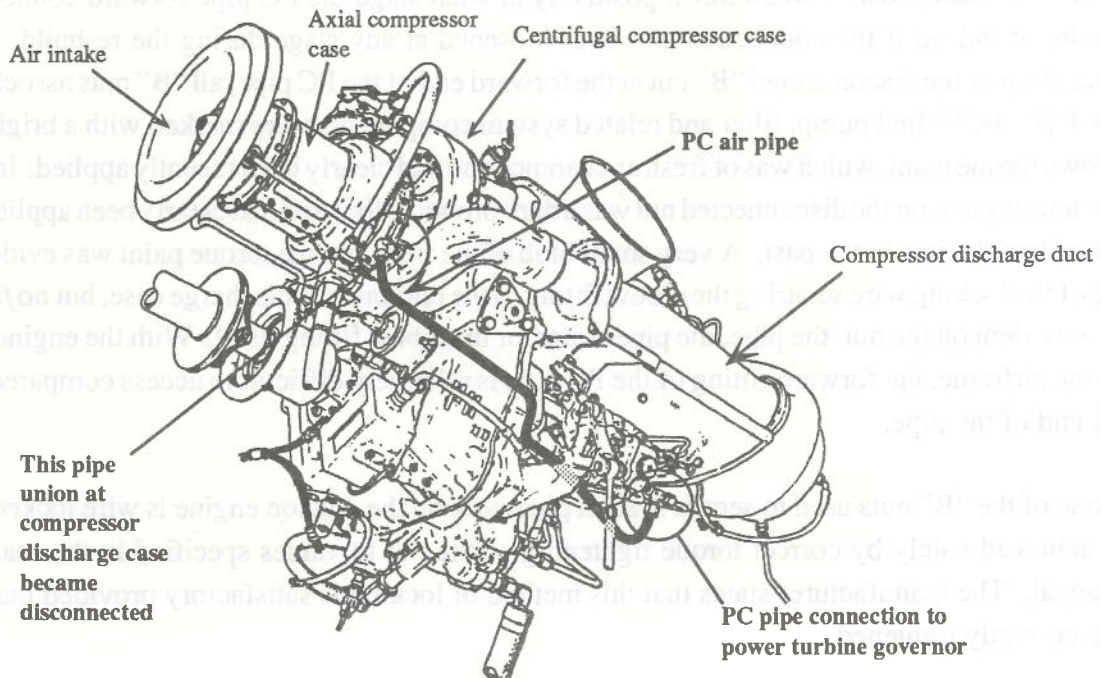
The PC pipe supplies both the power turbine fuel governor and the gas producer fuel control unit with a reference pressure which is used by both systems as an indication of gas producer speed. Any reduction in PC pressure, as seen by the fuel control/governor units, would result in a reduction in fuel flow. A major leak in the PC air pipework, due to a complete disconnection of the pipe, would cause the engine to run down to idle; intermediate conditions involving a partial leak would potentially produce power reductions of lesser proportions. Variations in leakage rate caused by movement of a loose pipe connection might be expected to produced power fluctuations, though the magnitude of such fluctuations cannot be accurately predicted.

**Fig 2. Allison C250 engine**  
(location of PC air pipe)

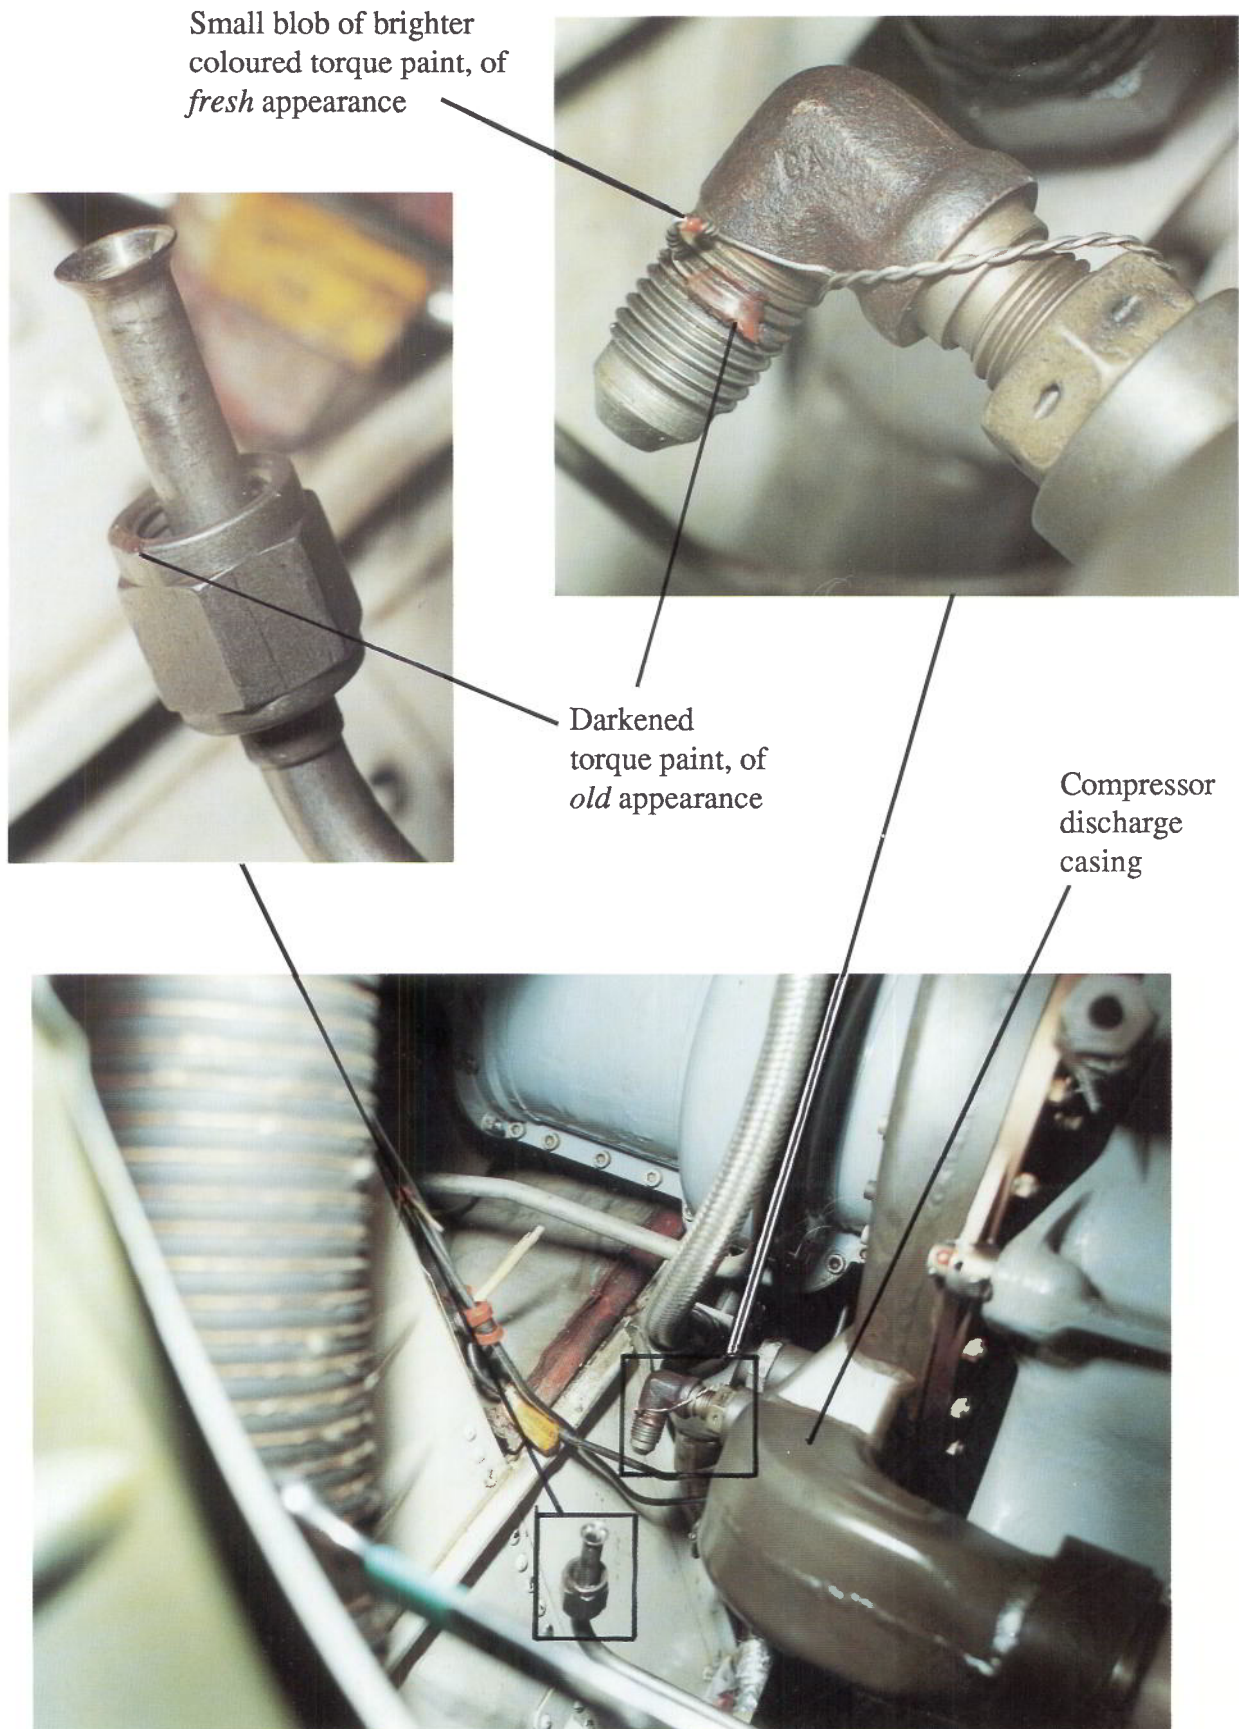
An external examination of the engine prior to removal from the airframe confirmed that both the gas producer and power turbine rotating assemblies were free and that the main transmission and over-run clutch were intact. However, it was found that the nut (of a type known as a “B” nut) securing the compressor delivery pressure sensing (PC) pipe to the elbow fitting at the compressor discharge casing was undone and the pipe had separated from the elbow.

No evidence was found to suggest that the nut had come undone, or had been knocked off, during the impact, although the pipe had suffered some impact damage at its opposite end, where it attaches to the power turbine governor (PTG). All the evidence clearly indicated that the nut had come undone prior to the impact, and the impact damage to the pipe at its aft end, adjacent to the PTG, had merely resulted in the already disconnected pipe moving further from the elbow at its forward end.

It has not been possible to establish positively at what stage the PC pipe forward connection was made, or indeed if the connection was ever loosened at any stage during the re-build. With the exception of the disconnected "B" nut at the forward end of the PC pipe, all "B" nuts associated with the PTG, FCU, fuel pump, filter and related system components were marked with a bright orange/brown torque paint, which was of fresh appearance and had clearly been recently applied. In contrast, the torque paint on the disconnected nut was a dark brown colour and had clearly been applied at some considerable time in the past. A very small blob of the fresh orange torque paint was evident on the tip of the locking wire securing the elbow fitting to the compressor discharge case, but no *fresh* paint was evident on the nut, the pipe, the pipe collar, or the elbow fitting itself. With the engine installed in the airframe, the forward fitting of the PC pipe is relatively difficult to access compared with the aft end of the pipe.

**Fig. 3** PC air pipe at compressor casing on G-OAIM  
(shown disconnected, *as found* post accident)

The CAA have been recommended to review the work practices generally in use by maintenance organizations engaged in the disassembly and rebuilding of modular engines.
