Aircraft Type and Registration:	Agusta A109E, G-HIMJ	
No & Type of Engines:	2 Pratt & Whitney Canada PW206C turboshaft engines	
Year of Manufacture:	2003	
Date & Time (UTC):	14 March 2004 at 1600 hrs	
Location:	Colney Park Heliport, Leeds Bradford Airport, Leeds	
Type of Flight:	Private	
Persons on Board:	Crew - 1	Passengers - 1
Injuries:	Crew - None	Passengers - None
Nature of Damage:	All three landing gear units badly damaged. Wrinkling of the aircraft structure. Tail rotor drive shaft failure. Damage to the tail rotor drive shaft tunnel and engine drive shaft. Failure of four bolts securing lower attachment lug bracket of main rotor gearbox aft left brace assembly	
Commander's Licence:	Private Pilot's Licence	
Commander's Age:	54 years	
Commander's Flying Experience:	2,958 hours (of which 614 were on type) Last 90 days - 46 hours Last 28 days - 26 hours	
Information Source:	AAIB Field Investigation

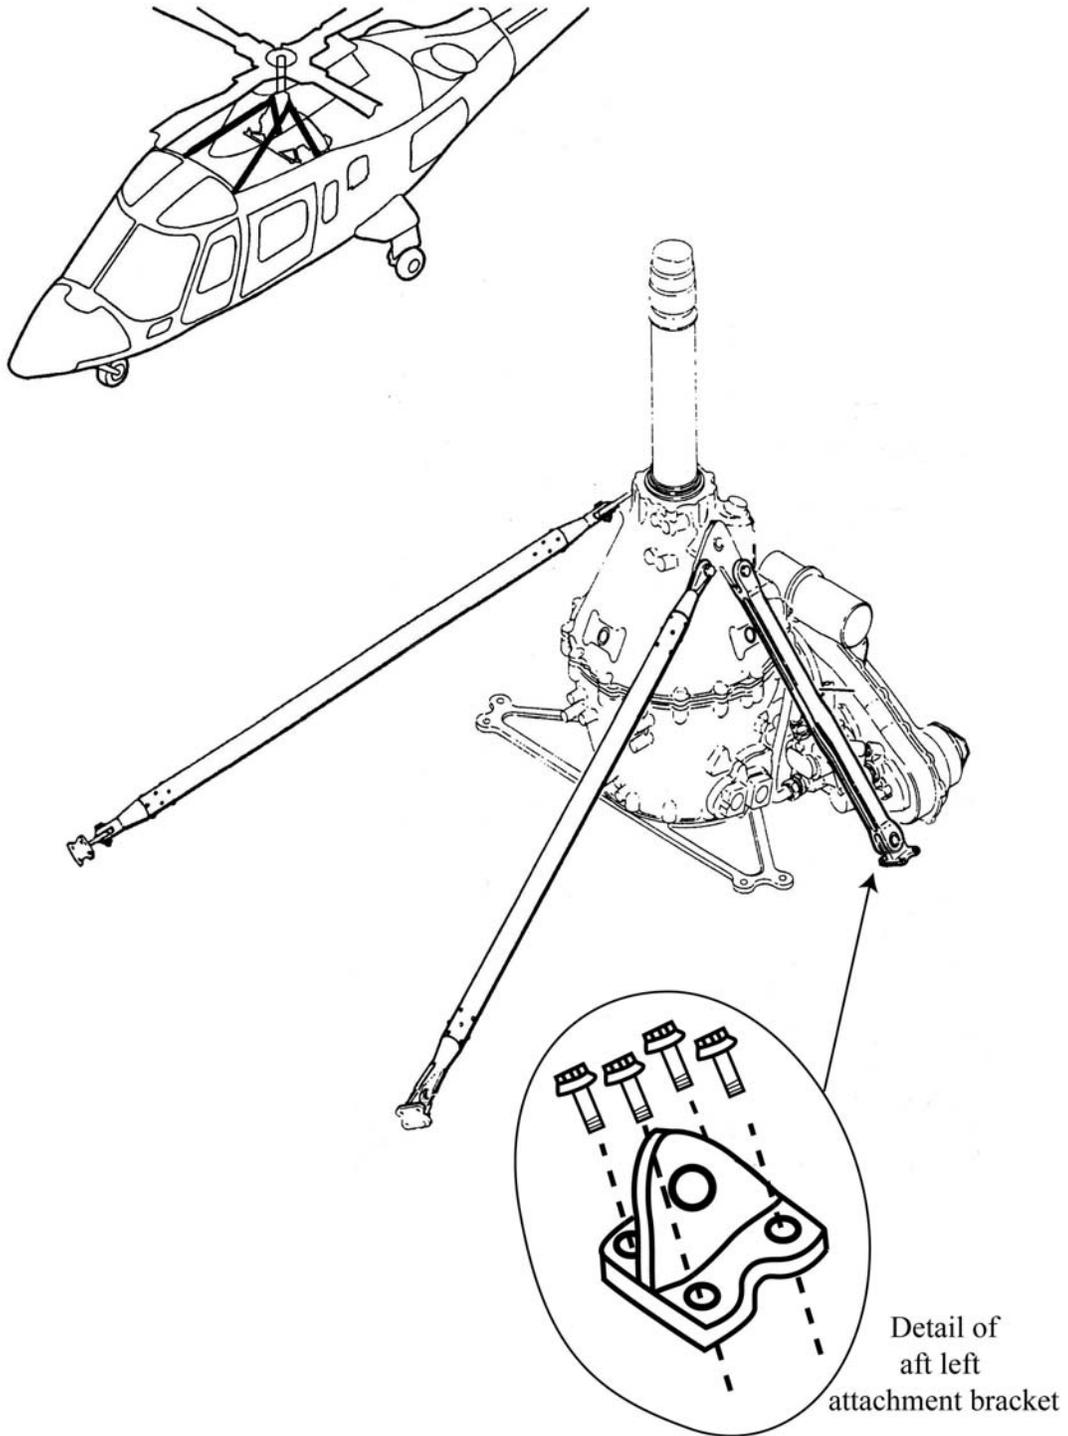
Figure 1

The two forward main rotor gearbox brace assemblies slope upwards and aft from their forward attachments on the cabin roof and are angled at approximately 30 degrees to the longitudinal axis of the aircraft when viewed in side elevation. The rear brace assemblies have axes nearer the vertical when so viewed. The lower ends of both forward and rear brace assemblies are mounted close the edges of the cabin roof structure and slope inwards to their attachments near the top of the gearbox when viewed in front or rear elevation. (See Figure 1.)
