ACCIDENT

Aircraft Type and Registration:	Piper PA-38-112 Tomahawk, G-BOLF	
No & Type of Engines:	1 Lycoming O-235-L2C piston engine	
Year of Manufacture:	1979	
Date & Time (UTC):	17 October 2008 at 1520 hrs	
Location:	Robin Hood's Bay, North Yorkshire	
Type of Flight:	Private	
Persons on Board:	Crew - 1	Passengers - None
Injuries:	Crew - 1 (Fatal)	Passengers - N/A
Nature of Damage:	Aircraft destroyed	
Commander's Licence:	Private Pilot's Licence	
Commander's Age:	45 years	
Commander's Flying Experience:	50 hours (all of which were on type) Last 90 days - 27 hours Last 28 days - 4 hours	
Information Source:	AAIB Field Investigation

Synopsis

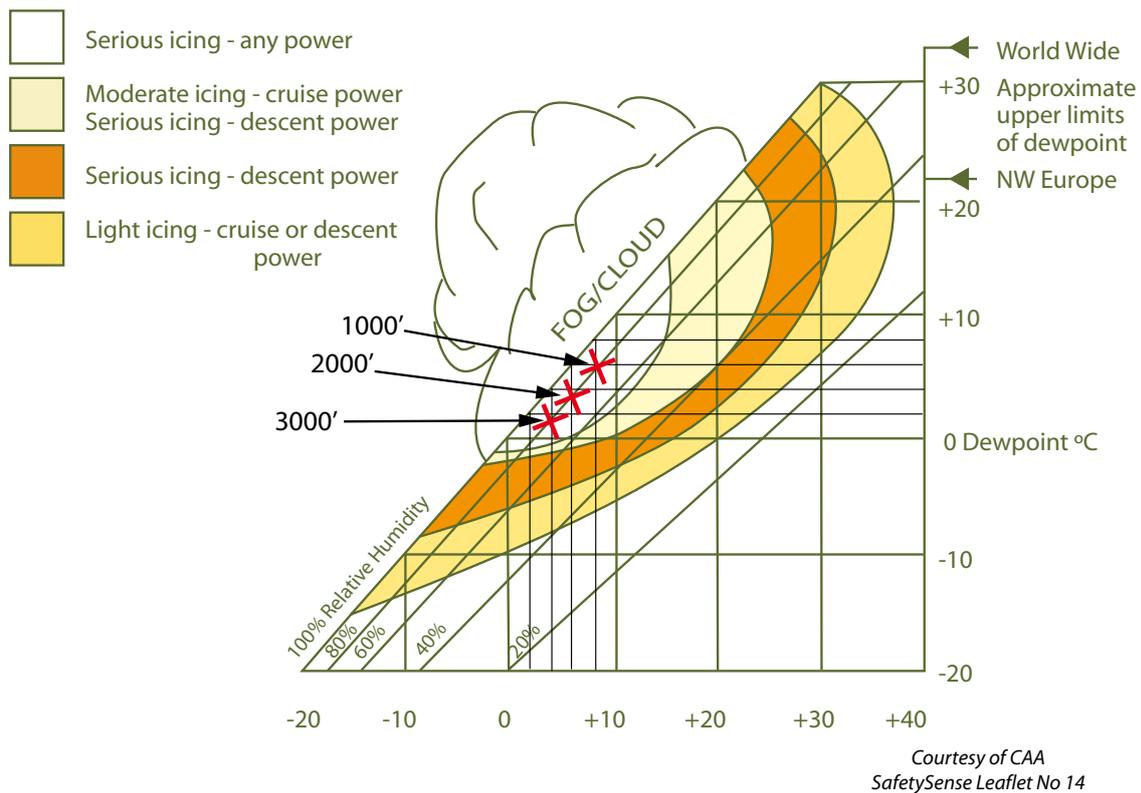
The Met Office aftercast for the Robin Hood's Bay area at the time of the accident gave the air temperature, dew point and humidity from the surface to 3,000 feet in bands of 500 ft. When these figures were plotted on the Civil Aviation Authority (CAA) Carburettor Icing Prediction Chart it gave a prognosis that serious carburettor icing could occur at any power setting between 1,000 and 3,000 feet amsl (Figure 1).

Figure 1
CAA carburettor icing probability chart

It was apparent that the aircraft had suffered a loss of engine power. Given that the conditions at the time were conducive to carburettor icing at any power setting, the possibility of loss of engine power due to carburettor icing could not be ruled out, but this does not appear consistent with the witness report of hearing an engine increasing to high power, then decreasing and increasing again. It could not be determined how or when the spindle of the fuel pump had become bent. It was not possible to positively determine the reason for the loss of engine power from the available evidence.
