Air Accidents Investigation Branch

**Report on the accident to
British Aerospace Jetstream 3202,
registration G-BUVC
at Wick Airport, Caithness, Scotland
on 3 October 2006**

Published 12 February 2008

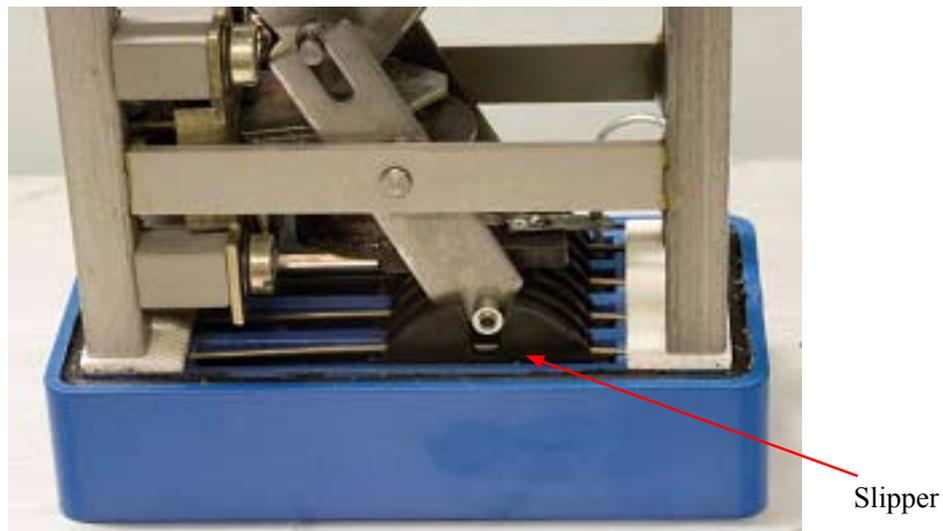
Figure 1
Landing gear selector switch

The landing gear selector switch is a four-pole device and each pole consists of a slipper contact that moves between three fixed contacts. The switch incorporates an electrically operated safety device that prevents an 'UP' selection being made when the aircraft is on the ground.

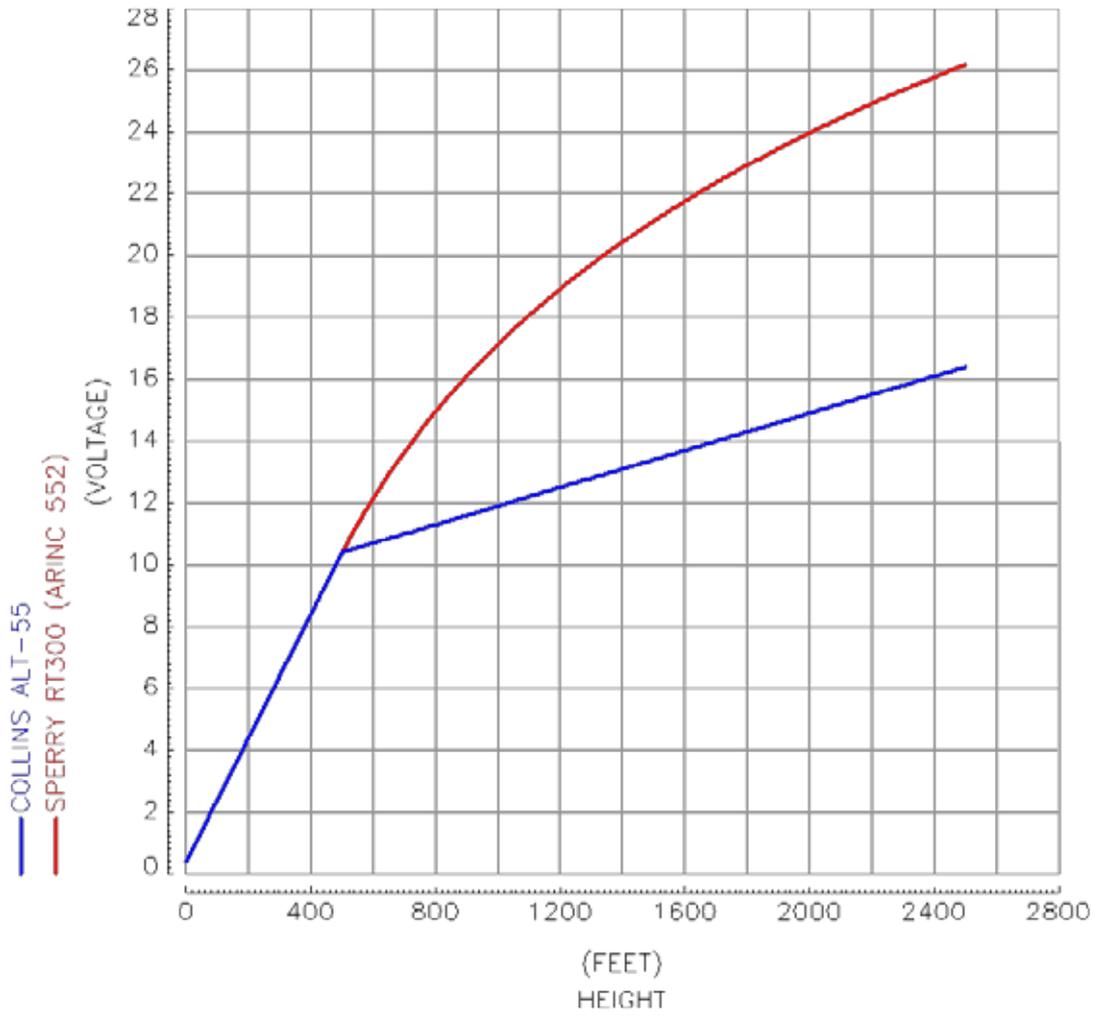
Figure 2

Shortly after the accident, it was found that the ST3400 RA configuration setting was set at 'ALT55'. It was not possible to determine whether this setting had been made at the time of installation, or subsequently. It was also discovered that the STC test of the TAWS RA would not have highlighted this incorrect setting. At heights of up to 500 ft, the signal characteristics from both RA's (Sperry RT300 and Collins ALT-55) were almost identical. The RT300 self test did not extend the height beyond 100 ft. The consequence of setting 'ALT55' was that the ST3400 would start to noticeably over-read at heights above 500 ft; the effect on TAWS warnings is discussed in detail in paragraph 1.6.3.8.

Sperry RT300 – Collins ALT-55 Voltage/Height

It is recommended that the US Federal Aviation Administration review the technical data supporting STC SA3020AT for the introduction of the Sandel ST3400 TAWS to ensure that the post installation test is sufficient to validate the full range of inputs into the system. (Safety Recommendation 2006-135)

It is recommended that the US Federal Aviation Administration take immediate action to ensure that aircraft equipped with the Sandel ST3400 TAWS have the correct radio altimeter type set and that the system is tested to ensure that the radio altimeter signal is correct over the operating range specified in the Sandel ST3400 installation manual. (Safety Recommendation 2006-136)

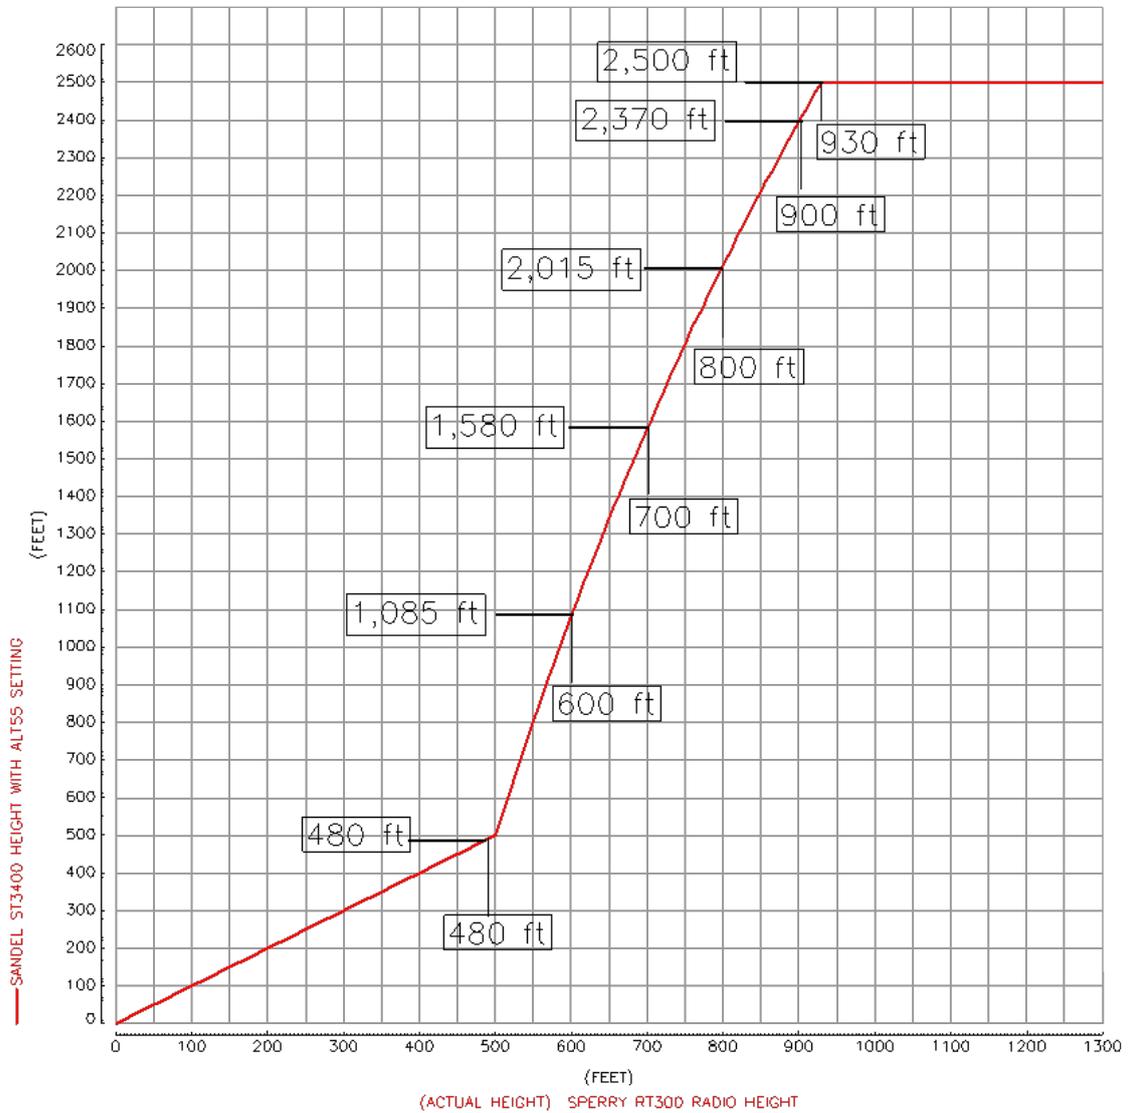
Figure 3
 SANDEL ST3400 height/actual height

At heights less than 500 ft, the warning envelope will not be affected. From 500 to 2,500 ft, the aircraft may have attained a higher rate of descent than specified by the Minimum Performance Standards (MPS), without triggering a warning. At a height of 1,000 ft, the MPS specified warning limit is 2,360 feet per minute (fpm); this trigger point will be increased to 4,900 fpm.

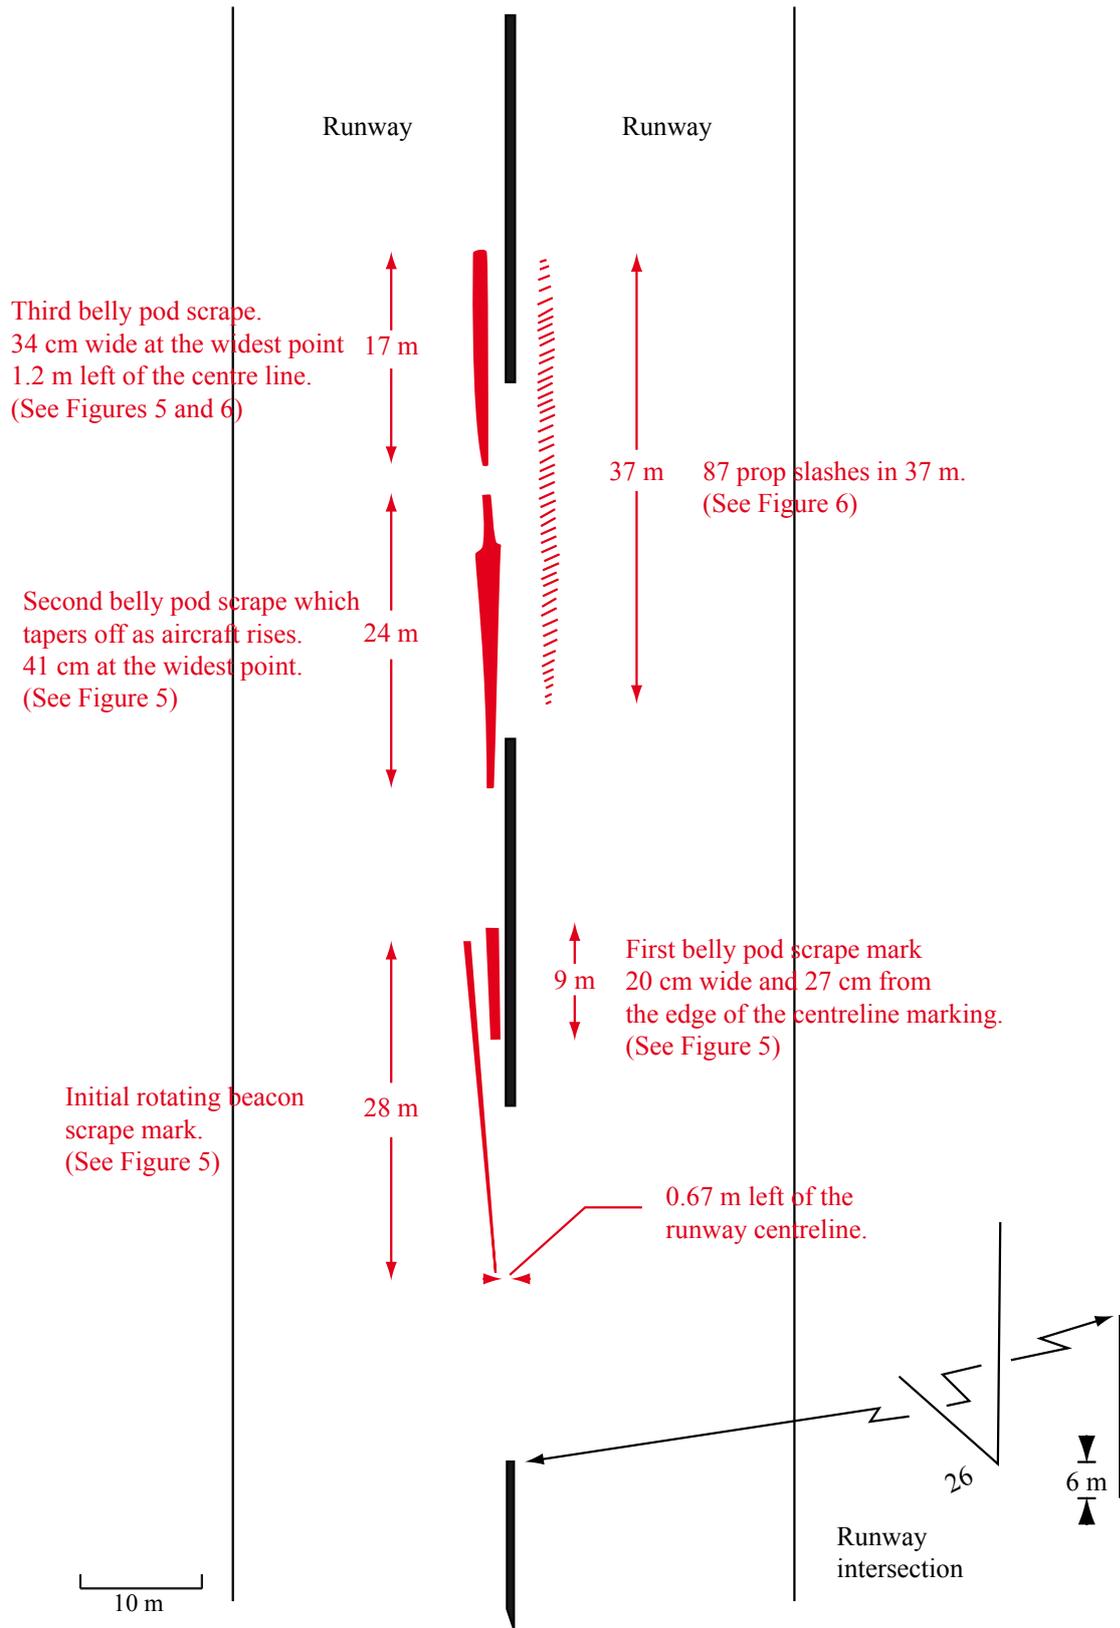
Figure 4
Runway Witness Marks

Witness marks indicate that G-BUVC had been in contact with the surface of Runway 31 at Wick for approximately 84 m (see Figures 4, 5 and 6). The marks started approximately 6 m from the intersection of Runway 26 and were slightly to the left of the runway centre line. The first contact was made by the lower rotating beacon followed by three separate scrape marks which had been made by the pannier. There were 87 propeller slash marks, 42 cm apart, over the last 37 m of the contact area. The marks from the pannier and propeller stopped at the same point on the runway.

Third belly pod scrape.
34 cm wide at the widest point
1.2 m left of centreline

First belly pod scrape mark
20 cm wide and 27 cm from the
edge of the centreline marking

Initial rotating beacon
scrape mark.

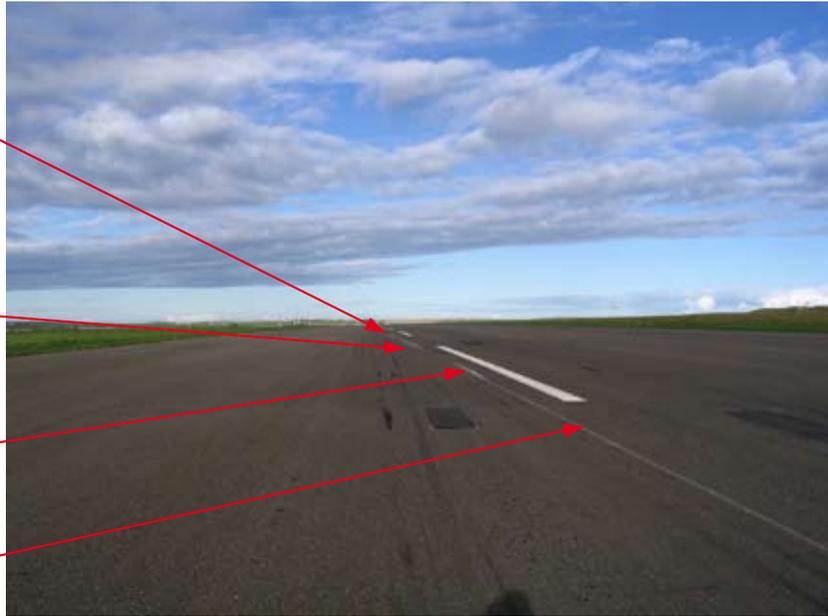
Figure 5

Pod and beacon scrape marks

Third belly pod scrape.
34 cm wide at the widest point
1.2 m left of centreline

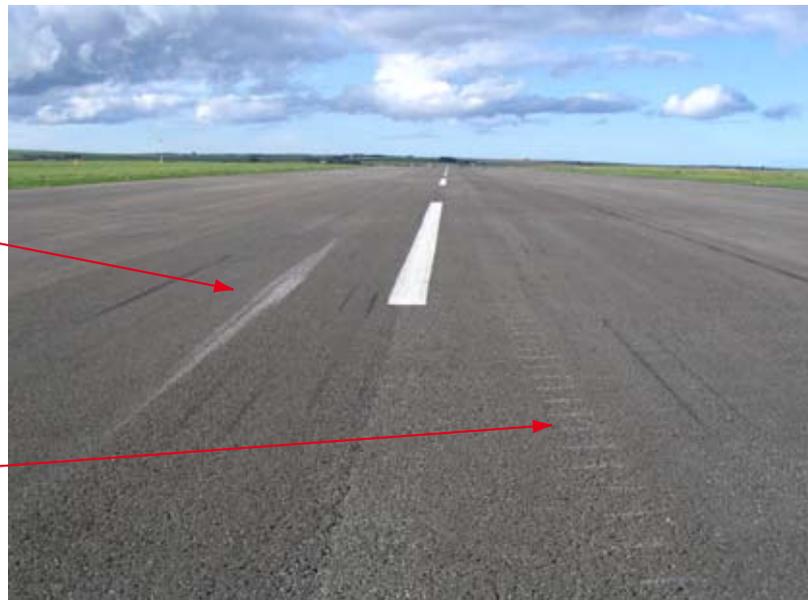
Figure 6

87 prop slashes in 37 m

Pod scrape and propeller slash marks

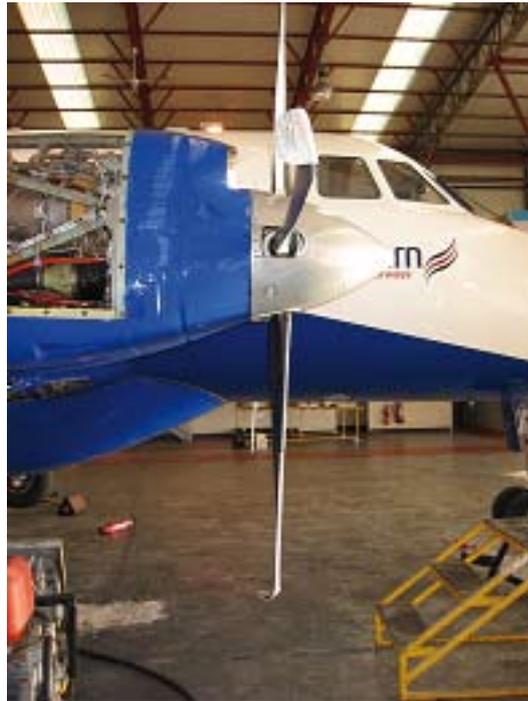
Figure 7

The outer 9 cm of all the blade tips on the right engine had bent backwards by approximately 110°; the bend started at 12 to 13 cm from the tips. The end of all the blades were scored and did not appear to have been bent either forward or backwards, which suggests that the engine was producing relatively little power when the blades contacted the runway.

Damage to propeller blade tips

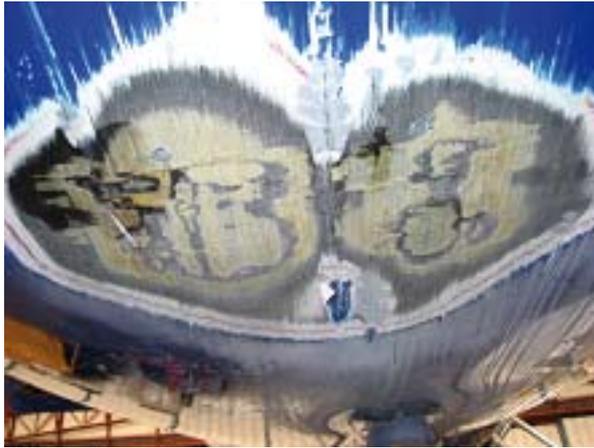
Figure 8

There were several small dents on the right flap which might have been caused by parts of the runway surface being thrown up by the propeller. An area on the bottom of the pannier, in line with the rear spar, approximately 40 cm long and 46 cm wide had worn through the gel coat and the first layer of fiberglass: the wear was slightly more extensive on the right side of the pannier. There was also a small crack on the top left side of the pannier just forward of the wing leading edge.

Damage to pannier

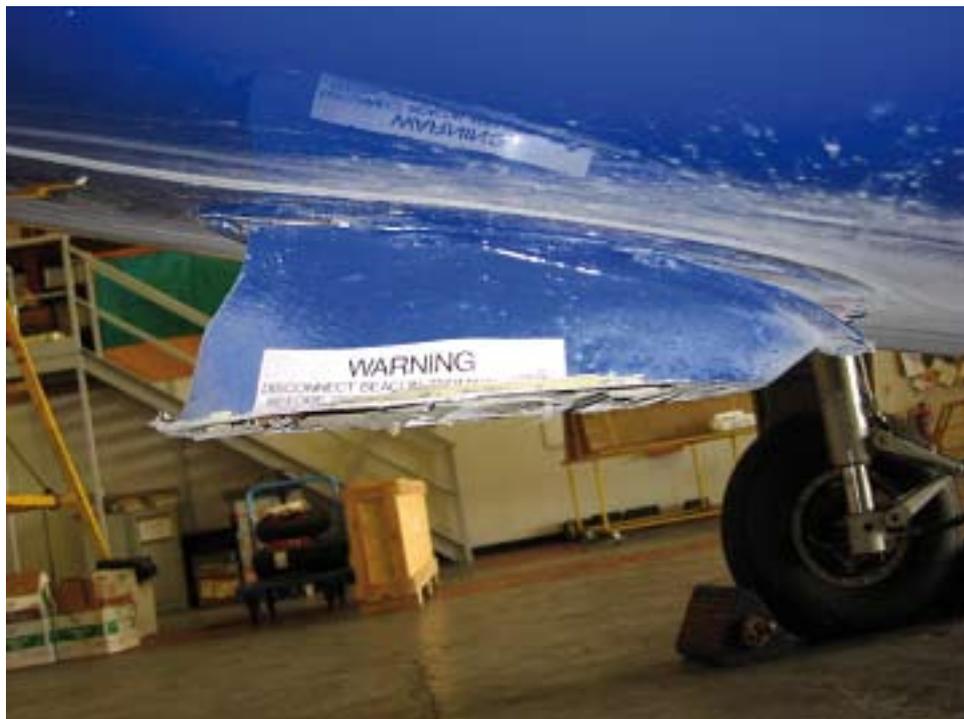
Figure 9

The lower anti-collision light cover was missing and the forward face of the mounting pylon had pulled away from the fuselage. It was estimated that approximately 1.5 cm of the mounting pylon had been either worn away or bent over.

Damage to anti-collision beacon

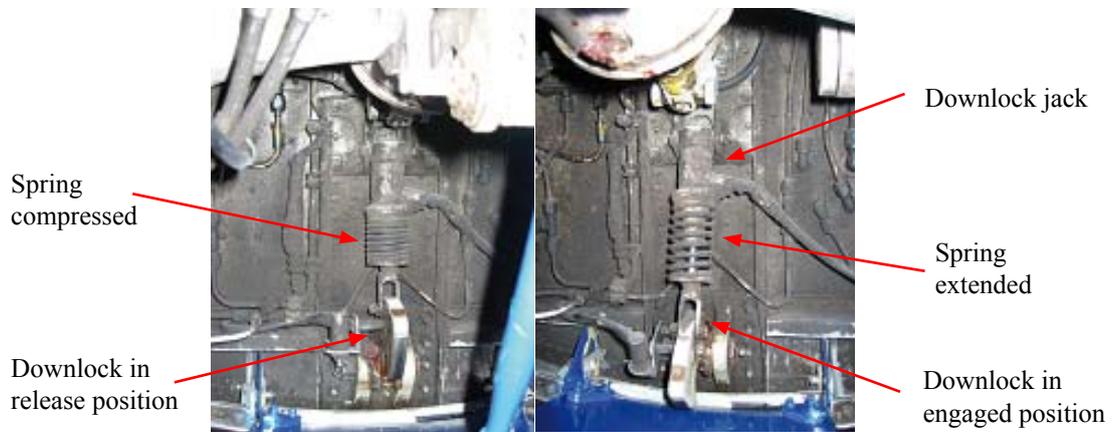
Figure 10

The noise was caused by the movement of nose leg downlock under spring pressure and the shaking of the aircraft was caused by the landing gear settling on to the uplocks. When the CB was pushed back the nose leg downlock again made a clunking noise as it moved to the release position and the aircraft shook as the gear moved off the uplocks.

Nose leg downlock

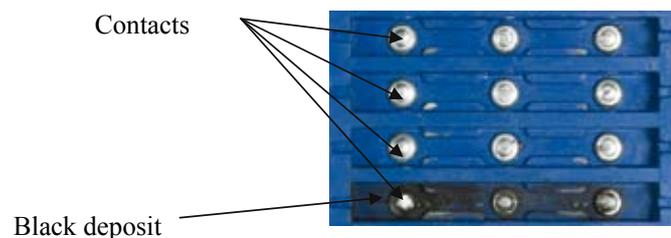
Figure 11
Contacts within the landing gear selector

All the fixed contacts in switch 107-91 displayed evidence of heavy wear and varied in height by 0.1 mm. There was also evidence of localized melting at fixed contacts 1 and 3. The heights of the fixed contacts were measured relative to the top of the switch base to establish if the combination of wear and deposits of black powder on the raised lands was sufficient to cause the sliding contacts to break contact with the fixed contact. It was concluded that the combination of the wear and deposits on the lands would have been insufficient to cause a break in the contacts.

Examination of the sliding contacts from both switches revealed evidence of heavy wear on all the contacts and evidence of localized melting at the ends of the sliding contacts that touched the fixed contacts 1 and 3. The silver layer on the fixed and sliding contacts had worn away and contact across the switch was achieved through the copper sub-layer.

QinetiQ concluded that a one-off failure of the switch may have been caused by a combination of poor surface contact due to wear and arcing and a build up of the black powder that contained cupric oxide.
