ACCIDENT

Aircraft Type and Registration:	MD Helicopters MD 900, G-EHMS	
No & Type of Engines:	2 Pratt & Whitney Canada PW206E turboshaft engines	
Year of Manufacture:	2000	
Date & Time (UTC):	4 June 2006 at 1548 hrs	
Location:	Walworth Road, London Borough of Southwark	
Type of Flight:	Commercial Air Transport	
Persons on Board:	Crew - 2	Passengers - 2
Injuries:	Crew - None	Passengers - None
Nature of Damage:	Damage to main rotor blades, main rotor head, main rotor gearbox and left vertical stabiliser	
Commander's Licence:	Airline Transport Pilot's Licence	
Commander's Age:	50 years	
Commander's Flying Experience:	4,000 hours (of which 300 were on type) Last 90 days - 60 hours Last 28 days - 20 hours	
Information Source:	AAIB Field Investigation

Synopsis

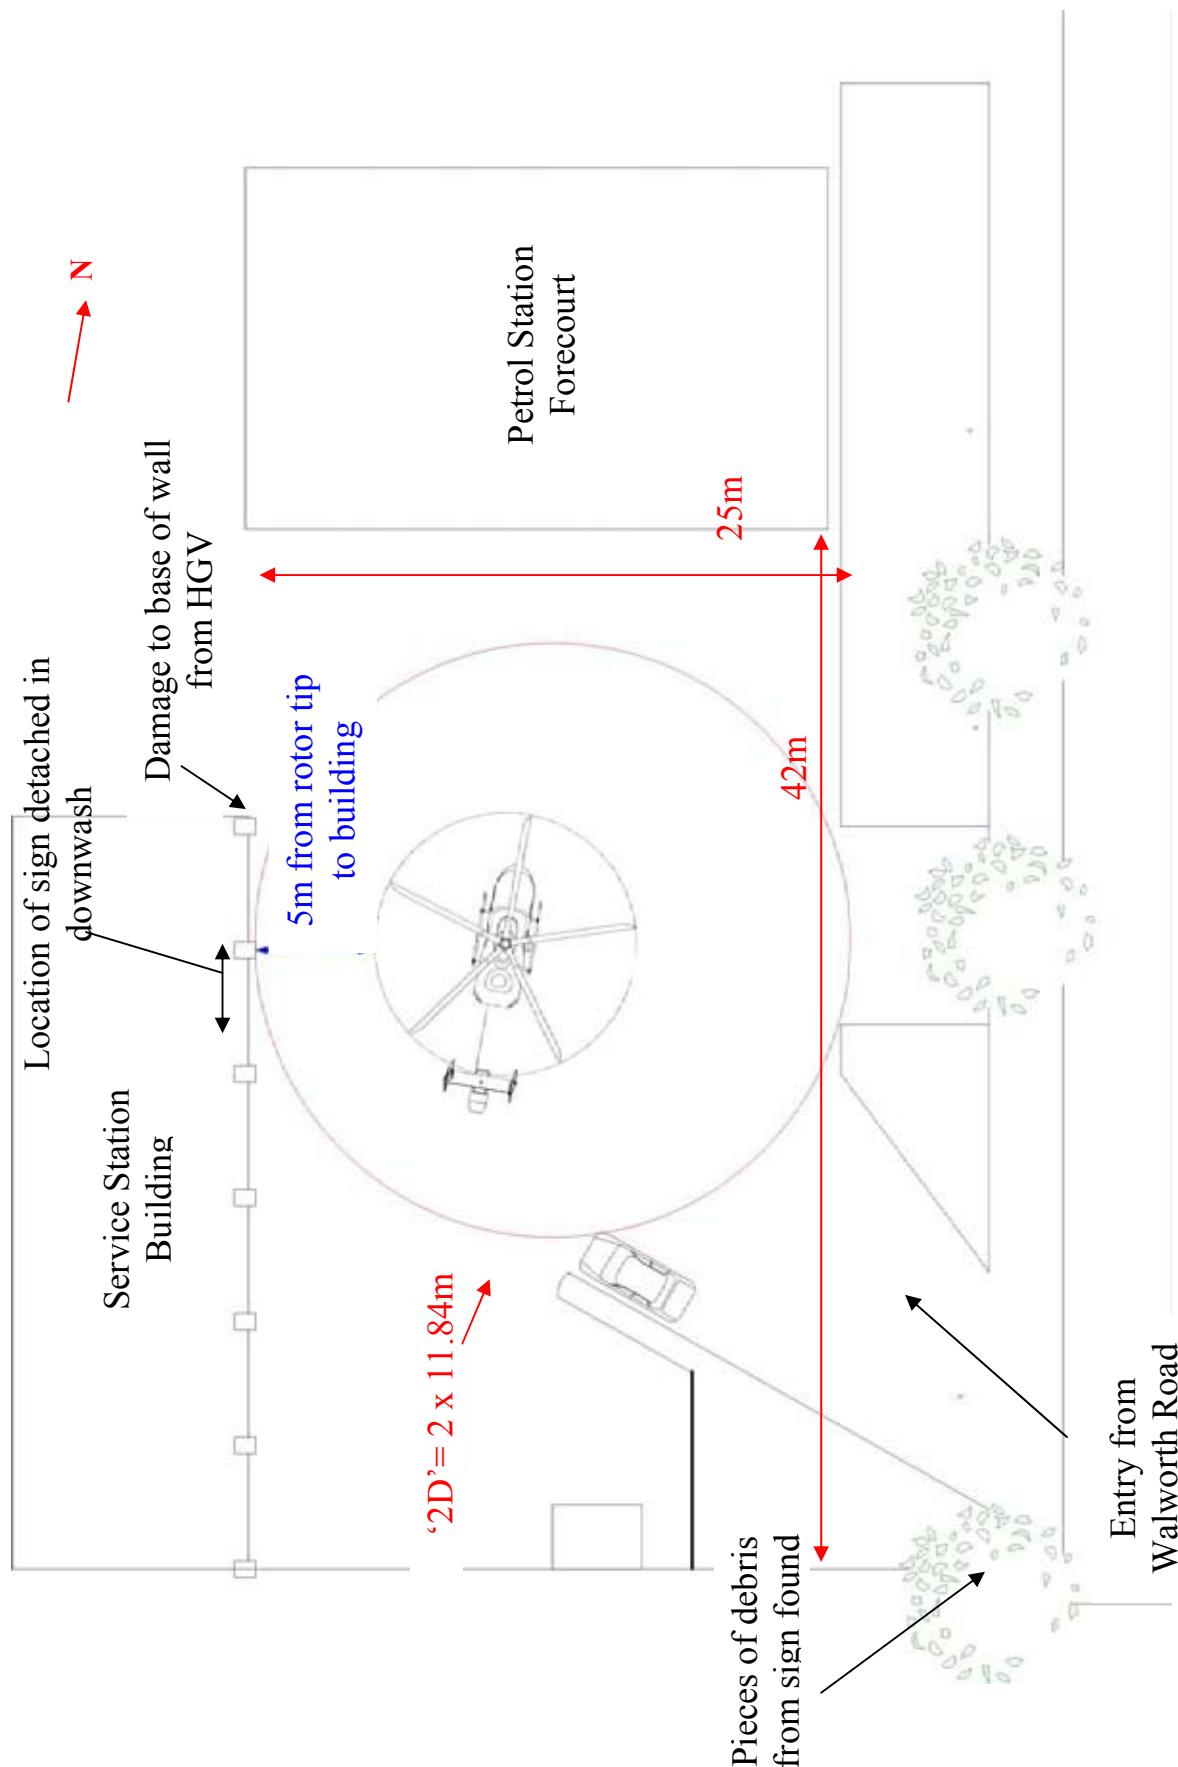
**Figure 1**

Figure 1 shows a plan of the garage and the petrol station forecourt on the Walworth Road. The garage has a clear area in front for vehicle manoeuvring and over which cars access the petrol station. There are kerbs and bollards within this area to direct entry and create parking areas. The total extent of the clear area is approximately 42 metres (from boundary wall to the petrol station canopy) by 25 metres (from the front of the garage to the pavement kerb). However, a car was parked within this clear area at the time of the accident (see Figure 1), approximately 13 metres from the front of the building.

The helicopter had come to rest on a northerly heading with the rotor disc approximately 5m from the front of the garage building. Numerous impacts with the rotor blades had shredded the metal sign, pieces from which had been flung to the edge of the garage forecourt. The remains of fixings on the fascia board indicated that the sign had been attached prior to the helicopter landing. The metal bracket connecting the fascia to the end brick wall had been dislodged so that the fascia was no longer attached to the wall. There was also damage to the brickwork at the base of the side wall. The garage manager stated that the base of the wall had been hit by a Heavy Goods Vehicle (HGV) at some time prior to the accident. It was not possible to determine whether the detachment of the fascia board had occurred in the HGV impact, or was part of the damage caused by the helicopter downwash.

G-EHMS at Walworth Road, 4 June 2006
