No: 1/91

Ref: EW/G90/10/09

**Aircraft Type and Registration:** Piper PA-24-260, G-ATNV

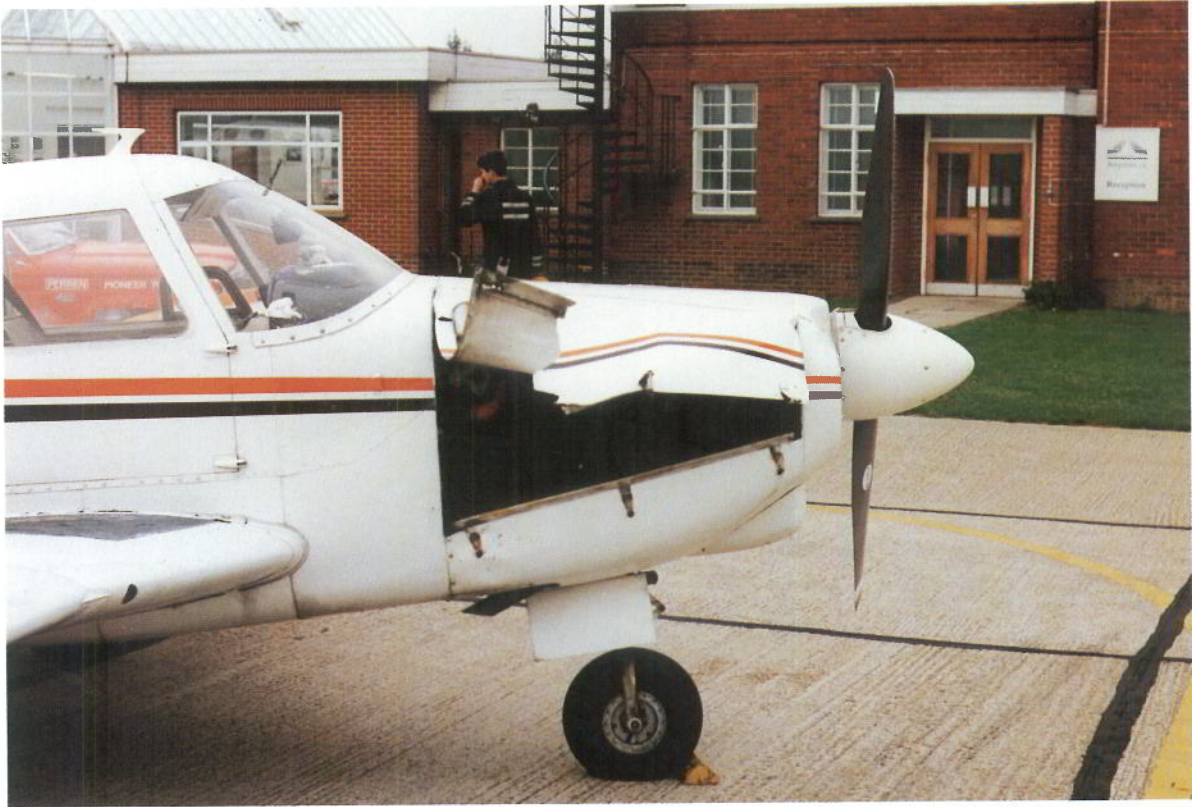
SCHEMATIC VIEW OF COWLING LATCH

Of the three right hand cowling latches, the forward two were complete, whilst the rearmost one was not. Its cam-lock fastener, the articulated lower latch section and the pivot/clevis-pin, were all missing (see diagram). One of the two lugs of the upper latch section which carry the lower latch pivot pin was found to be bent, whilst the other was undamaged. The cowling had suffered failure of the lower edge member and extensive tearing of the panel between the rear and middle latches. Most of the markings evident on the cowling were consistent with the effects of damage inflicted by the rear portion curling in the airflow after tearing had occurred, allowing its edge to repeatedly strike the painted surface.

The lower articulated section of the cowling latch, which carries the cam-lock fastener, is attached to the upper section by means of an elongated clevis-pin secured by a very small split-pin. The split-pin cannot readily be seen when the cowling is fastened.
