<b>Aircraft Type and Registration:</b>	Cessna T310R, G-OGTX	
<b>No &amp; Type of Engines:</b>	2 Continental TSIO-520-B piston engines	
<b>Year of Manufacture:</b>	1977	
<b>Date &amp; Time (UTC):</b>	13 March 2004 at 1155 hrs	
<b>Location:</b>	Hotham, South Cave, Humberside	
<b>Type of Flight:</b>	Training	
<b>Persons on Board:</b>	Crew - 2	Passengers - None
<b>Injuries:</b>	Crew - 2 (Fatal)	Passengers - N/A
<b>Nature of Damage:</b>	Aircraft destroyed	
<b>Commander's Licences:</b>	UK Basic Commercial Pilot's Licence with Instructor rating and multi-engine examiner authorisation and FAA Airline Transport Pilot Licence with Flight Instructor Certificate	
<b>Commander's Age:</b>	63 years	
<b>Commander's Flying Experience:</b>	20,283 hours (of which 893 were on type) Last 90 days - 79 hours Last 28 days - 31 hours	
<b>Information Source:</b>	AAIB Field Investigation

## Synopsis

The aircraft departed from Humberside Airport on an instructional flight and was being flown in clear air at medium level when radar contact was lost. Shortly afterwards it impacted the ground in a steep nose-down attitude at high speed which killed both pilots on board.

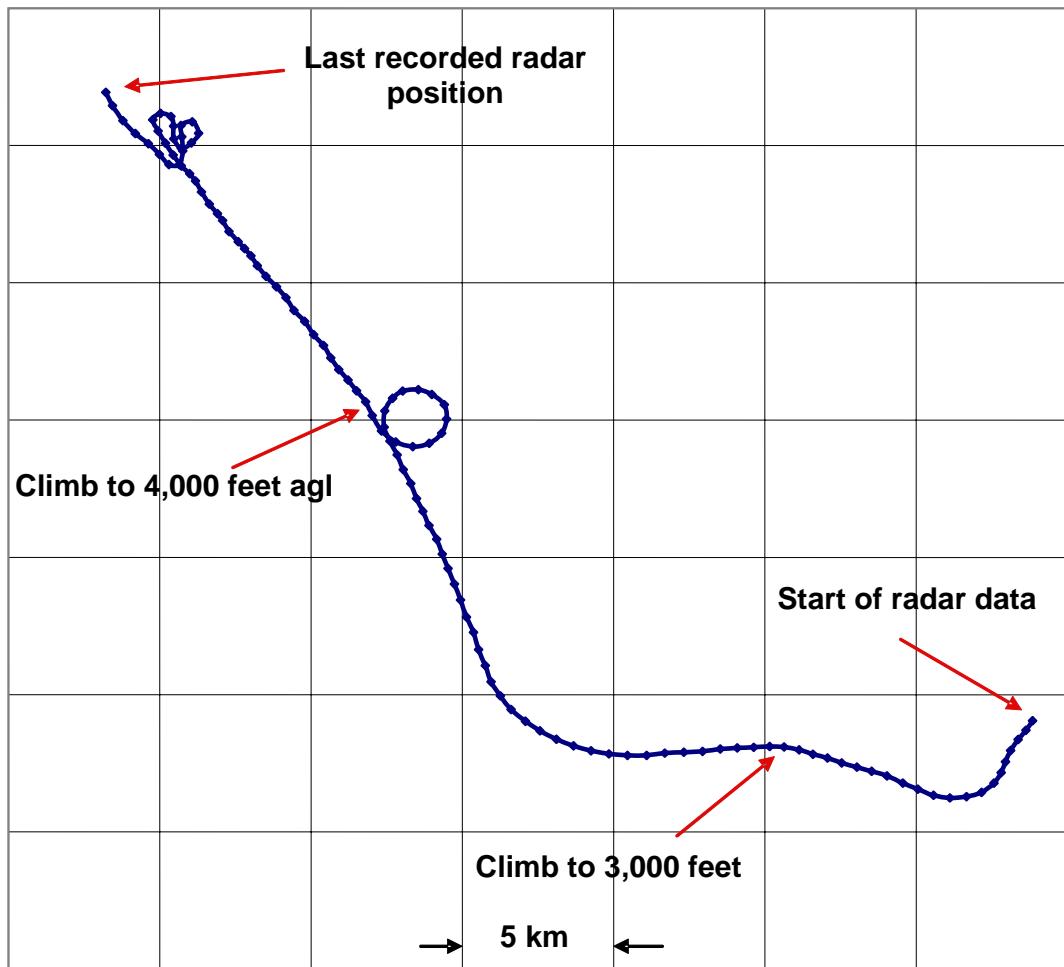
**Figure 1 - Still Air Plot of Complete Flight**

Radar heads situated at Claxby and Great Dun Fell recorded much of the aircraft's flightpath. The recorded radar returns show the aircraft flying west from Humberside Airport for 7 nm before turning northwards to the Humber estuary. An orbit was carried out at approximately 3,000 feet altitude before the northerly track was resumed and the aircraft climbed to approximately 4,000 feet. The wind at altitude was westerly at 25 kt. Allowance for the wind was applied to the radar data to derive the equivalent 'still air' flight path, thus removing wind effect from the manoeuvres depicted by the radar plot. The entire 'still air' flight path is depicted at Figure 1 and the final three minutes of the flightpath is shown, together with associated altitudes and approximate airspeeds, at Figure 2.

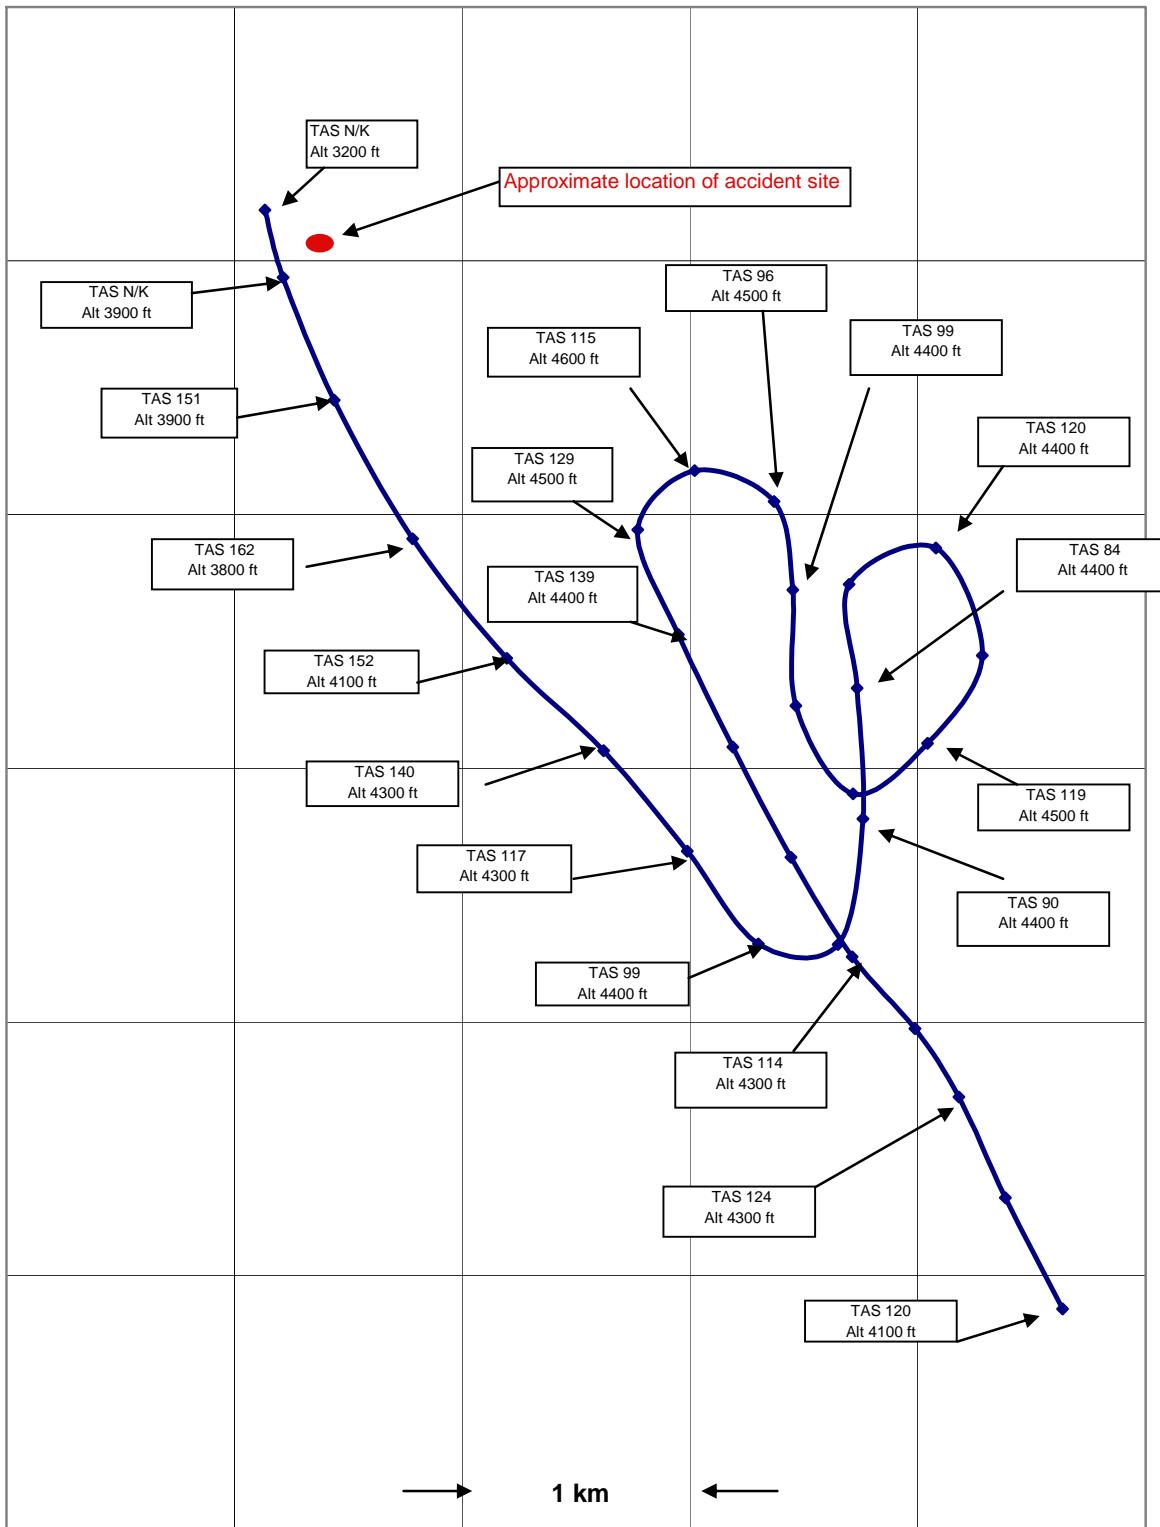
**Figure 2 - Final Still Air Manoeuvring**

The final leg began with the aircraft at an airspeed of approximately 100 kt TAS and its speed accelerated throughout the remainder of the leg to about 150 kt TAS when radar contact was lost. The last recorded altitude of the aircraft was 3,200 feet.

A test flight was flown over the same area in order to establish the base of the radar cover. This figure will vary from day to day depending on the atmospheric pressure setting and the aircraft's aspect to the radar head. However, 700 feet altitude was established as an approximate base. Although the precise elapsed time from the last radar contact to ground impact is not known, the aircraft was not detected by the next radar sweep, which was eight seconds later. If the aircraft had already descended below the base of the radar cover, it would have averaged a rate of descent during that time of over 18,000 feet per minute.
