INCIDENT

Aircraft Type and Registration:	Fokker 100, G-UKFA	
No & Type of Engines:	2 Rolls-Royce Tay 620-15 turbofan engines	
Year of Manufacture:	1989	
Date & Time (UTC):	12 October 1995 at 0945 hours	
Location:	London Stansted Airport	
Type of Flight:	Public Transport	
Persons on Board:	Crew - Not known	Passengers - Not known
Injuries:	Crew - None	Passengers - None
Nature of Damage:	Minor damage around centre hinge cover, No 5 lift dumper, left-hand side	
Commander's Licence:	Not applicable	
Commander's Age:	Not applicable	
Commander's Flying Experience:	Not applicable	
Information Source:	AAIB Field Investigation

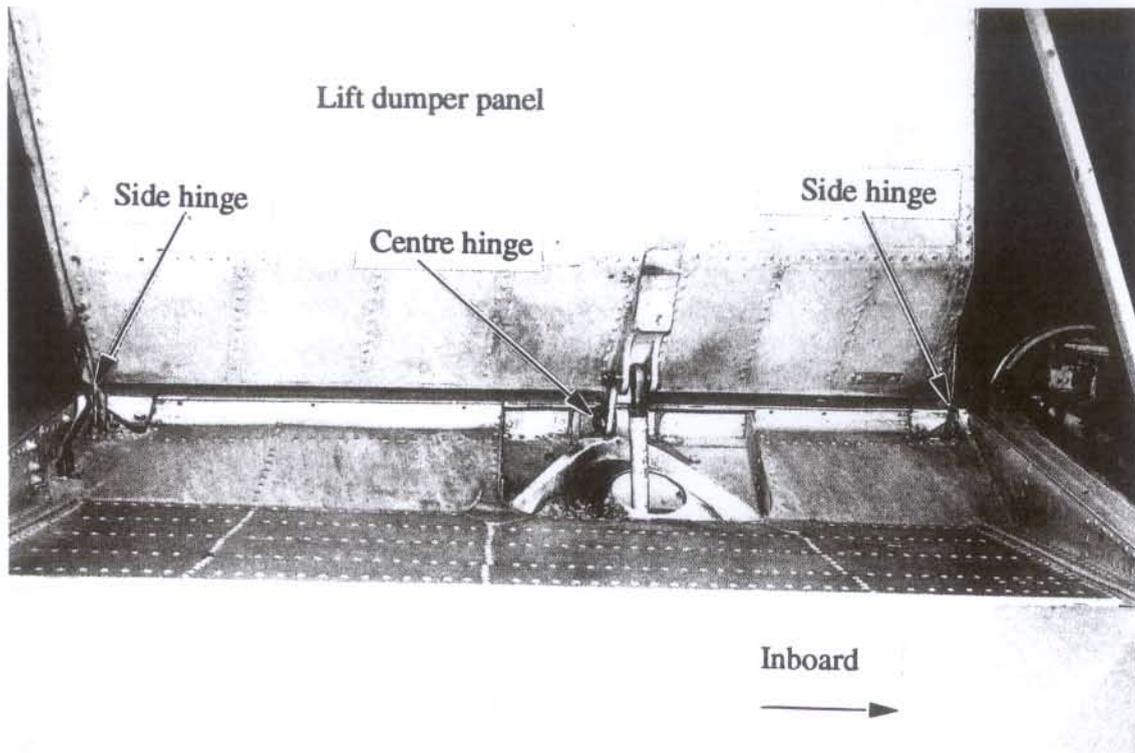
Figures 1 and 2 show the correct configuration for the No 5 lift dumper on another Fokker 100.

Figure 1 - No. 5 lift dumper, left-hand side, Fokker 100

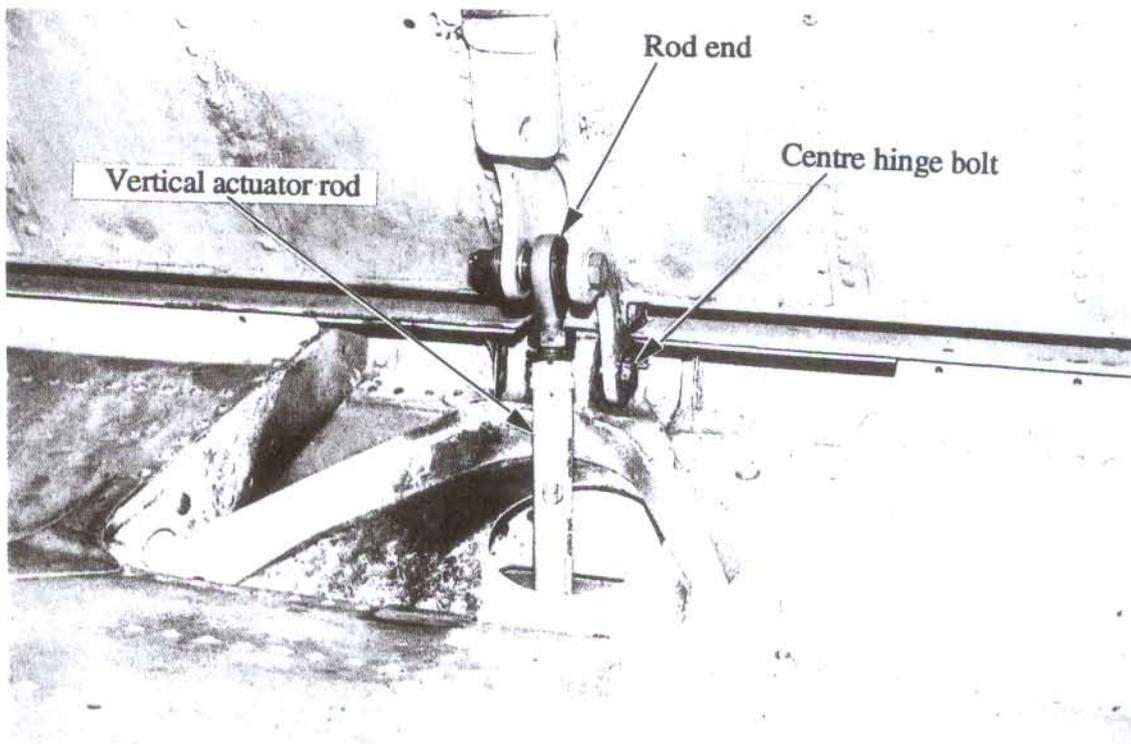
Figure 2 - Centre hinge and vertical actuating rod
