## Yak-50, G-YAKK

<b>AAIB Bulletin No: 2/2004</b>	<b>Ref: EW/C2003/08/06</b>	<b>Category: 1.3</b>
<b>Aircraft Type and Registration:</b>	Yak-50, G-YAKK	
<b>No &amp; Type of Engines:</b>	1 Ivchenko Vedeneyev M-14P radial-piston engine	
<b>Year of Manufacture:</b>	1985	
<b>Date &amp; Time (UTC):</b>	22 August 2003 at 1430 hrs	
<b>Location:</b>	North Weald Airfield, Essex	
<b>Type of Flight:</b>	Private (Display)	
<b>Persons on Board:</b>	Crew - 1	Passengers - None
<b>Injuries:</b>	Crew - None	Passengers - N/A
<b>Nature of Damage:</b>	Forward fuselage holed, propeller blades shattered, nose cowl distorted, aircraft damaged beyond economic repair	
<b>Commander's Licence:</b>	Private Pilot's Licence	
<b>Commander's Age:</b>	35 years	
<b>Commander's Flying Experience:</b>	466 hours (of which approximately 125 hours were on type)	
	Last 90 days - 35 hours	
	Last 28 days - 26 hours	
<b>Information Source:</b>	AAIB Field Investigation

### Synopsis

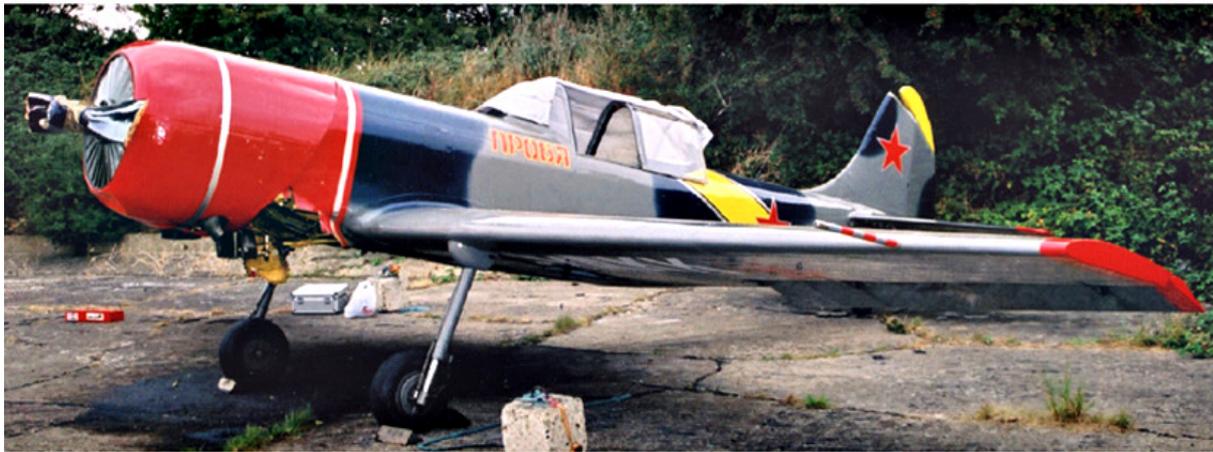
### G-YAKK Post Accident

pressures in the aircraft's pneumatic system, were normal. Approximately eight minutes after engine start he retarded the throttle to idle and released the wheel brakes in order to taxi forwards a short distance to provide access for an approaching fuel bowser. As the aircraft was moving slowly forwards there was a loud bang and the engine accelerated to high speed. The aircraft accelerated, pitched nose down and the propeller shattered as it contacted the concrete at high RPM. The pilot switched off the magnetos; bystanders, who were very quickly on the scene, noticed a small fuel leak, which ceased when the pilot operated the fuel cut-off selector. The bystanders tipped the aircraft back onto its tailwheel (Figure 1) and the pilot vacated unhurt. He subsequently participated in the display at Clacton in another Yak-50. Examination revealed that the main reservoir of G-YAKK's pneumatic system had burst.

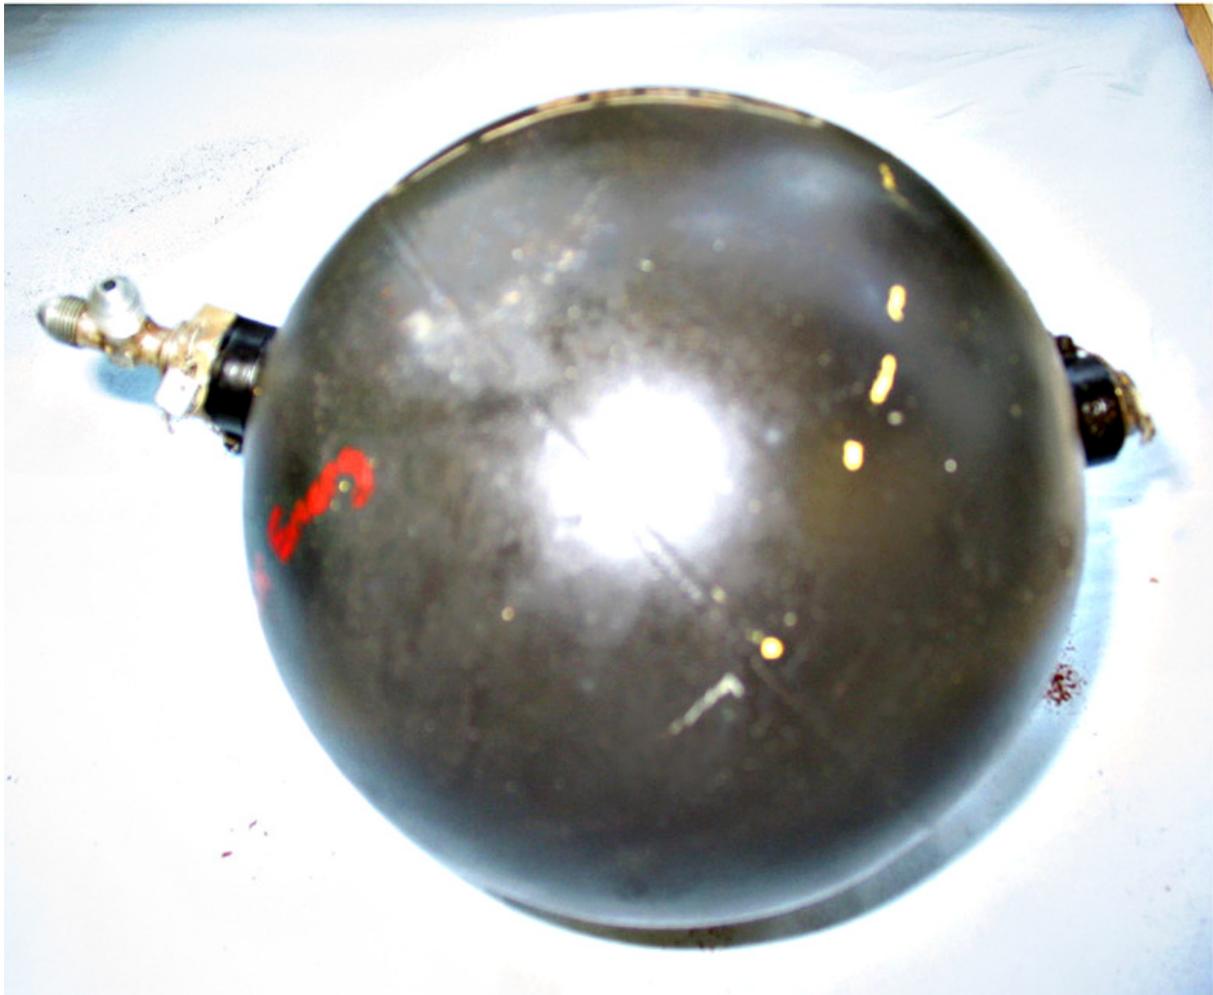
### Sample Reservoir

The pneumatic system reservoirs each consist of a spherical steel bottle fabricated from two hemispheres butt-welded together (Figure 5), mounted on a pad on the firewall and retained by a steel strap assembly. The main reservoir, located on the left, has a 9.1 inch (23 cm) diameter and a

6.4 litre capacity. The emergency reservoir, located on the right, has a 7.2 inch (18 cm) diameter and a 3.2 litre capacity. Each bottle is connected to the respective system via a 0.6 inch (16 mm) diameter threaded port formed in a boss welded to the bottle; a second similar port near the installed bottle's low point is fitted with a blanking plug. Both main and emergency systems are arranged with the system connection near the bottle's high point and any water in the bottles will therefore not drain away through the system pipework. It appeared likely that the bottle material is a carbon/manganese steel alloy; wall thickness is approximately 0.060 inch (1.5 mm). The external surface is painted; it is unclear whether internal surface protection is provided at manufacture.

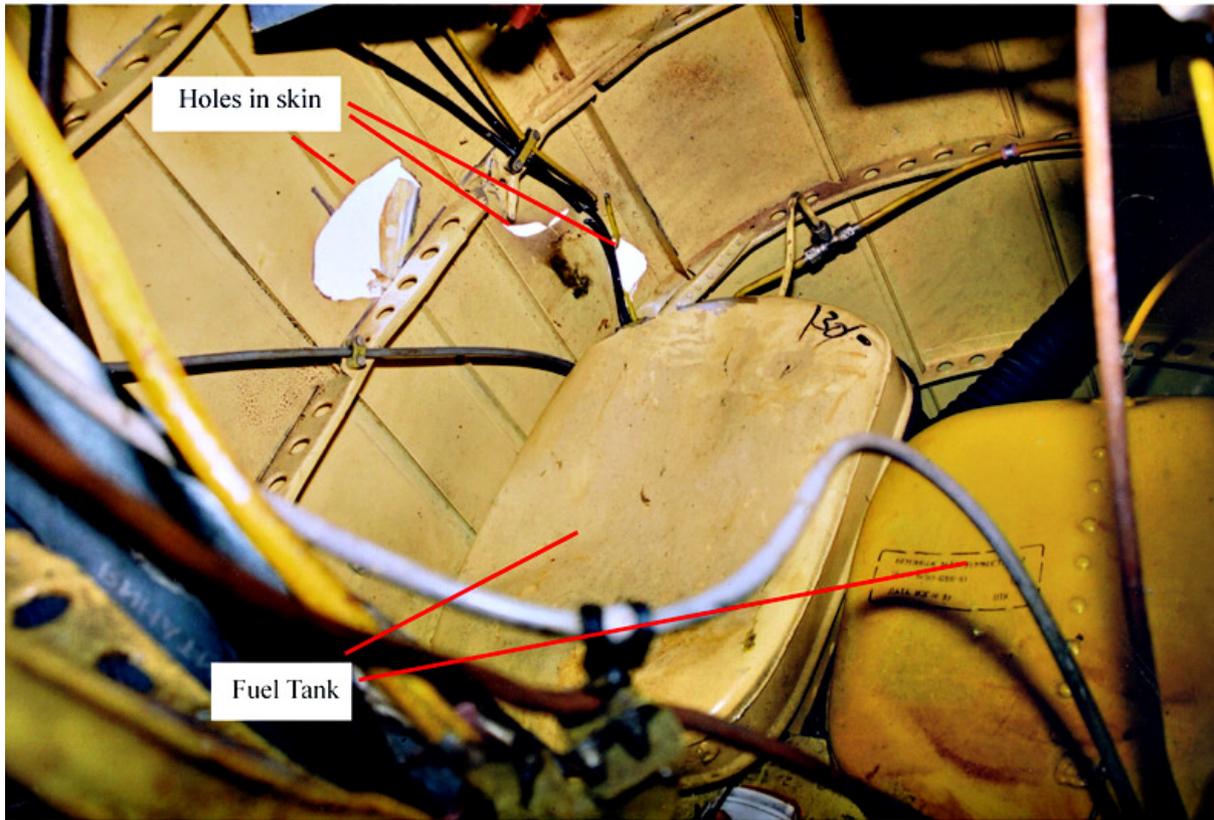
G-YAKK RIGHT HAND SIDE DAMAGE

Examination showed that the main bottle of G-YAKK's pneumatic system had split and the retaining strap assembly had fractured. One part, comprising approximately one half of the bottle and including the connector port, had travelled aft, up and to the right, striking a number of components. Two pneumatic system pipelines and a fuel system line were severed, three substantial holes were punched in the fuselage sidewall and the right fuel tank suffered severe local deformation (Figure 2).

The bottle portion came to rest jammed between the top of the fuel tank and the fuselage structure. A second part, comprising approximately one third of the bottle and including the drain port, had been propelled to the left and had torn an approximately 2 foot diameter hole in the lower left part of the fuselage just aft of the firewall (Figure 3).

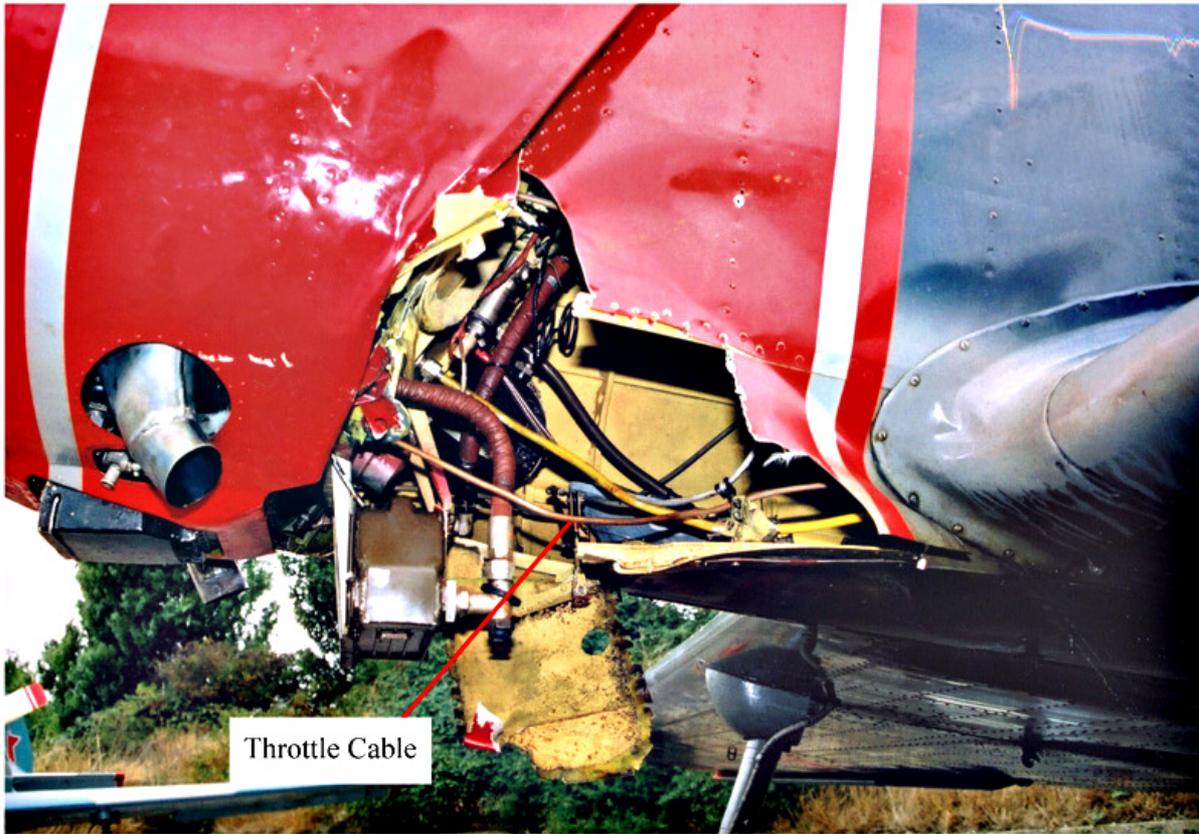
### G-YAKK LEFT SIDE DAMAGE

The oil cooler fairing detached and a portion of a fuselage main longeron was torn out, separating the associated engine mount from the airframe. The throttle cable sheath had been permanently deformed forward of its fuselage attachment, displacing the inner cable and thus opening the throttle.

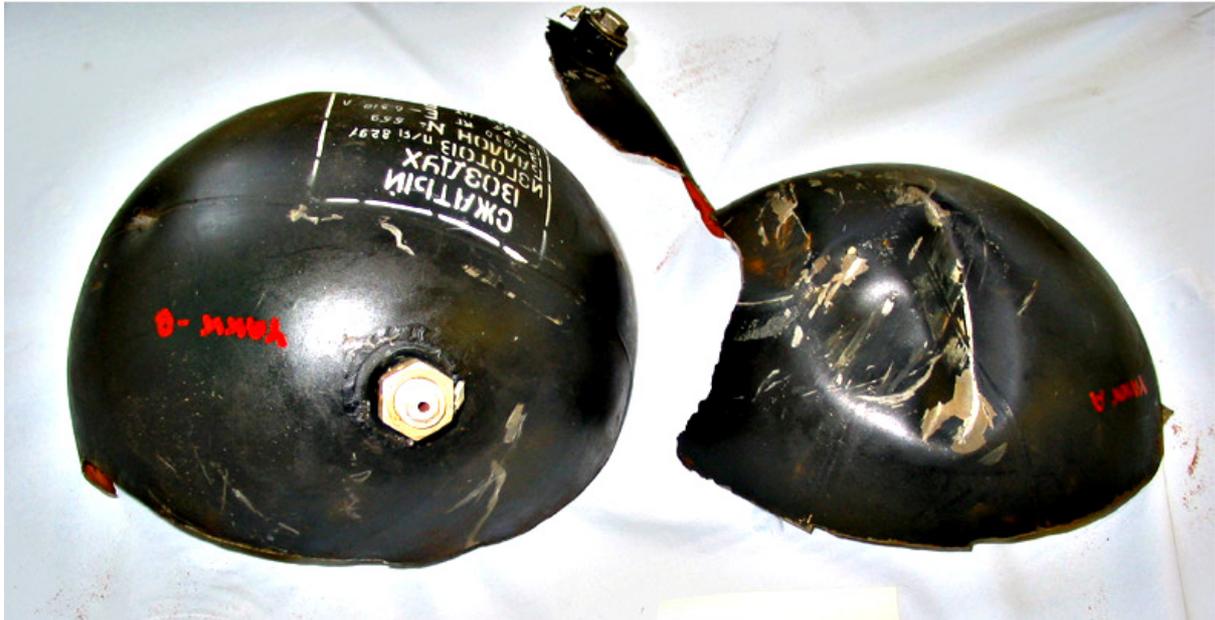
## G-YAKK MAIN RESERVOIR

The two major portions of the bottle were recovered (Figure 6).

It was clear that the accident had resulted from bursting of G-YAKK's pneumatic system main reservoir. In view of the evidence that the pneumatic system pressure indications had been normal and that the PRV was operating normally it was highly unlikely that overpressure had contributed to the bottle failure, particularly given the slow charge rate of the engine-driven pump. The severe internal corrosion evident included many deep pits that had extended almost to the outer surface. However, it also included a region of drastically reduced wall thickness in the bottom of the bottle, apparently associated with pooling of water at some stage. The evidence suggested that deformation in this thinned area had led to initiation of a crack that had extended rapidly around the bottle. It was therefore concluded that the burst had resulted from fracturing of the bottle at normal pressure due to gross weakening caused by the effects of severe internal corrosion.

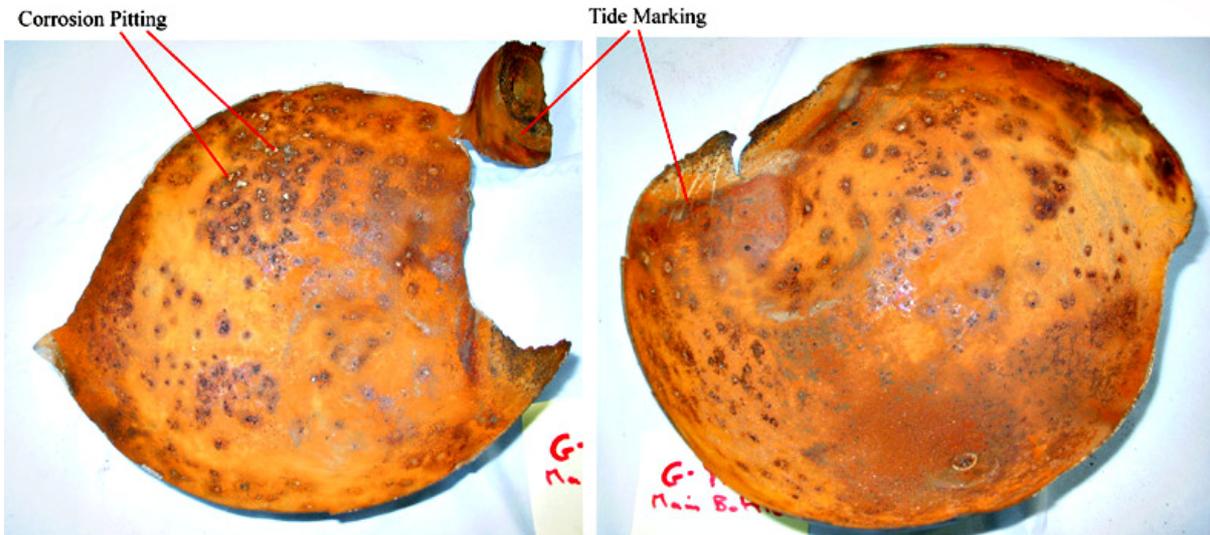
## G-YAKK MAIN RESERVOIR INTERNAL SURFACE

The internal surfaces of both were found to be covered completely with rust deposits, with numerous areas of deep corrosion pitting (Figures 7 and 8).

It was inevitable that water would be present in a system of this sort, both in liquid form due to condensation and as a vapour. While the water trap would possibly retain much of the water, it appeared probable that the interior of the bottles would be wet for much of the time. It was likely that this environment, with the air present, would oxidise the steel material of the bottles in the absence of adequate internal surface protection. The action of draining the water trap could tend to give the expectation that the system had been drained of water but would in fact have no effect on removing any water present in the bottles. There appeared to be no published or generally accepted standards for inspection or corrosion protection of the bottles. In this situation, given that previous cases of advanced corrosion had occurred, it appeared that the five year interval between overhauls was excessive. Information suggested that annual inspection and proof-pressure testing of high-pressure gas bottles is common industry practice.

The CAA, as a matter of urgency, specify a maintenance schedule and procedures for the Yak-50 pneumatic system reservoirs, and similar reservoirs fitted to other aircraft types, aimed at preventing serious internal corrosion and reservoir failure. This should include reservoir draining, inspection, rejection criteria and corrosion protection aspects. It is recommended that the required repeat interval for inspection and proof-pressure testing should be no more than one year.

The CAA require all UK operators of aircraft fitted with pneumatic system reservoirs similar to those on the Yak-50 to thoroughly inspect, proof-pressure test and effectively corrosion protect the reservoirs as a matter of urgency.

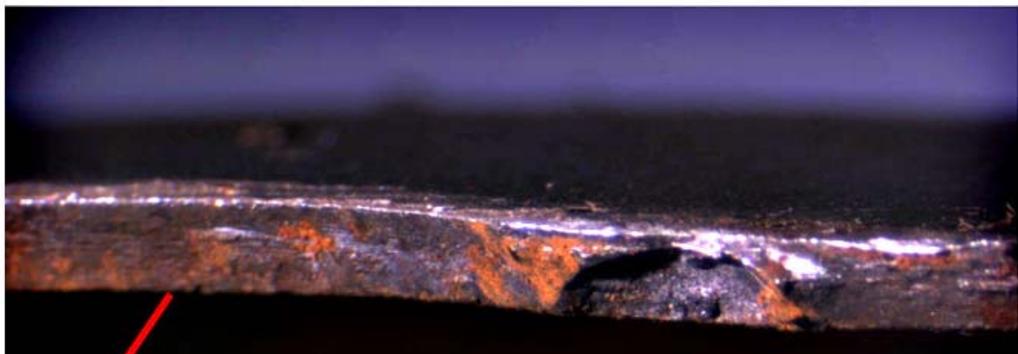
## TYPICAL CORROSION PIT

A number of corrosion pits had extended almost to the exterior surface; this was clearly evident in the case of a number of pits that had been bisected by the fracture (Figure 9).

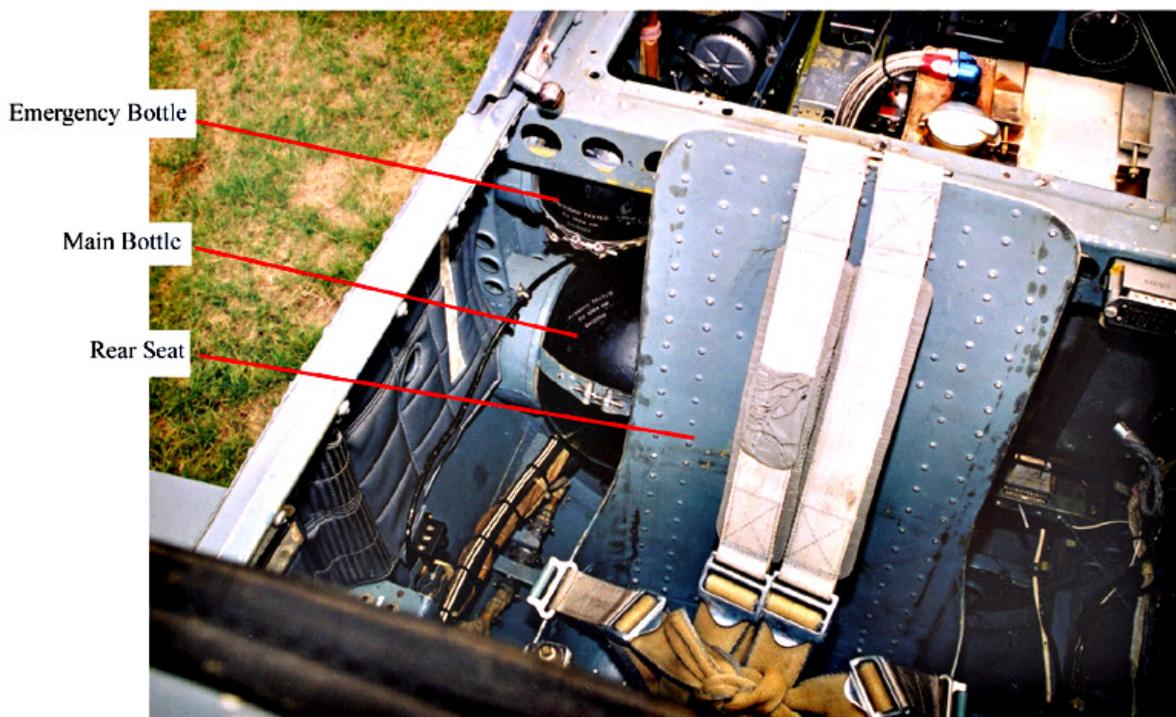
YAK-52 PNEUMATIC RESERVOIRS

Pneumatic systems similar to that on the Yak-50, with similar bottles, are used on the Yak-52, 11 and 18T. It is understood that, including the Yak-50, there are around 130 aircraft of these types on the UK CAA Register. Information indicated that similar systems are possibly used on other UK registered types manufactured in the former Eastern Bloc. In the case of the Yak-52 both the main and emergency bottles are mounted close together immediately behind the rear seat (Figure 4).

The failure on G-YAKK was potentially hazardous to the pilot, other personnel and aircraft on the ground and could have been catastrophic had it occurred in flight. Furthermore, the bursting of one of the bottles on the Yak-52, apart from the effects on the aircraft and its systems, could cause major trauma to the rear seat occupant. Additionally, severe injury to maintenance or other personnel would be a distinct possibility if a bottle, fitted to aircraft types with a similar system, burst on the ground.

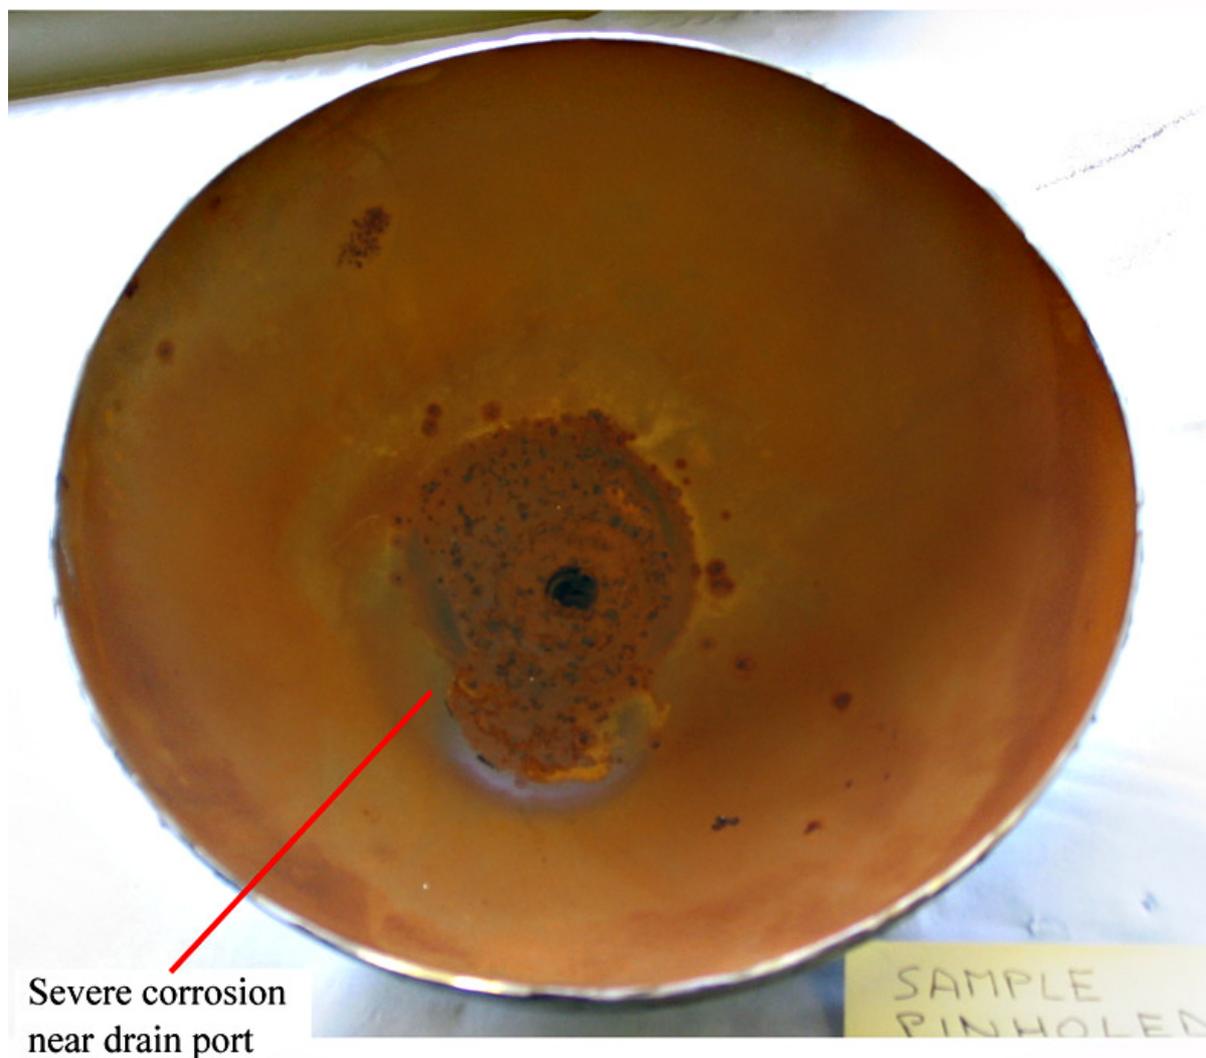
## SAMPLE PINHOLED BOTTLE

Previous known cases of failure of this type of bottle due to severe internal corrosion had apparently been relatively benign, as pinholing of the wall by pitting had caused loss of pressure and thus prompted maintenance action and fracturing had not occurred. There was insufficient evidence to establish the reasons for the different failure mode in G-YAKK's case. However, G-YAKK's bottle had almost reached the pit penetration stage and examination of one of the bottles that had previously suffered the more benign failure again found a region of advanced corrosion near the drain port (Figure 10) that could have been close to fracturing. Pooling of water in the bottle had apparently been a factor in both of these failures and no reason was evident as to why such pooling would be unusual. It appeared that small variations in conditions as internal corrosion progressed could cause the fracture mode to occur before a pinhole formed and provided an alert.
