ACCIDENT

Aircraft Type and Registration:	Tecnam P2002-JF Sierra, G-UFCM	
No & Type of Engines:	1 Rotax 912-S2 piston engine	
Year of Manufacture:	2011 (Serial no: 192)	
Date & Time (UTC):	25 July 2013 at 1620 hrs	
Location:	Playing field in Newtownards, County Down, Northern Ireland	
Type of Flight:	Training	
Persons on Board:	Crew - 1	Passengers - 1
Injuries:	Crew - 1 (Minor)	Passengers - 1 (Minor)
Nature of Damage:	Damaged beyond economic repair	
Commander's Licence:	Commercial Pilot's Licence	
Commander's Age:	38 years	
Commander's Flying Experience:	1,326 hours (of which 320 were on type) Last 90 days - 77 hours Last 28 days - 37 hours	
Information Source:	Aircraft Accident Report Form submitted by the pilot

Synopsis

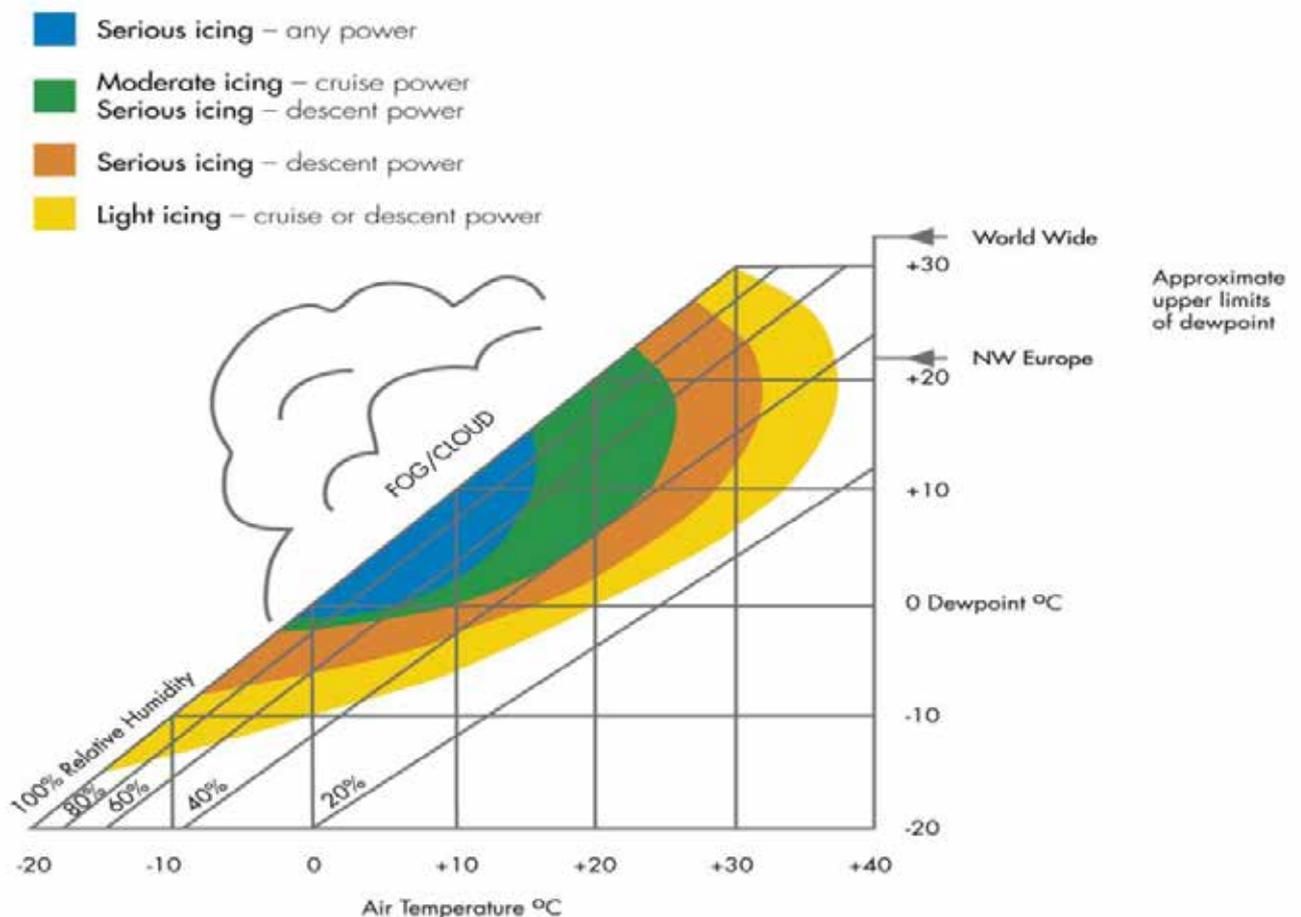
Figure 1

Airport (EGAC) was reporting a temperature of 19°C and a dewpoint of 15°C; this would place the engine as being potentially at serious risk of icing at descent power (Figure 1). The instructor considered that the engine could have stopped due to carburettor icing, fuel starvation or spark plug fouling but it was not possible to determine which of these was most likely.
