ACCIDENT

Aircraft Type and Registration:	Socata TB10 Tobago, G-JURE	
No & Type of Engines:	1 Lycoming O-360-A1AD piston engine	
Year of Manufacture:	1986	
Date & Time (UTC):	25 September 2006 at 2028 hrs	
Location:	Delamere, near Chester, Cheshire	
Type of Flight:	Private	
Persons on Board:	Crew - 1	Passenger - None
Injuries:	Crew - 1 (Serious)	Passenger - N/A
Nature of Damage:	Aircraft destroyed	
Commander's Licence:	Private Pilot's Licence	
Commander's Age:	52 years	
Commander's Flying Experience:	300 hours (of which 25 were on type) Last 90 days - 4 hours Last 28 days - 0 hours	
Information Source:	AAIB Field Investigation

Synopsis

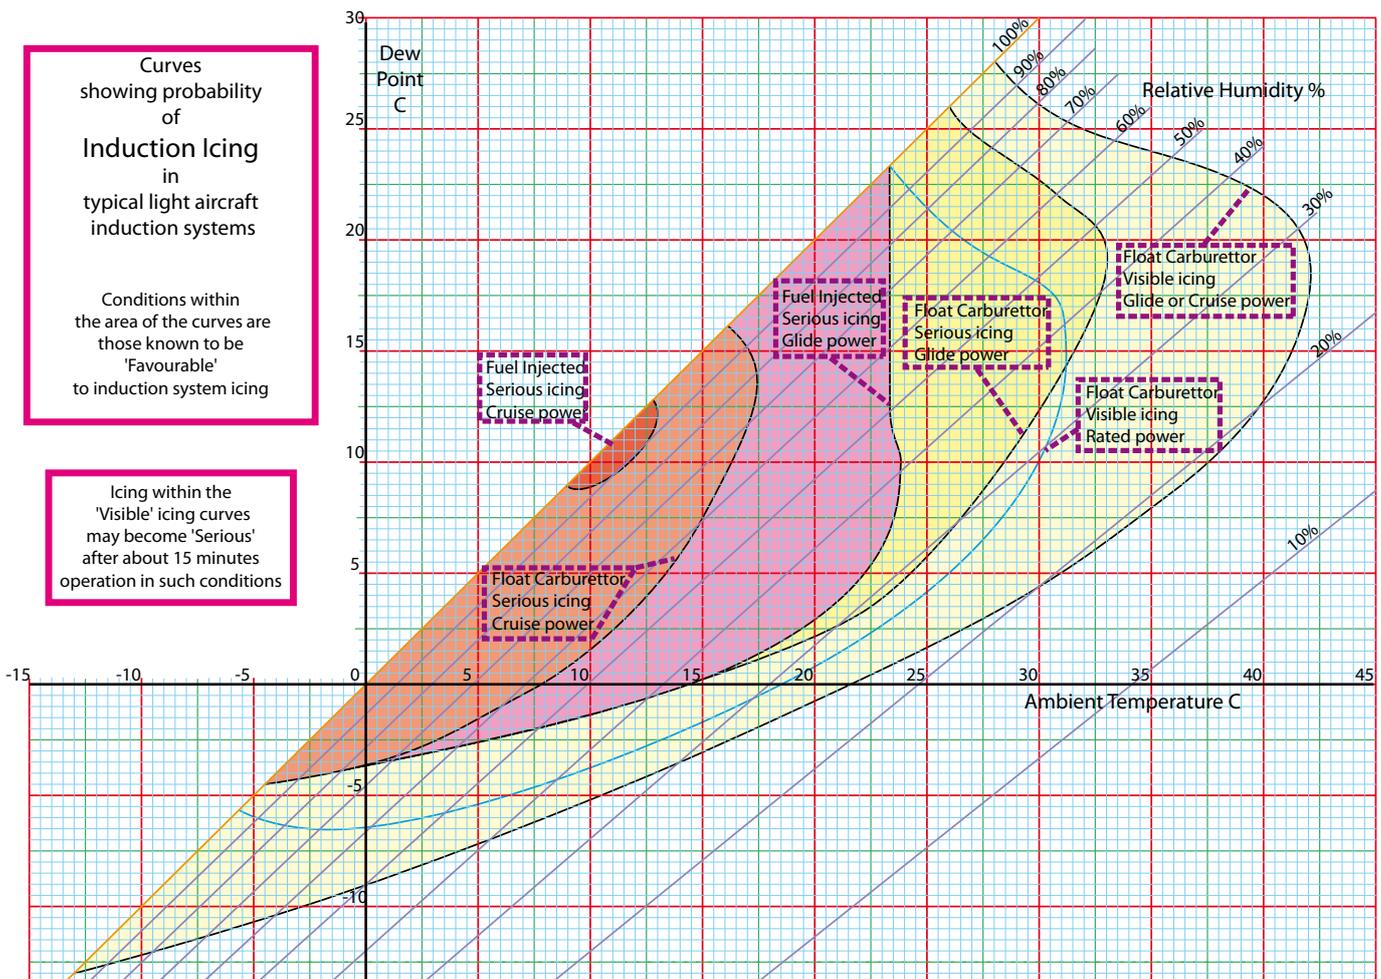
Figure 1

The Liverpool Airport weather, observed at 2001 hrs, reported a surface wind from 310° at 5 kt, scattered cloud at 2,500 ft amsl and a temperature of +16°C with a dew point of +12°C.

Examination of carburettor icing charts, using the prevailing atmospheric conditions for the altitude of the aircraft, suggests that the aircraft would experience moderate levels of carburettor icing at cruise power settings and serious icing during a descent (Figure 1). The presence of carburettor icing would lead to the engine losing power and running roughly. The application of carburettor heat would then result in an increase in the

rough running and further power loss until all the ice had dissipated. The periodic application of carburettor heat for short periods of time during cruise checks may not have been sufficient to remove completely any accumulated ice. Whilst running roughly at low power the effectiveness of carburettor heat quickly diminishes as the engine exhaust manifold rapidly cools. In the event of a significant build-up of ice, it could take a considerable amount of time to clear all the ice and regain full engine power.
