ACCIDENT

| Aircraft Type and Registration: | Piper PA-28-140 Cherokee, G-BRWO | |
| Date & Time (UTC): | 26 September 2009 at 1445 hrs | |
| Location: | Humberside Airport, North Lincolnshire | |

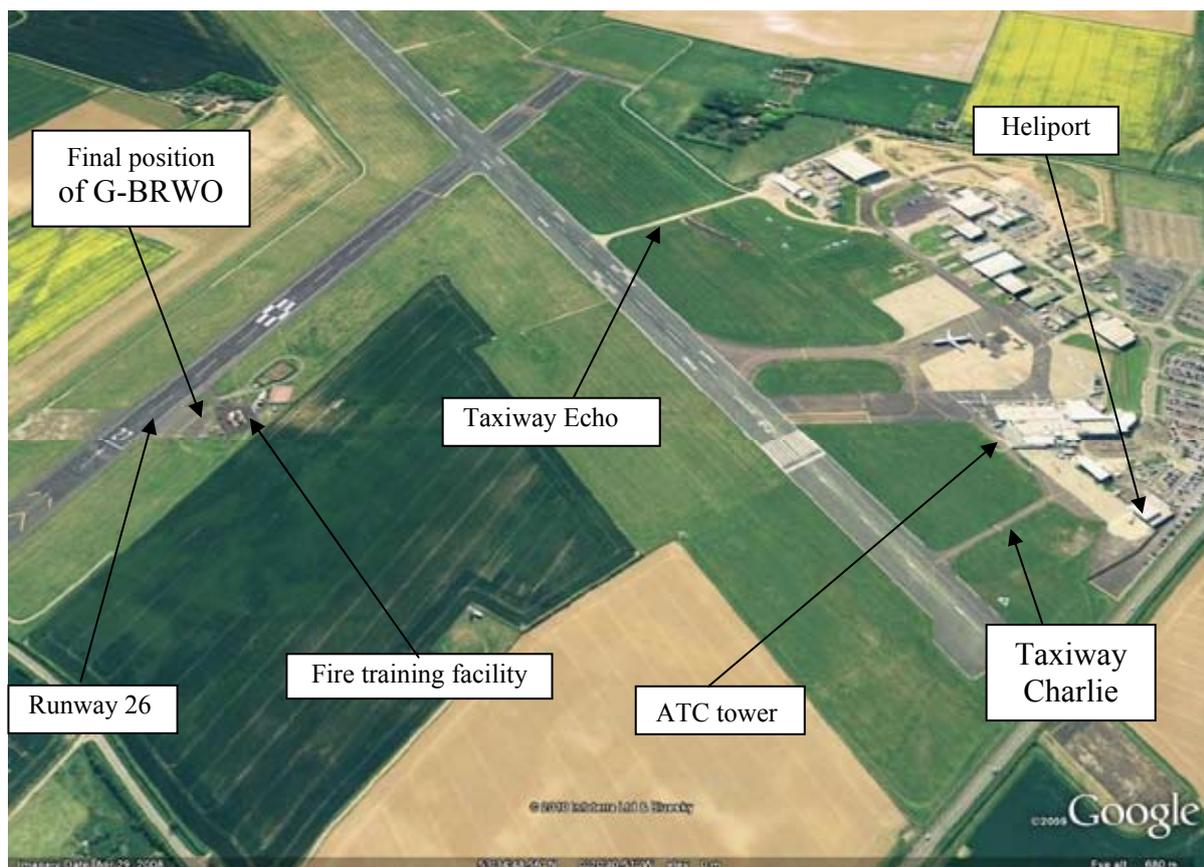
Figure 1

The fire training facility is positioned close to the threshold of Runway 26 and obstructs the view of the runway, immediately beyond the threshold, from the ATC tower, Figure 1. This prevented the ATC controller from directly observing the accident site. G-BRWO probably crossed the runway threshold approximately one minute after its pilot received clearance to land and the aircraft was located by the R22 pilot approximately three minutes after the accident. Approximately two minutes after being given the command to deploy to the location the AFRS units were at the scene of the accident.

Humberside International Airport

(Note: At the time this picture was taken, Runway 26 was designated as Runway 27 hence the markings of '27'; the runway designation changed due to magnetic variation)

The position of the fire training facility prevented direct observation of the area of Runway 26 immediately beyond the threshold from the control tower. This resulted in a delay of approximately three minutes before ATC confirmed that G-BRWO had been involved in an accident and deployed the AFRS. The AFRS were on scene approximately two minutes later. After ATC's confirmation that an accident had occurred, aircraft movements were allowed to continue despite the deployment of the AFRS to the accident. This temporarily reduced the ability of the AFRS to respond to any subsequent incidents and the airfield Fire Category was not downgraded to reflect this until four minutes later.

The response to the accident was reviewed by the airfield ATC Safety Management Committee to determine what changes could be made to improve the airport's response to a similar event and to minimise the possibility of a similar incident occurring. As a result of the review a CCTV camera has been installed on the site of the airfield's DME which provides a means for staff in the ATC Tower to view the threshold and approach path to Runway 26 and several changes

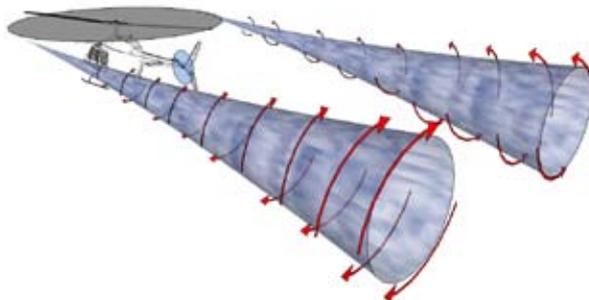
Figure 2

Every aircraft, including helicopters, produces wake vortices, which can be considered as two counter-rotating air masses trailing aft from the aircraft, Figure 2.

Typical helicopter wake vortices
