SERIOUS INCIDENT

Aircraft Type and Registration:	Airbus A300B4-605R, G-MAJS	
No & Type of Engines:	2 General Electric CO CF6-80C2A5 turbofan engines	
Year of Manufacture:	1991	
Date & Time (UTC):	26 July 2011 at 1035 hrs	
Location:	London Gatwick Airport	
Type of Flight:	Commercial Air Transport (Passenger)	
Persons on Board:	Crew - 12	Passengers - 335
Injuries:	Crew - None	Passengers - None
Nature of Damage:	None	
Commander's Licence:	Airline Transport Pilot's Licence	
Commander's Age:	49 years	
Commander's Flying Experience:	12,074 hours (of which 8,680 were on type) Last 90 days - 147 hours Last 28 days - 74 hours	
Information Source:	Aircraft Accident Report Form submitted by the pilot and further enquiries by the AAIB

Synopsis

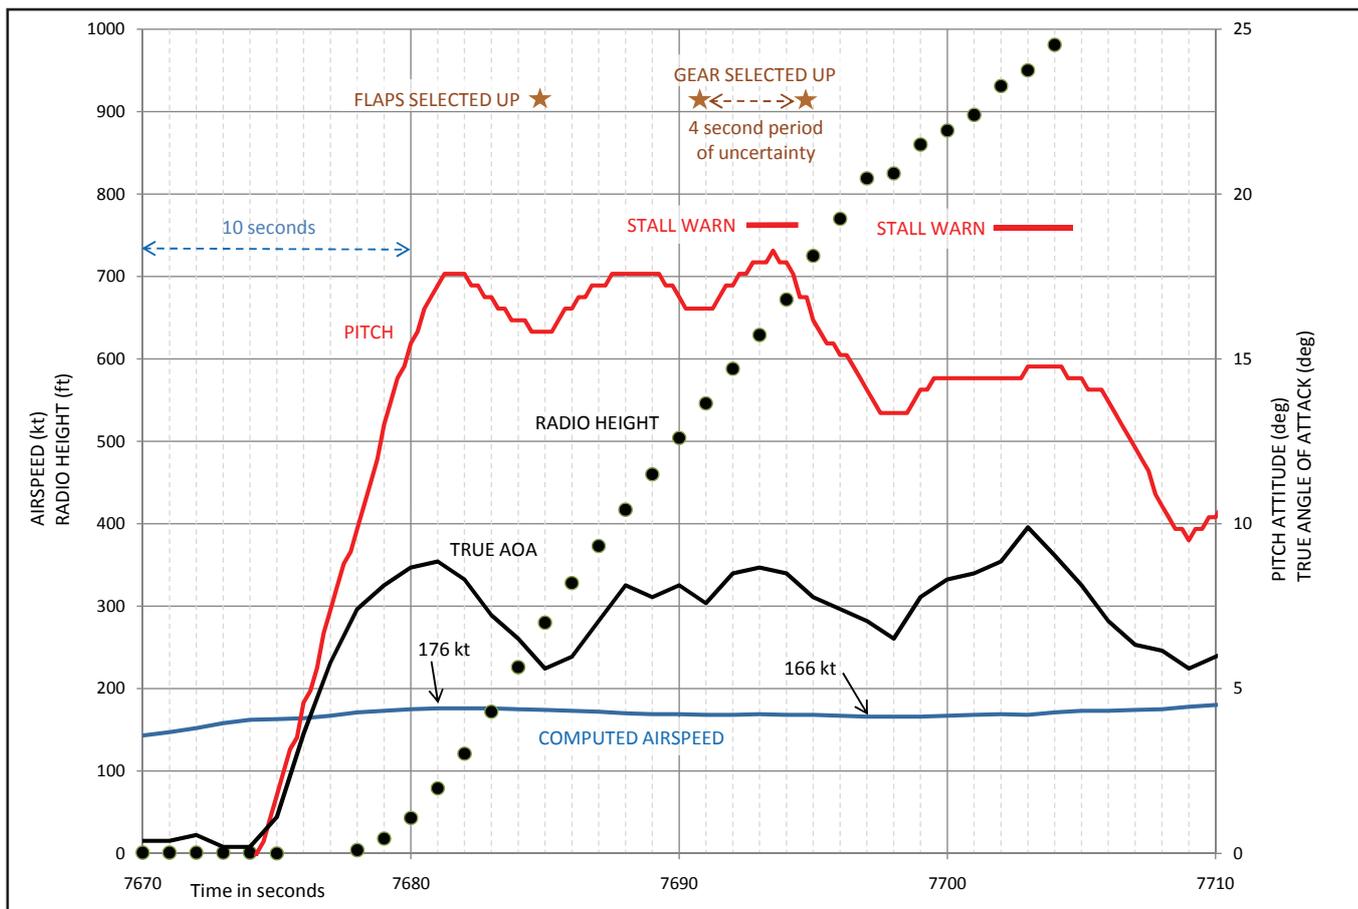
Figure 1
Flight parameters

The co-pilot operated the slat/flap lever about eight seconds after takeoff and the slats and flaps started to retract. At this point the true angle of attack (TAOA) was 5.6° and the aircraft was climbing through 280 ft agl. During the following three seconds, the TAOA increased to approximately 8° and, apart from a three-second interlude, remained above 7.5° for the following 18 seconds during which time the slats and flaps fully retracted. The stall warning system operated twice during this period. The airspeed decayed from 176 KCAS to 166 KCAS during the 12 second period after the slats/flaps lever was first moved but increased thereafter. Relevant aircraft parameters are shown in Figure 1.
