ACCIDENT

Aircraft Type and Registration:	Britten Norman Islander BN-2A-27, VP-MNI	
No & Type of Engines:	2 Lycoming O540 piston engines	
Year of Manufacture:	1971	
Date & Time (UTC):	17 April 2011 at 1915 hrs	
Location:	John A Osborne Airport, Montserrat	
Type of Flight:	Commercial Air Transport (Passenger)	
Persons on Board:	Crew - 1	Passengers - 7
Injuries:	Crew - None	Passengers - None
Nature of Damage:	Damage to nose structure, nose landing gear, left wing tip and left propeller	
Commander's Licence:	Commercial Pilot's Licence	
Commander's Age:	37 years	
Commander's Flying Experience:	2,332 hours (of which 839 were on type) Last 90 days - 135 hours Last 28 days - 51 hours	
Information Source:	AAIB Field Investigation

Synopsis

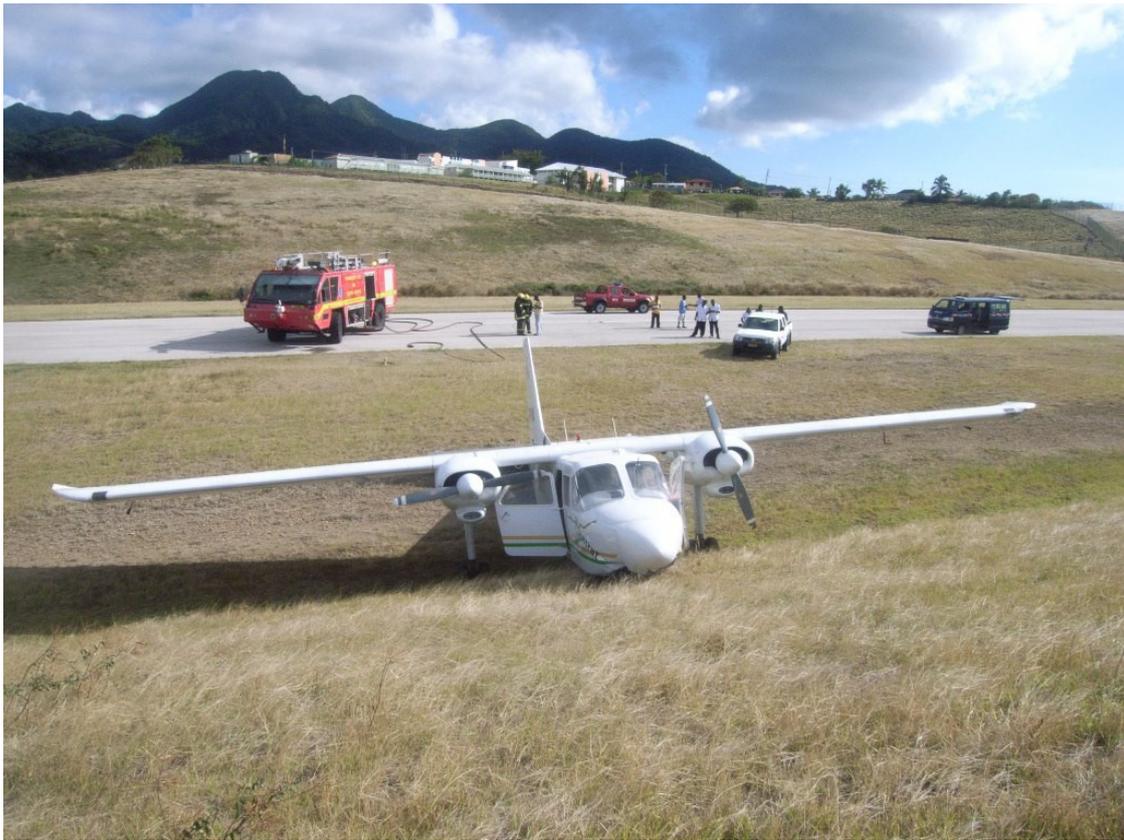
Figure 1
Accident site

Following an uneventful flight from VC Bird Airport, Antigua, the aircraft made an approach to Runway 10 at John A Osborne Airport, Montserrat. After a normal touchdown the pilot applied the brakes and noticed that there was no resistance from the right brake pedal. While maintaining directional control with the rudder pedals the pilot tried to "pump" the brake pedals but this had no effect on the right brakes. To avoid departing the end of the runway the pilot applied left brake and allowed the aircraft to veer left onto the grass just beyond the taxiway exit. The aircraft struck an embankment located 20 m north of the runway edge, about 150 m from the end of the runway (see Figures 1 and 2). The impact, which was estimated by the pilot to be at about 10 kt, resulted

in damage to the nose structure and caused the nose landing gear leg to collapse. The left wing tip leading edge was also damaged when it struck the embankment. After the aircraft came to rest the passengers were able to exit the aircraft via the main door.

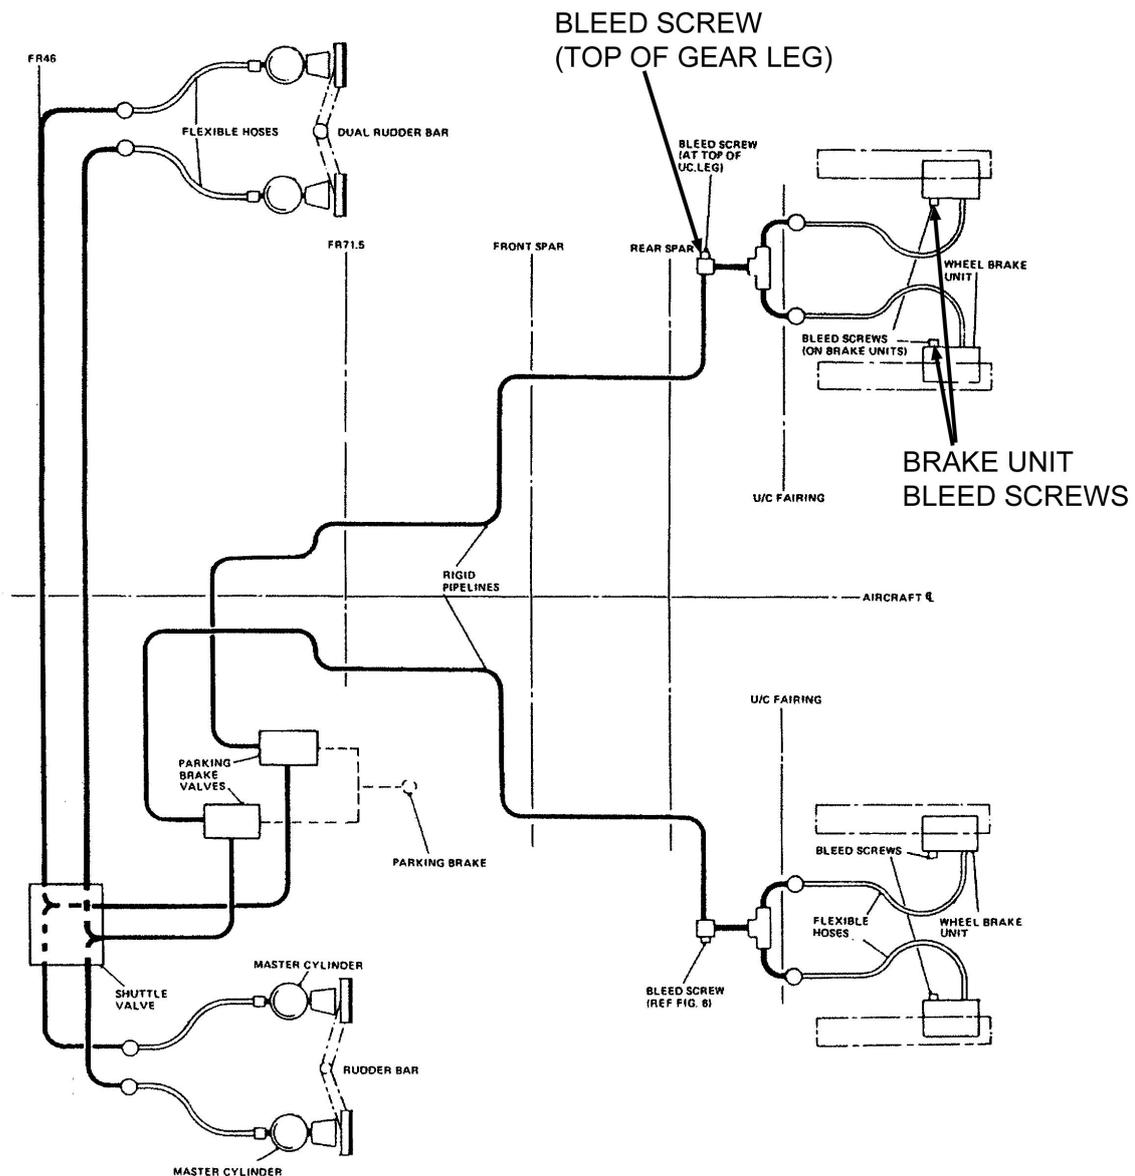
Figure 3

The Islander is equipped with four conventional hydraulic fluid operated brake units, one fitted at each main landing gear wheel. The brake system includes four hydraulic master cylinder reservoirs, one fitted at each toe-operated brake pedal which form part of the rudder pedals (see Figure 3). When a brake pedal is

actuated, fluid under pressure is routed via a combination of flexible hoses and rigid pipelines to the brake units at the wheels. Bleed screws are located at the top of each main gear leg and at each wheel brake unit. These bleed screws are used to bleed any air within the system. Trapped air in the system can cause the brakes to feel 'spongy' and can prevent brake actuation.

On landing, the aircraft suffered a loss of right braking and, in order to avoid the steep drop at the end of the runway, the pilot elected to use the left brake to steer the aircraft into the grass to the left side of the runway where it hit a raised embankment. The probable cause for the loss of right braking was trapped air in the right brake hydraulic lines. This air may have been present prior to the O-ring seal removal but was more likely to have been introduced during the seal removal and replacement. The engineer had carried out a brake bleeding procedure but he had not completed the full procedure as described in the AMM. He had not opened the bleed screw at the top of the right landing gear leg, and therefore air may have remained trapped in these lines. The investigation revealed the existence of several different brake bleeding procedures. The aircraft manufacturer had three different brake bleeding procedures, namely the Islander AMM procedure, the Trislander AMM procedure and their own production procedure. Three engineers from three different maintenance organisations had suggested that sometimes the manufacturer's procedures were inadequate for completely bleeding all the air out and that a hand pump attached to the brake bleed screws was sometimes required. Therefore the following Safety Recommendation is made:

Britten-Norman Aircraft Limited should review the different brake bleeding procedures for the Islander and Trislander aircraft including those used by engineering organisations, determine the most effective procedure and publish it in the aircraft maintenance manuals.
