INCIDENT

Aircraft Type and Registration:	BAE Systems Jetstream 4100, G-MAJI	
No & Type of Engines:	2 Garrett Airesearch turboprop engines	
Year of Manufacture:	1993	
Date & Time (UTC):	26 February 2007 at 0705 hrs	
Location:	Durham Tees Valley Airport, County Durham	
Type of Flight:	Commercial Air Transport (Passenger)	
Persons on Board:	Crew - 3	Passengers - 29
Injuries:	Crew - None	Passengers - None
Nature of Damage:	None	
Commander's Licence:	Air Transport Pilot's Licence	
Commander's Age:	59 years	
Commander's Flying Experience:	11,300 hours (of which 278 were on type) Last 90 days - 94 hours Last 28 days - 46 hours	
Information Source:	Aircraft Accident Report Form submitted by the pilot and additional AAIB enquiries

Synopsis

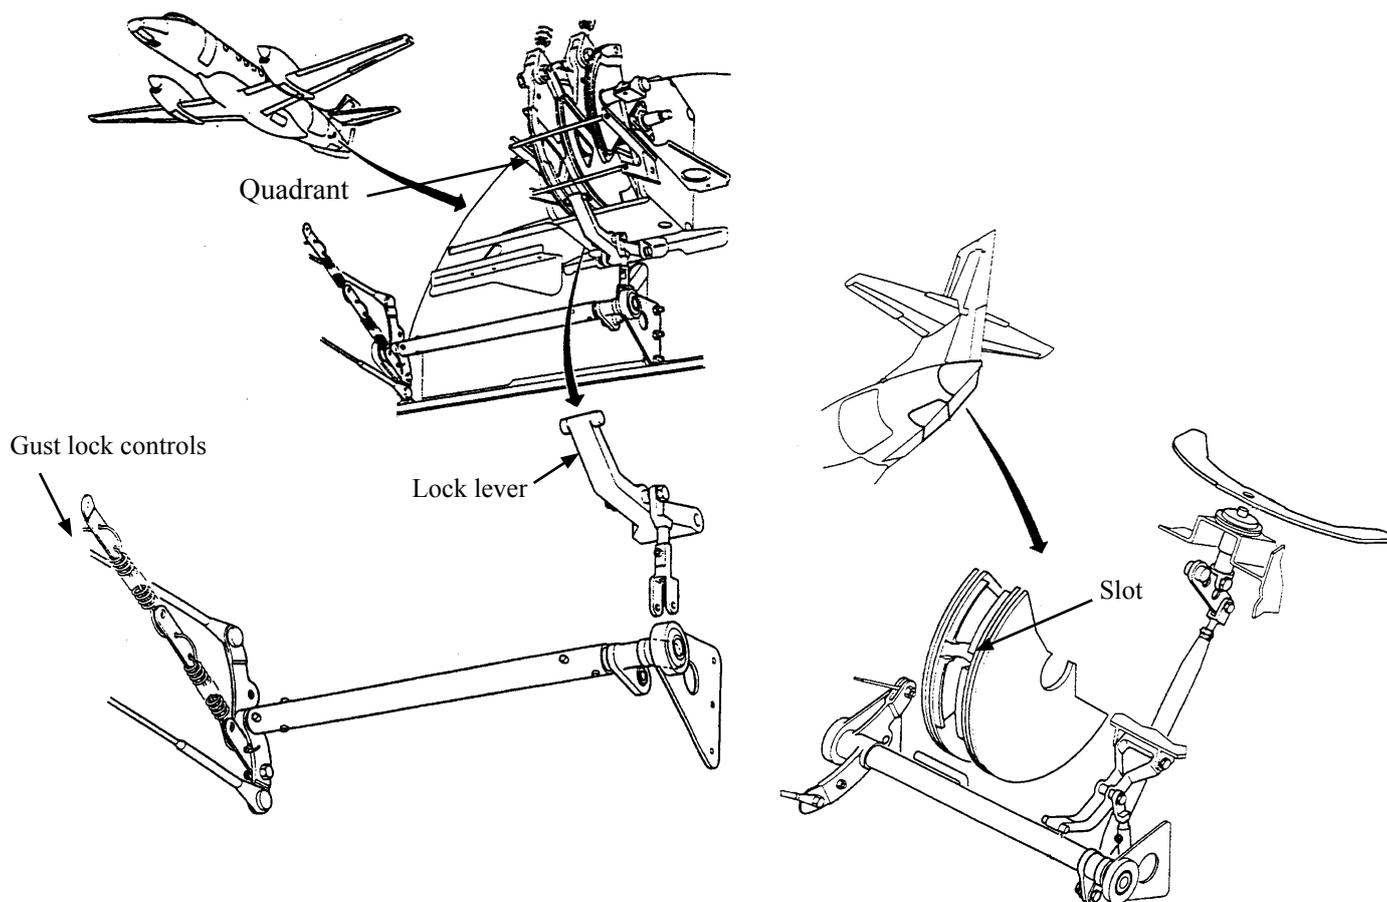
Figure 1

Operation of the gust lock control lever, with respect to the elevator circuit, causes a lock pin to engage in a slot cut into a cable quadrant located in the rear fuselage, Figure 1.

In this case, an apparent lack of lubrication was causing the pin to 'hang up' in the slot, thus keeping the elevators in a locked condition. When the operating lever on the flight deck was moved to the unlocked position, the 'lost motion' was taken up by the compression of a spring within the locking mechanism. The operator, who has a fleet of 25 Jetstream 41 aircraft, has stated that they have experienced 19 similar occurrences involving the gust lock system, although many of these were the result of

Details of elevator gust lock controls in rear of fuselage

The Maintenance Schedule required that the gust lock system components be lubricated every 6,000 flight hours which, with this operator, occurred approximately every four years. Since this incident the operator has adopted a policy of applying lubrication every year. Also, the aircraft manufacturer is in the process of changing the Maintenance Schedule to increase the frequency of gust lock system lubrication. Since this will take some time, they are considering raising the matter in an All Operators Message (AOM) to be published in the shorter term.
