ACCIDENT

Aircraft Type and Registration:	Cessna F406 Caravan II, N17CK	
No & Type of Engines:	2 Pratt & Whitney Canada PT6A-112 turboprop engines	
Year of Manufacture:	1985	
Date & Time (UTC):	8 November 2008 at 1313 hrs	
Location:	Tortola, British Virgin Islands	
Type of Flight:	Private	
Persons on Board:	Crew - 1	Passengers - None
Injuries:	Crew - None	Passengers - N/A
Nature of Damage:	Damage to underside of fuselage, inboard flaps and both propellers	
Commander's Licence:	Airline Transport Pilot's Licence	
Commander's Age:	65 years	
Commander's Flying Experience:	Not known Last 90 days - 20 hours (estimated from aircraft log books) Last 28 days - 10 hours (estimated from aircraft log books)	
Information Source:	Aircraft Accident Report Form submitted by the pilot and reports collated by Air Safety Support International (ASSI)

Synopsis

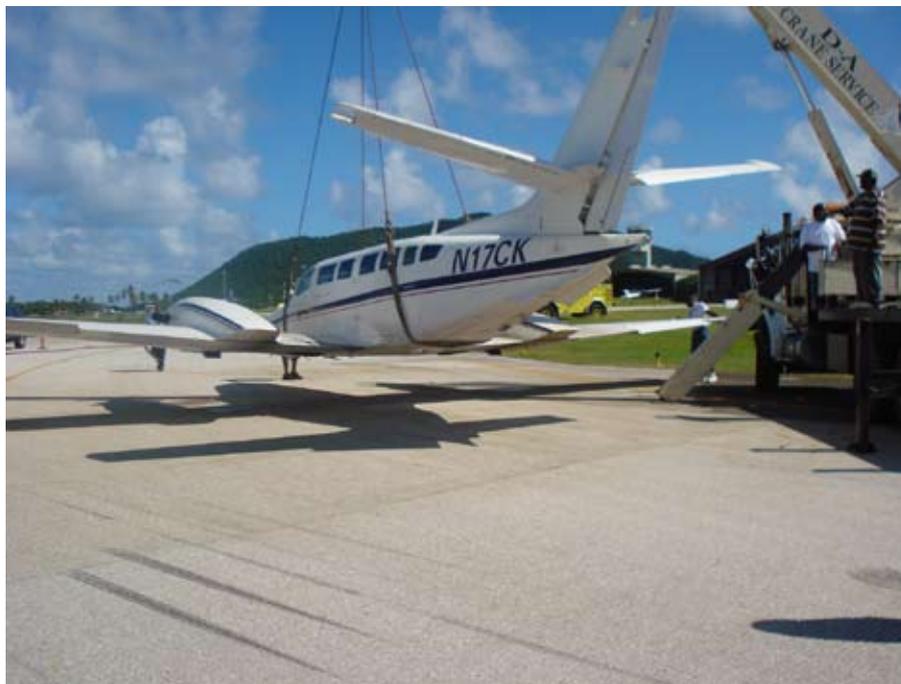
Figure 1
Recovery Operation (courtesy ASSI)

The aircraft was lifted using a mobile crane and strops, Figure 1, which enabled the local mechanic to lower the landing gear using the alternative 'blow-down' procedure. The gear lowered and locked in the DOWN position without fault and the three green, locked down, indicators in the cockpit illuminated. This procedure is available in-flight for emergency lowering of the gear should the normal system fail. The aircraft was lowered onto its wheels and towed to a hangar without further incident.
