Schweizer 269C, G-TASS

AAIB Bulletin No: 10/2004	Ref: EW/C2004/05/02	Category: 2.3
Aircraft Type and Registration:	Schweizer 269C, G-TASS	
No & Type of Engines:	1 Lycoming HIO-360-D1A piston engine	
Year of Manufacture:	1992	
Date & Time (UTC):	10 May 2004 at 1425 hrs	
Location:	Near Bowscale Tarn, Cumbria	
Type of Flight:	Training	
Persons on Board:	Crew - 2	Passengers - None
Injuries:	Crew - 2 (Serious)	Passengers - N/A
Nature of Damage:	Helicopter destroyed	
Commander's Licence:	Private Pilot's Licence (Helicopter)	
Commander's Age:	35 years	
Commander's Flying Experience:	270 hours (of which 88 were on type)	
	Last 90 days - 20 hours	
	Last 28 days - 13 hours	
Information Source:	AAIB Field Investigation

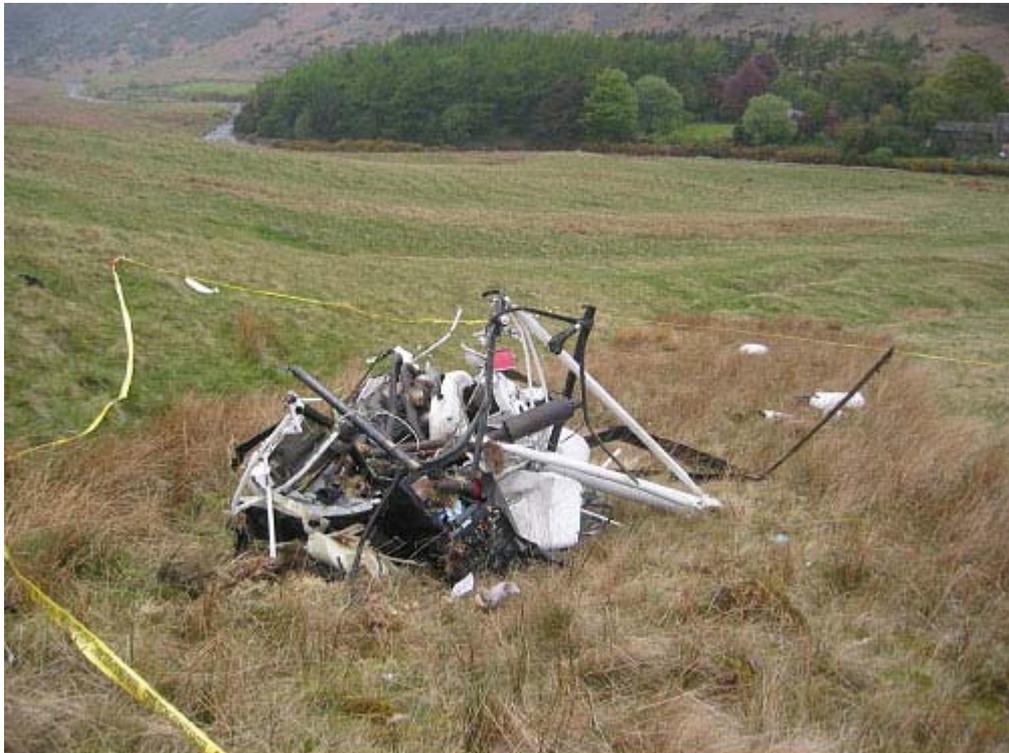
The aircraft had then skipped some 16 metres further down the hill, where a substantial impact had occurred. A left skid imprint indicated that the aircraft was yawed slightly to the left compared to the earlier ground contact. Some fragments from the underside of the aircraft, including engine parts, were found here and it was apparent that most of the cockpit glazing structure had become detached at this time. The aircraft had become airborne again before landing some 10 metres further on at the bottom of a steeper section of the slope in soft, marshy ground. The absence of main rotor strike marks on the ground suggested that the aircraft had remained upright up to this point, although it then rolled over, coming to rest on its right hand side, having sustained extensive damage, see Figure 1.

Figure 1. General view of the wreckage

All three main rotor blades were found to be intact, with no evidence of high-speed impacts with the ground. In addition, all were found at a high flapping angle, indicating significant 'coning' prior to impact. It was also noted that the collective control setting was at maximum pitch angle. Thus the overall impression was one of low rotational energy, which accorded with the pilots' account of an engine failure.

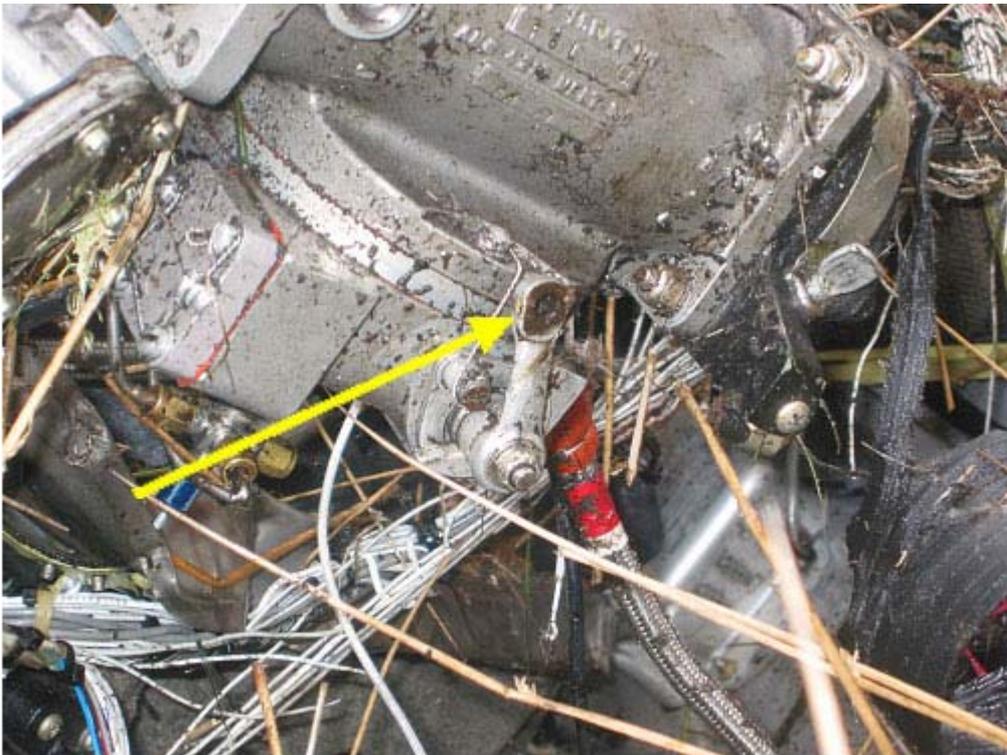
During the on-site phase of the investigation it was observed that the mixture control lever on the injector servo had become disconnected from its control cable, without apparently causing any distress to the bolt hole within the lever, see Figure 2.

Figure 2. View of injector servo as found, showing apparently disconnected mixture lever

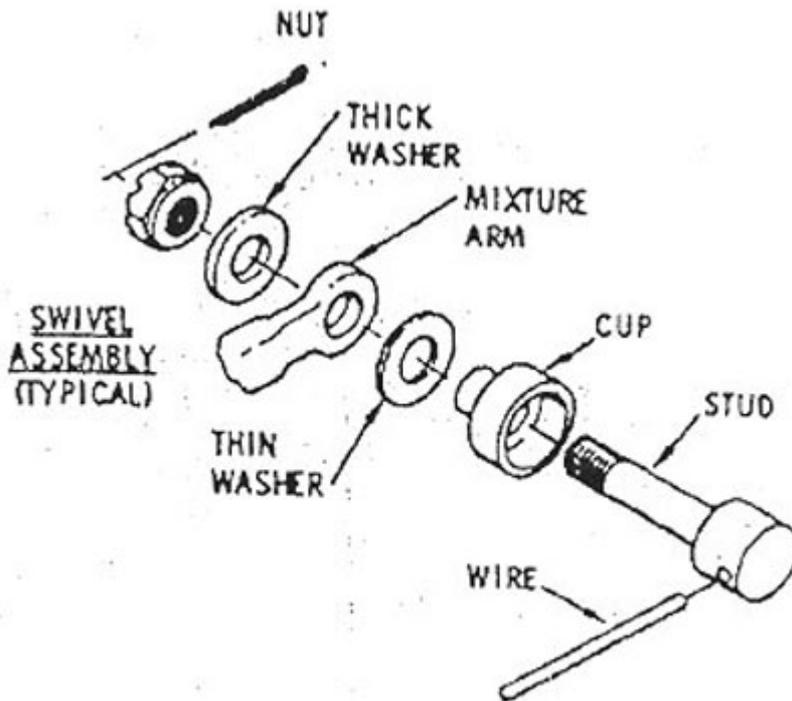
The engineering investigation focused mainly on the potential causes of the engine failure, and paid particular attention to the disconnect of the mixture control cable. This had been attached to the lever by means of a stud, cup, washers, nut and split pin, with the cable passing through a hole in the head of the stud. The Maintenance Manual illustration is shown at Figure 3a, where it can be seen that the head of the stud is wider than the shank.

Figure 3a. Maintenance Manual diagram of typical cable attachment

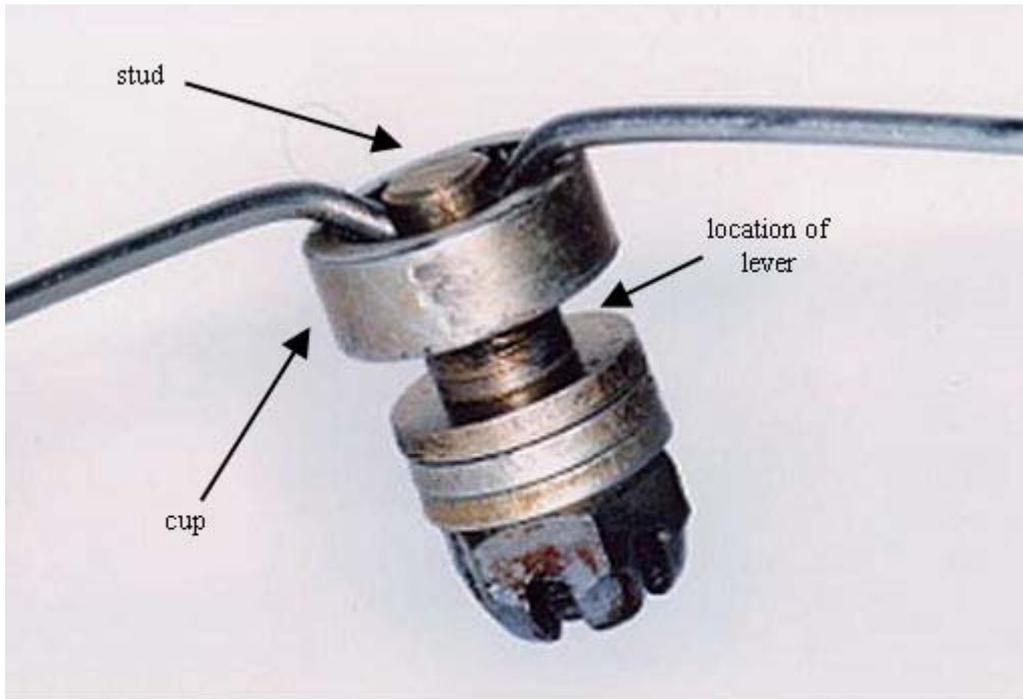
The fuel shut-off control utilised a similar cable to that of the mixture control, and was attached to the valve operating lever by means of the 'step-less shank' stud design, as shown at Figure 3b.

Figure 3b. Current method of attachment, using "stepless shank" stud design. Split pin not shown

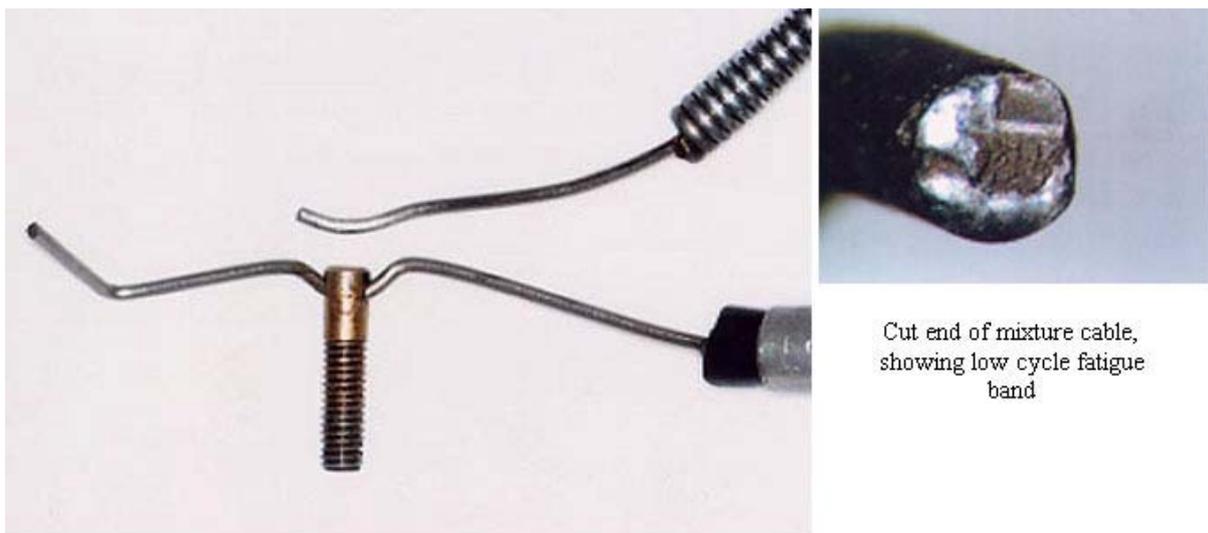
This was disassembled for examination and comparison with the mixture control cable, see Figure 4. It was immediately apparent that the mixture cable terminated very close to the stud, whereas the fuel shut-off cable extended several inches beyond it, with the final half-inch being bent at right angles. The latter style was similar to mixture controls cables seen on a number of intact aircraft that were examined during the course of the investigation.

Figure 4. Comparison of mixture cable (top) and fuel shut-off cable

A microscopic examination of the end of the mixture cable (see inset in Figure 4) revealed a central band containing evidence of low cycle fatigue, flanked by smooth, sloping surfaces, together with an

area of overload. This was consistent with the action of a set of wire cutters, with the loose end being repeatedly moved up and down until it broke away. It was thus concluded that the end of the cable had been cut during the attachment process, as opposed to failing in the accident.

The fact that the mixture cable had been cut so close to the end of the lever meant that the final bend in the joggle contributed nothing to the strength of the joint. In a test on the fuel shut-off cable, a force of 25 lbs failed to pull the wire through the stud/cup/nut assembly. In contrast, the mixture cable required only 5 lbs force to pull it through. In both cases, the nut was finger tight. Whilst this may seem very little, it was observed, during a separate test on a piece of wire, that less than 10 lb ins of torque was required on the nut in order to draw the stud into the cup, in order to create a joggle.

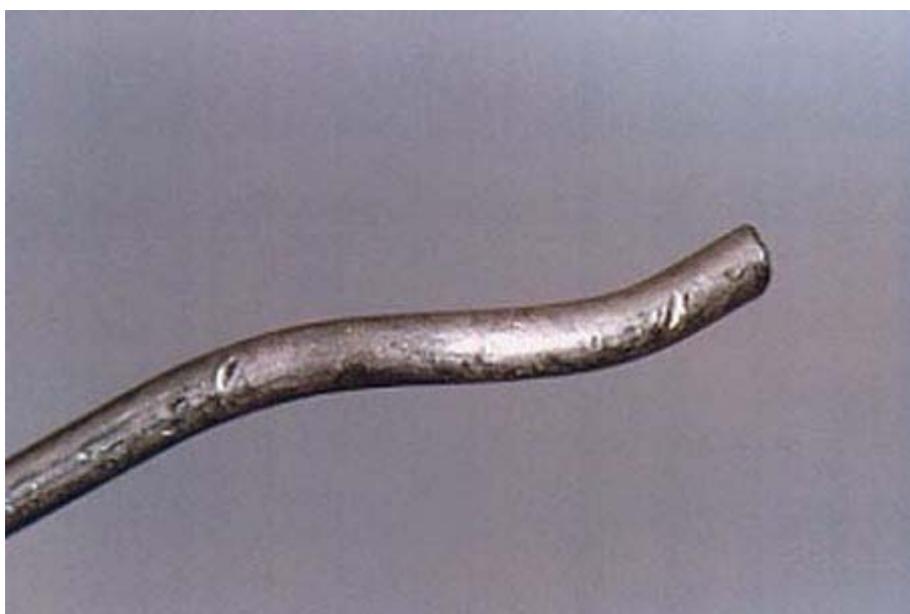
Figure 5 shows a close-up view of the end of the mixture cable. Two indentations can be seen, which lined up with the edge of the cup. In the pull-off test described above, two similar marks were made, which were immediately adjacent to the existing ones.

Figure 5. "Joggle" area of mixture cable, showing indentations from cup rim
