**AAIB Bulletin No:** 8/95      **Ref:** EW/C95/3/6      **Category:** 2.3

**Aircraft Type and Registration:** Schweizer 269C (300C) G-LSLH

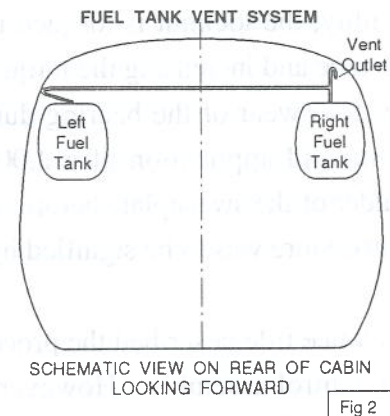
The two fuel tanks located behind the upper part of the cabin are vented into a  $\frac{3}{8}$  inch diameter aluminium pipe attached to the upper surface of each tank near its centre (Fig 2). A tee off this pipe connects to a short upstanding vertical open-ended standpipe with the end curved downwards forming the overboard drain. The vent pipe from the left tank initially loops outwards to just outboard of the left edge of the tank before routing across the helicopter, but that from the right tank passes immediately inboard after connecting to the outlet standpipe (Fig 2). Thus it appears that the configuration will prevent the overboard release of fuel from the

left tank with the aircraft lying on either its left or right side, but will cause the right tank in either case to release overboard through the vent outlet any contents above approximately half full. It appears that such overboard fuel spill in this situation could be prevented by minor reconfiguration of the vent pipe run and outlet.

The fuel tank vent system configuration and a previously damaged tank filler cap seal allowed considerable quantities of gasoline to spill overboard after the aircraft rolled onto its side, although the fuel system was undamaged and the fuel selector was turned off.

- 1 Reconfiguration of the fuel tank vent system to prevent fuel release through the vent outlet.
- 2 Measures aimed at ensuring the integrity of fuel tank filler cap seals.

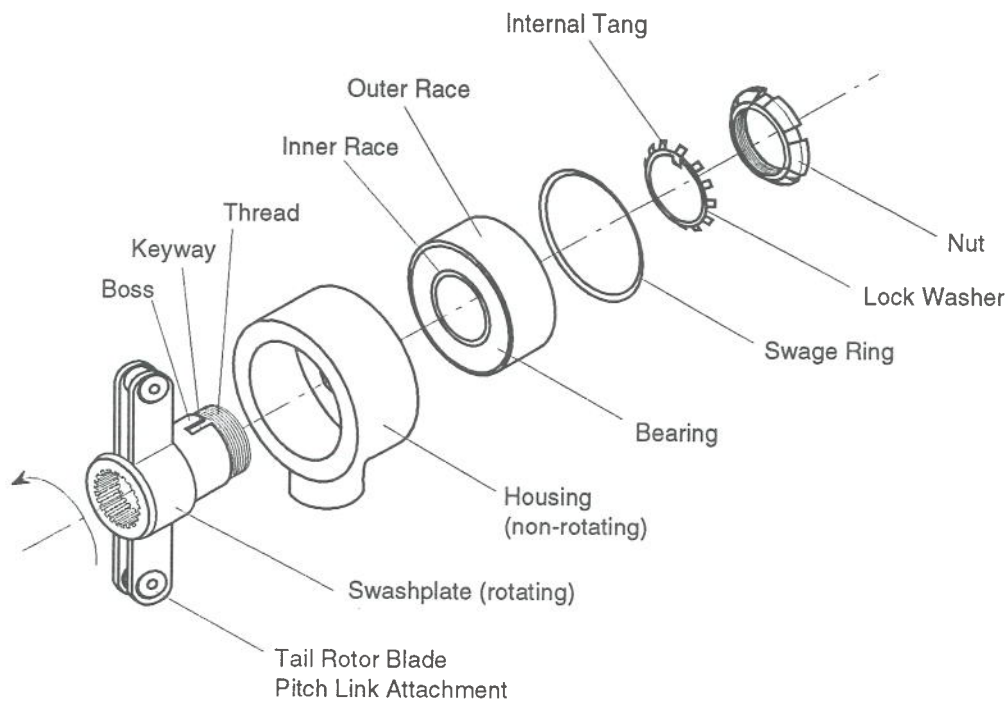
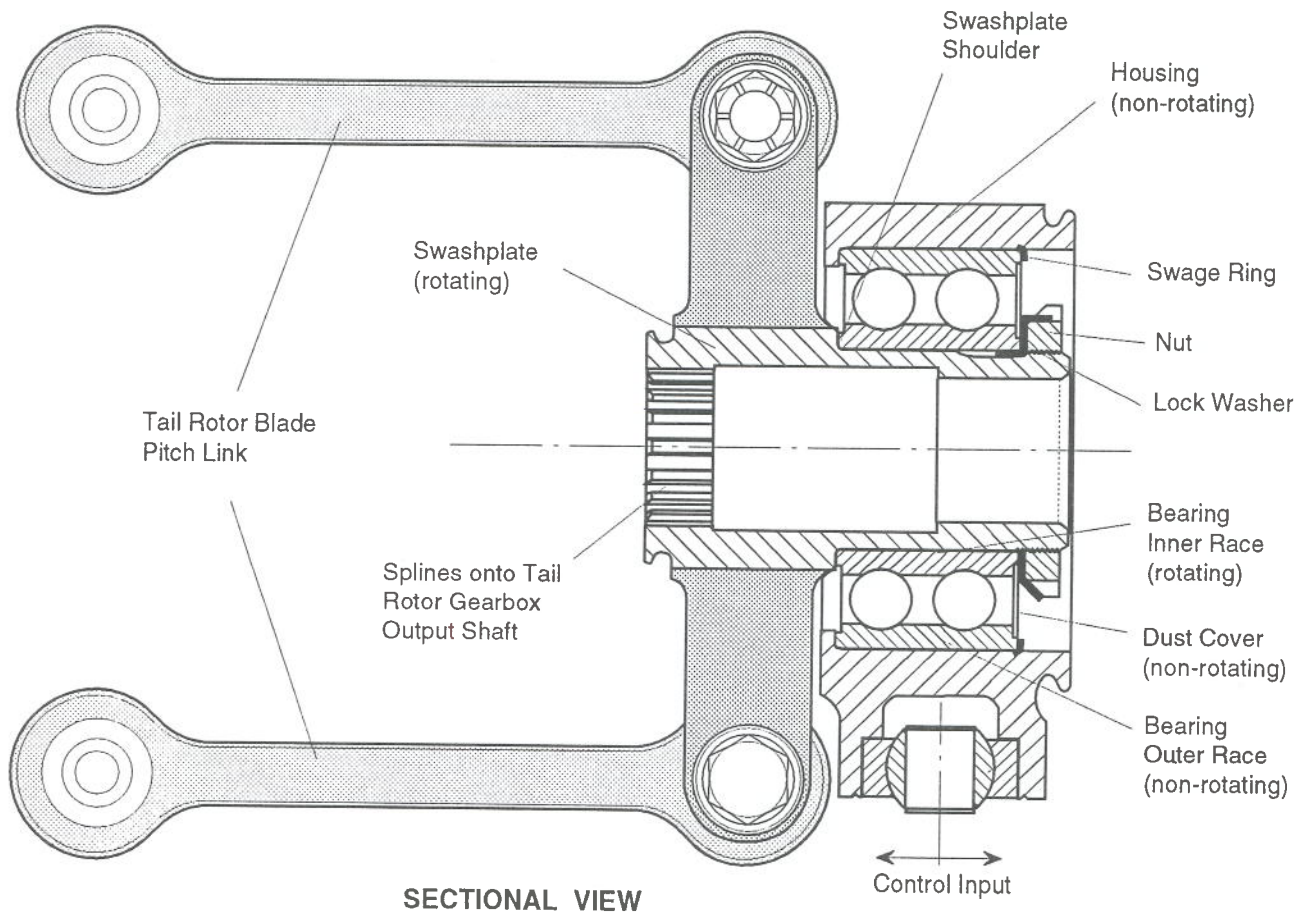
Fig 1

The pitch control assembly (PN 269A6050-5) comprised a non-rotating aluminium housing connected via a double row ball bearing to a rotating swashplate assembly splined to the gearbox output shaft (Fig 1). The outer race of the bearing was an interference fit in the housing and secured in it by a swage ring. The bearing inner race was an interference fit on a boss, or shaft, forming an integral part of the aluminium swashplate and was axially clamped against a shoulder formed at the outboard end of the boss by a nut screwed onto a thread formed on the inboard end of the boss. The nut was secured by a lock washer which was fitted between the nut and the inner race and prevented from rotating by a tang that protruded inside the internal diameter and located in a keyway in the boss; thirteen external tangs protruded from the outer diameter of the washer, one of which would be bent into one of eight slots formed in the nut. The inboard end of the pitch control assembly was covered by a non-rotating flexible boot wired to the housing and to the gearbox casing and the outboard end was covered by a rotating boot wired to the swashplate and to the fork assembly carrying the tail rotor blades.

AAIB examined the aircraft after partial disassembly of the tail rotor control system. This revealed that the nut in the pitch control assembly on the tail rotor gearbox output shaft had disengaged from the swashplate boss; the nut had not been damaged apart from signs of fretting wear on the face normally bearing against the lock washer, and the boss thread, while damaged, remained intact. The lock washer had been heavily rubbed and considerably distorted and had broken into two major portions with the internal and two external tangs fractured off, one of the latter showing signs of having been bent consistent with engagement with the nut. These components were recovered from within the stationary boot. The swashplate boss showed signs of major fretting and wear; the outer diameter was measured at 1.165-1.175 inches, 0.0166-0.0066 inch below the minimum requirement of 1.1816 inches. The bearing inner race bore was measured at approximately 1.180 inches. The swashplate thus exhibited considerable play within the bearing, both diametrically and in the angular rocking sense, together giving a relative motion of approximately 0.03-0.04 inch at the plane of the pitch link attachment bearings in the swashplate forks. The bearing remained secure within the housing and was apparently undamaged and rotated smoothly and without signs of play or binding. Markings on the component surfaces surrounding the normal position of the lock washer and nut suggested that parts of the lock washer had contacted the swage ring and the exposed bore of the housing inboard of the bearing after the washer had fractured. Other markings suggested washer rotational contact with the bearing inner race and dust cover (non-rotating) and showed that the washer's inner tang had been driven out of the swashplate keyway in a clockwise rotation direction, viewed from outboard. The tail rotor gearbox output shaft was undamaged apart from an area of rubbing adjacent to the gearbox casing, consistent with a period of running with the nut lying on the shaft in this region.

The evidence was consistent with wear of the swashplate boss having allowed the boss to spin within the bearing inner race and with friction loads between the inner race and/or the dust cover and the lock washer having applied a retardation torque to the washer. The boss had a normal right-hand thread and any retardation torque applied to the nut, either via the washer or by direct contact with a slower rotating inner race and/or non-rotating dust cover, would tend to unscrew the nut from the boss. No assessment of the operating timescale over which the major part of the wear had occurred was possible from the component damage.

The evidence was consistent with the effects of a loss of preload in the attachment of the swashplate to the tail rotor pitch change assembly bearing having allowed fretting wear to occur to the point where the swashplate became loose in the bearing, resulting in further wear. Subsequent relative rotation between the swashplate and the bearing inner race and dust cover caused the lock washer to disengage or fail and the nut to screw off the swashplate. The reason for a loss of preload could not be positively established but the assembly technique used by the maintainer, while in accordance with the HMI, did not include the procedure specified by Schweizer Notice N-163 published in 1979 for seating the swashplate in the bearing with a 2,000 lb press load that was likely to be much higher than that used if following the HMI procedure, together with an approximate doubling of the nut torque load. This procedure was not listed as applicable to G-LSLH's Serial No, as the change had been incorporated on the production line, and due to an oversight had not been incorporated in the HMI. The rate of progression of the failure could not be positively established but the previous occurrence to G-LSLH suggested that noticeable play in the assembly may be present for some period before disconnection occurs.

- 1 Liaise with the manufacturer to confirm the assembly procedure necessary to ensure a satisfactory installation of the tail rotor pitch change assembly.
- 2 Consider the implementation of a disassembly inspection of the tail rotor pitch change assembly for excessive wear and reassembly in accordance with the necessary procedure.
- 3 Consider the implementation of a suitable inspection of the tail rotor pitch change assembly for excessive play before each flight until the inspection and reassembly recommended in 2 has been carried out.
