BULLETIN ADDENDUM

AAIB File: EW/G92/11/11
Aircraft Type and Registration: Piper PA38-112 Tomahawk, G-BSVW
Date & Time (UTC): 13 November 1992 at 1630 hrs
Location: Leicester Airport, Leicestershire
Type of Investigation: Aircraft Accident Report Form submitted by the pilot and examination of failed nose leg

SYNOPSIS (AAIB Bulletin 2/93 refers)

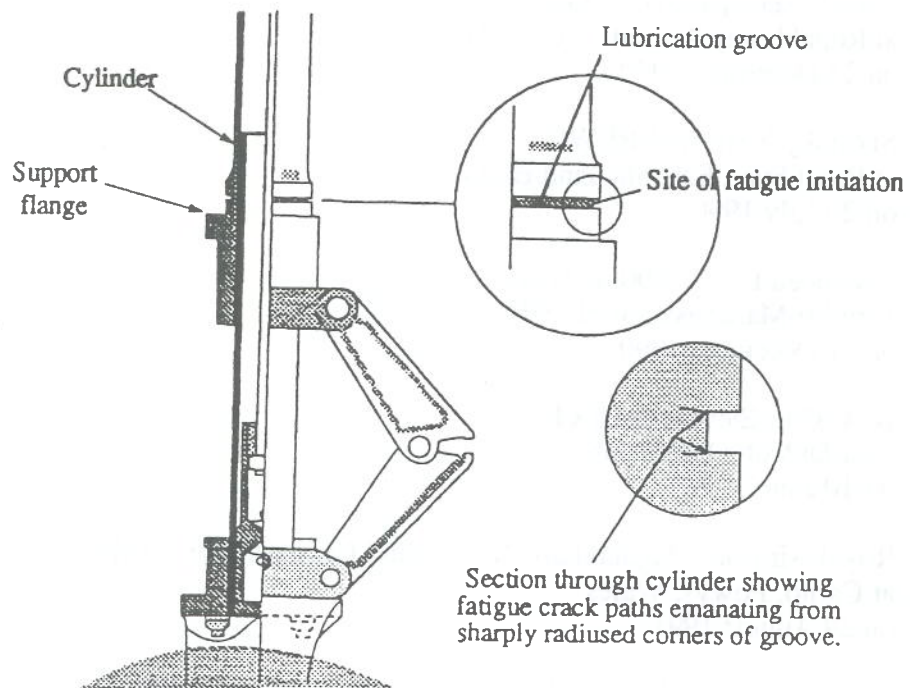
Fig. 1

Following a normal touchdown, the nose landing gear leg detached. Although the propeller and lower cowling were damaged, the student pilot was uninjured. Subsequent metallurgical examination of the fractured leg, at the Materials and Structures Department at DRA Farnborough, found that the leg had failed due to pre-existing fatigue cracking which had emanated from multiple origins within a lubrication groove which had been machined into the outer diameter of the oleo cylinder. The absence of blending radii within this groove had generated the fatigue cracking, which was almost identical to that found on other PA38 aircraft (Bulletin 3/91).

As the Tomahawk fleet continues to accumulate time in service it is probable that the incidence of nose landing gear failures will increase. The underlying problem of the lack of any blend radii in the base of the lubrication groove (Fig. 1) is compounded by the lack of any Maintenance Manual requirement to subject this component to a periodic crack detection process. The ideal solution would be the introduction of a modified leg which incorporated blend radii in the groove. However, the US aircraft manufacturer, which is currently in 'Bankruptcy Protection', is unlikely to be able to offer such a modification in the near future. In the meantime, it is probable that the incidence of similar failures could be prevented by the introduction of periodic crack detection inspection.

**Half Section of PA38
(Tomahawk) Nose Leg**

- 93-7** The CAA should introduce a service maintenance requirement for a periodic dye penetrant inspection of the lubrication groove at the lower end of the nose leg oleo cylinder on Piper PA38 Tomahawk aircraft, in order to reduce the incidence of associated nose leg failure due to fatigue cracking initiation from the sharp radii at the base of this groove. (Issued 19 April 1993)
