**ACCIDENT**

<b>Aircraft Type and Registration:</b>	1) Boeing 767-204, G-SATR 2) Boeing 737-37Q, G-ODSK
<b>No &amp; Type of Engines:</b>	1) 2 General Electric Co CF6-80A2 turbofan engines 2) 2 CFM CFM56-3C1 turbofan engines
<b>Category:</b>	1) 1.1 2) 1.1
<b>Year of Manufacture:</b>	1) 1989 2) 1997
<b>Date &amp; Time (UTC):</b>	4 November 2004 at 1620 hrs
<b>Location:</b>	Manchester Airport, Manchester
<b>Type of Flight:</b>	Public Transport (Passenger)
<b>Persons on Board:</b>	1) Crew - None            Passengers - None 2) Crew - None            Passengers - None
<b>Injuries:</b>	1) Crew - None            Passengers - None 2) Crew - None            Passengers - None
<b>Nature of Damage:</b>	1) Left wing damaged 2) Tail damaged
<b>Commander's Licence:</b>	1) Airline Transport Pilot's Licence 2) Airline Transport Pilot's Licence
<b>Commander's Age:</b>	1) 50 years 2) 46 years
<b>Commander's Flying Experience:</b>	1) 8,040 hours (of which 6,234 were on type) Last 90 days - 75 hours Last 28 days - 36 hours 2) 4,070 hours (of which 450 were on type) Last 90 days - 256 hours Last 28 days - 66 hours

**Synopsis**

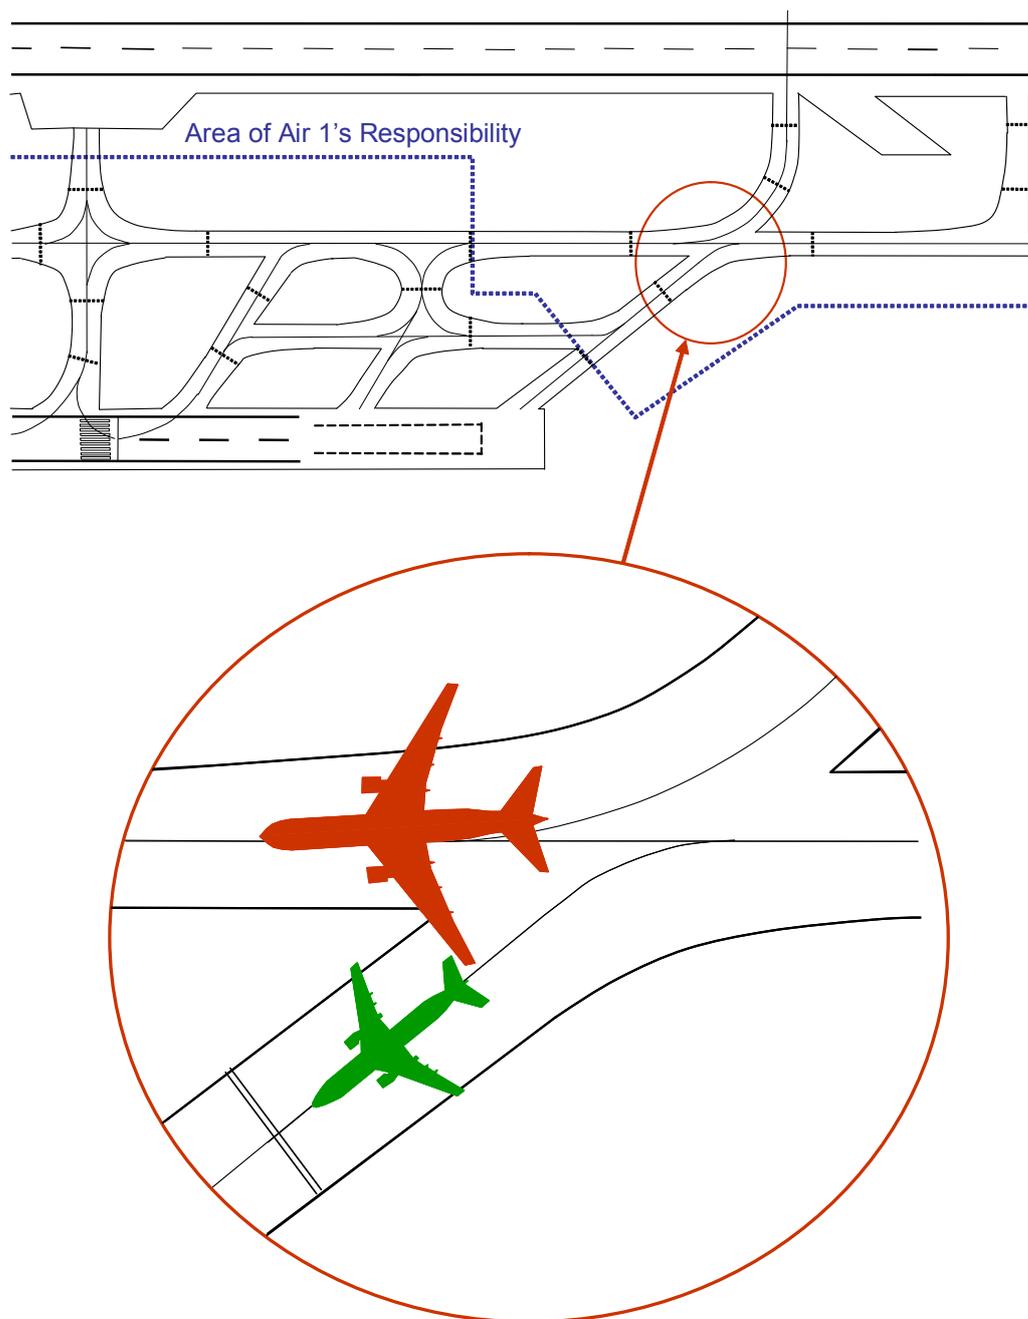
**Figure 2**

South Side Taxiways and Geometry of Collision

The B767 commander could see the B737 holding in turn at 'T1' and, expecting to have to come to a stop behind it, had reduced taxi speed accordingly. When the revised taxi instructions were issued to the B767 crew, the commander continued taxiing to follow the marked taxiway centreline right onto 'V' Taxiway and called for the 'Before Take-off' checklist. As he did so, the co-pilot checked the taxiway chart to confirm the routing and located the appropriate checklist. Neither the commander nor the co-pilot thought that there was a problem regarding wing tip clearance between their aircraft and the B737. As the B767 was turning right onto Taxiway 'V', its left wing collided with the right horizontal stabilizer of the B737.

Analysis of the SMR and the nature of the damage to both aircraft indicated that the B767 was on or very close to the marked taxiway centre line during the turn and at the point of collision. The aircraft would therefore have begun to turn away from the B737 when it was still some distance from it. As the turn continued, the B737 would have moved into the commander’s left side window, giving him the impression that his aircraft was moving away from the B737 when the wingtip was still, in fact, moving towards it. As the tail of G-ODSK moved further aft, the task of monitoring it and looking ahead and to the right to follow the taxiway would have become increasingly difficult, with the commander having to monitor two points separated by about 150°. It is not certain that the pilot was physiologically equipped to assess the separation between a wing tip which he could not see and which was behind him, and the tail of
