**SERIOUS INCIDENT**

<b>Aircraft Type and Registration:</b>	Boeing 747-436, G-CIVK
<b>No &amp; type of Engines:</b>	4 Rolls-Royce RB211-524G2-19 turbofan engines
<b>Year of Manufacture:</b>	1997
<b>Date &amp; Time (UTC):</b>	23 August 2008 at 2120 hrs
<b>Location:</b>	Heathrow Airport, London
<b>Type of Flight:</b>	Commercial Air Transport (Passenger)
<b>Persons on Board:</b>	Crew - 19                      Passengers - 293
<b>Injuries:</b>	Crew - None                      Passengers - None
<b>Nature of Damage:</b>	Damage to No 7 wheel bearing, hub and axle
<b>Commander's Licence:</b>	Airline Transport Pilot's Licence
<b>Commander's Age:</b>	50 years
<b>Commander's Flying Experience:</b>	8,500 hours (of which 6,000 were on type) Last 90 days - 185 hours Last 28 days - 36 hours
<b>Information Source:</b>	AAIB Field Investigation

**Synopsis**

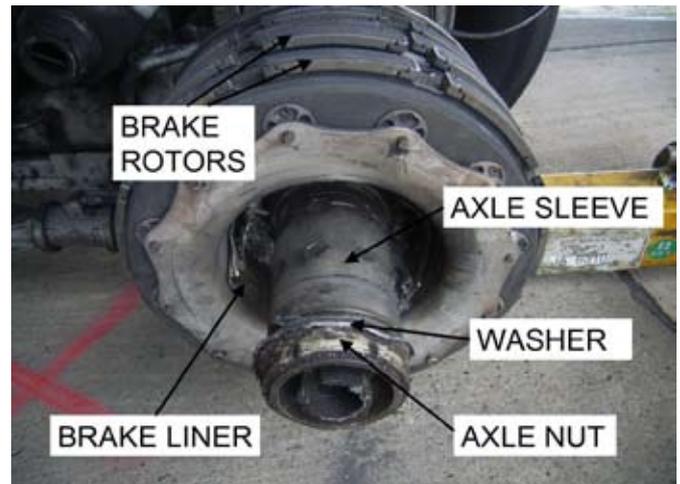
The debris recovered from the taxiways included the hub cap, part of the TPIS in-axle assembly with a severed cable, rollers, parts of the retaining rings and broken pieces of outer bearing cone. The axle nut was found seized to the axle. Both axle nut lockbolts were reportedly in place and were removed by the operator's engineers, although one of these was subsequently lost. The remaining lockbolt was bent with a sheared shank, indicating that it was installed at the time of the failure. The washer was in place but had been flattened, Figure 3. The upper surface of the axle sleeve was in good condition but the lower surface had been partially abraded away; discolouration associated with high temperatures and evidence of molten metal was present, Figure 4. There were large deposits of molten aluminium alloy from the wheel hub inside the brake-liner heat shield, and the wheel hub was extensively damaged with loss of material both inside and around the outside hub circumference, Figure 5. The section of inner wheel hub that would have supported the inner cone had been completely removed. There was no evidence of inner bearing rollers or cage material inside the hub, although the inner bearing cone was found intact around the axle. There were no remains of outboard bearing rollers, roller cage or cone inside the wheel, although the outboard wheel bearing cup was still in place in the outboard hub, and this exhibited significant surface erosion

**Figure 3**  
Damage to wheel axle

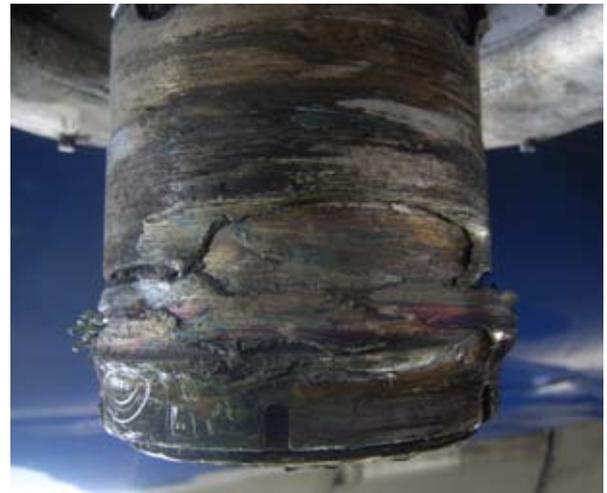
**Figure 4**  
Damage to wheel axle underside (6 o'clock position)

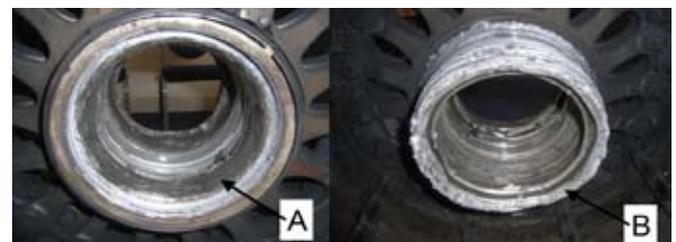
**Figure 5**  
Left: Outer wheel hub showing remains of outer bearing cup (A).  
Right: Inner wheel hub showing that at (B) the inner bearing hub support and inner bearing cup are missing.

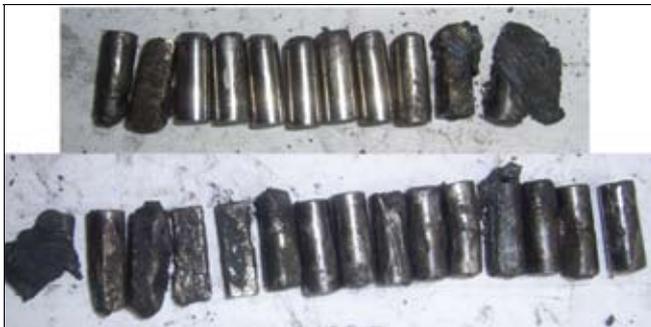
**Figure 6**

and the outboard bearing had the same part number, but it was possible to separate the rollers into two groups on the basis of a batch mark indentation (shaped like a house) present on some of their ends. This indentation revealed that the rollers were from a batch manufactured in 1995. The rollers without the indentation mark were blackened, and exhibited evidence of high temperature exposure and some minor plastic deformation (the lower row in Figure 6). Some of the rollers with the indentation mark were relatively undamaged and had not been exposed to high temperatures; others exhibited crushing damage (the upper row in Figure 6). The sliding ends of both sets of rollers were in good condition, which is an indication that lubrication was present. Also, the roller bodies had not elongated, which is an indication that failure occurred rapidly and at relatively low rotational speed.

Some of the recovered rollers from the outer bearing (lower image) and inner bearing (upper image)

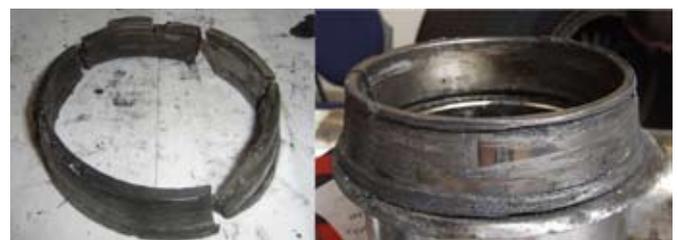
**Figure 8**

The outer bearing cone had fractured into six large pieces (left image in Figure 8) and its race surface exhibited evidence of elevated temperatures. The inner bearing cone was recovered intact from the axle and did not exhibit evidence of elevated temperature (right image in Figure 8). The original ground surface was visible with

deposits of smeared steel, probably originating from the cup, and smeared aluminium from the wheel hub. On the basis of the bearing cone evidence it was established that the rollers with the elevated temperature characteristics were from the outer bearing and the rollers without the elevated temperature signatures were from the inner bearing.

The bearing manufacturer's report concluded that the outer bearing was the first to fail, because the first bearing to fail normally generates the most heat, and that the failure probably occurred due to the outboard bearing cage becoming trapped between rollers and the rotating cup. The report stated that:

Damaged outer bearing cone (left) and inner bearing cone (right)
