INCIDENT

Aircraft Type and Registration:	BAe 146-300, G-JEBB	
No & Type of Engines:	4 Lycoming ALF502R-5 turbofan engines	
Year of Manufacture:	1991	
Date & Time (UTC):	15 February 2006 at 1330 hrs	
Location:	Approach to Birmingham International Airport	
Type of Flight:	Public Transport (Non revenue)	
Persons on Board:	Crew - 3	Passengers - None
Injuries:	Crew - None	Passengers - N/A
Nature of Damage:	Ruptured hydraulic accumulator and small hole in fuselage pressure hull	
Commander's Licence:	Airline Transport Pilot's Licence	
Commander's Age:	35 years	
Commander's Flying Experience:	4,500 hours (of which 3,000 were on type) Last 90 days - 82 hours Last 28 days - 28 hours	
Information Source:	Aircraft Accident Report Form submitted by the pilot and metallurgical examination commissioned by the AAIB

Synopsis

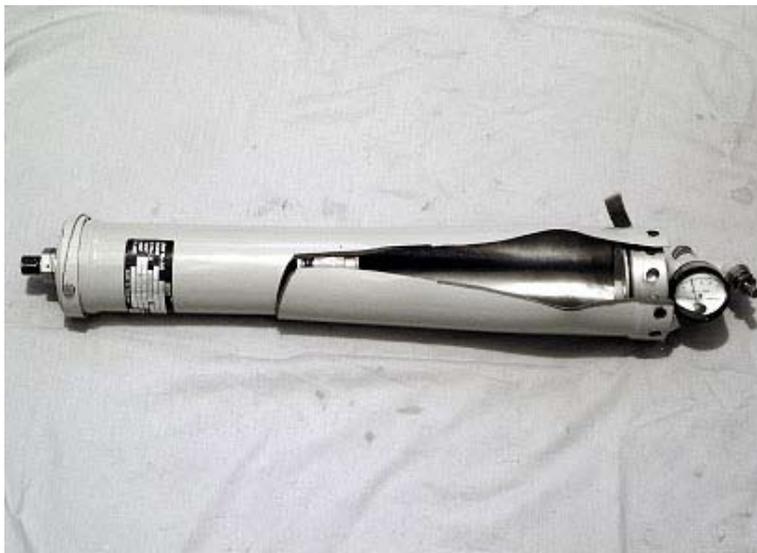
After the shutdown checks were completed it was determined that the yellow system accumulator had burst causing immediate loss of functionality of the yellow hydraulic system. Moreover a metal pin from the accumulator had pierced the fuselage pressure hull.

The burst accumulator (see Figure 1) was removed from the aircraft and sent to the AAIB.

Figure 1
Accumulator as removed from
the aircraft
