# **Boeing 747-235, N516MC, 20 December 1995**

**AAIB Bulletin No: 5/96 Ref: EW/C95/12/3 Category: 1.1**

**Aircraft Type and Registration:** Boeing 747-235, N516MC

**No & Type of Engines:** 4 General Electric CF6-50-E2 turbofan engines

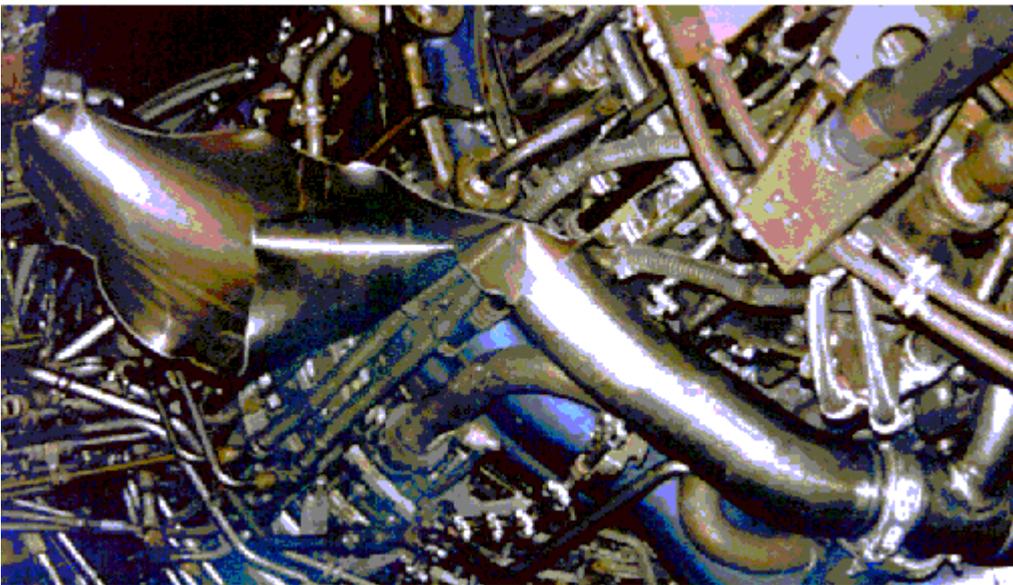
The 14th stage HP air duct on the No 4 engine, part number 9068M-40-G01, had failed causing two blow-out panels to operate, and damage to one half of the reverser shroud. The No 4 reverser deployed, but would not stow. Braking, followed by the aircraft being held stationary had caused brake overheating which led to tyre failures and brake seizure on the right main gear, and, in order to move the aircraft, wheels and brake packs had to be changed.

'The duct had burst approximately mid way along its length becoming grossly distorted around its circumference and fracturing one of the attachment lugs. Examination of the duct fracture

surfaces revealed the presence of a fatigue crack growing from multiple origins at the weld toe at the base of an attachment lug. The fatigue crack, which was approximately 40 mm in length, had penetrated through the saddle/duct section and extended along the duct for approximately 5 mm on either side of the saddle. This led to a longitudinal tear approximately 450 mm in length before changing direction in a manner consistent with a high pressure rupture, causing one end of the duct to become detached.

Examination of the other saddle-lug welds remote from the fracture revealed one other example of cracking along a saddle weld. This crack, when broken open and examined, was also caused by fatigue growth from multiple origins at the weld toes and had penetrated through the saddle material but had not progressed into the duct wall.

Examination of the fracture surfaces at high magnification by scanning electron microscopy revealed a large number of very fine fatigue striations. However, due to rubbing damage at the crack origins it was not possible to determine for how long the crack had been present. The large number of striations observed would tend to suggest that the cracks had been present before the last inspection, 104 cycles previously, although it is possible that they could also have been caused since by a resonant condition present in the assembly.

An improved design has been introduced by Service Bulletin 75-065 which provided a duct with a revised mounting system to be fitted on an attrition basis. This duct was designed to match its thermal expansion with that of the engine structure, and incorporated integral rings to replace the fillet welded lugs. The manufacturer stated that the new duct had addressed the majority of the early failure modes, but had revealed new failure modes. The proposed solution to these new difficulties introduced spring links to reduce thermal stresses and used rod-end bearings to provide an improved tolerance to misalignment. A six month service evaluation of the new configuration was due to start in February 1996 with a projected release of the field modification during the second quarter of 1996.

In December 1994 the manufacturer replaced a fluorescent penetrant inspection (FPI) of the duct attachment lugs with a visual inspection at the same frequency - every 750 hours or 250 cycles. The AAIB were informed that the failed duct had been inspected 104 cycles previously, and was coming up to a further inspection on flight hours. Some operators have decided to continue with the FPI as they do not have sufficient confidence in the probability of success of the visual inspection. This lack of confidence would appear to be justified by the failure of the visual inspection technique to detect the two cracks on the duct from N516MC 104 cycles before the duct failed.
