Yak-52, G-YAKW

AAIB Bulletin No: 10/2003	Ref: EW/C2003/01/01	Category: 1.3
Aircraft Type and Registration:	Yak-52, G-YAKW	
No & Type of Engines:	1 Ivchenko Vedeneyev M-14P piston engine	
Year of Manufacture:	1985	
Date & Time (UTC):	5 January 2003 at 1125 hrs	
Location:	2 miles north-east of Towcester, Northamptonshire	
Type of Flight:	Private	
Persons on Board:	Crew -1	Passengers - 1
Injuries:	Crew - 1 (Fatal)	Passengers - 1 (Fatal)
Nature of Damage:	Aircraft destroyed	
Commander's Licence:	Private Pilot's Licence	
Commander's Age:	48 years	
Commander's Flying Experience:	1,715 hours (of which 119 were on type)	
	Last 90 days - 2 hours	
	Last 28 days - 1 hour	
Information Source:	AAIB Field Investigation

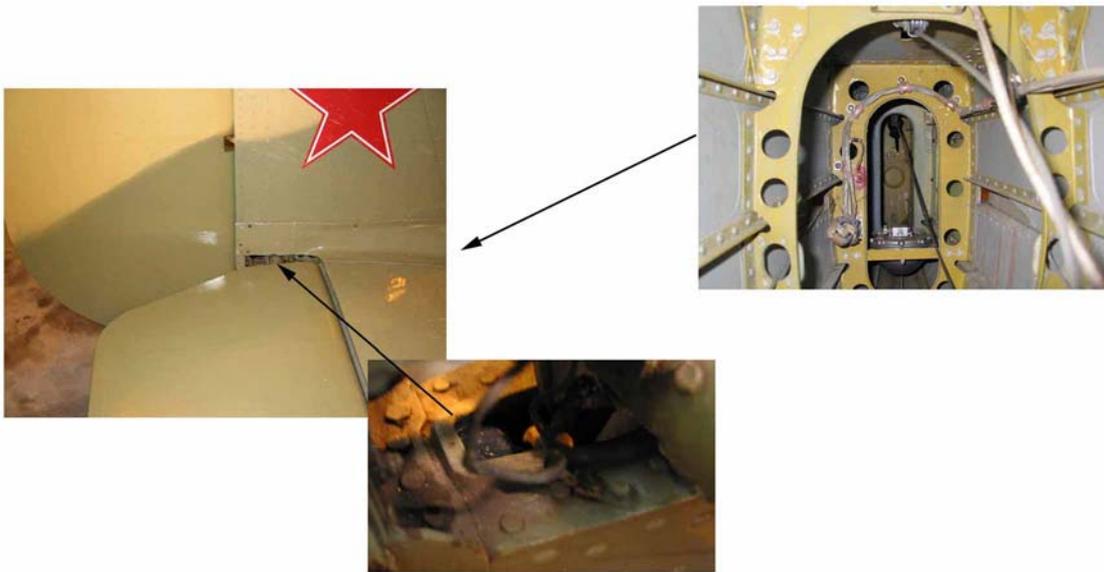
The aircraft was recovered to the AAIB at Farnborough for a detailed examination. During an inspection of the aft fuselage section it was discovered that the elevators, although free to move in the nose-down direction, would not move beyond neutral when moved in the up direction. Examination of the aperture at the base of the tail on the top of the fuselage revealed a restriction that was preventing the aft elevator quadrant assembly from passing through the aperture (see Figure 1).

Figure 1: View from above the aperture and inside the aft fuselage

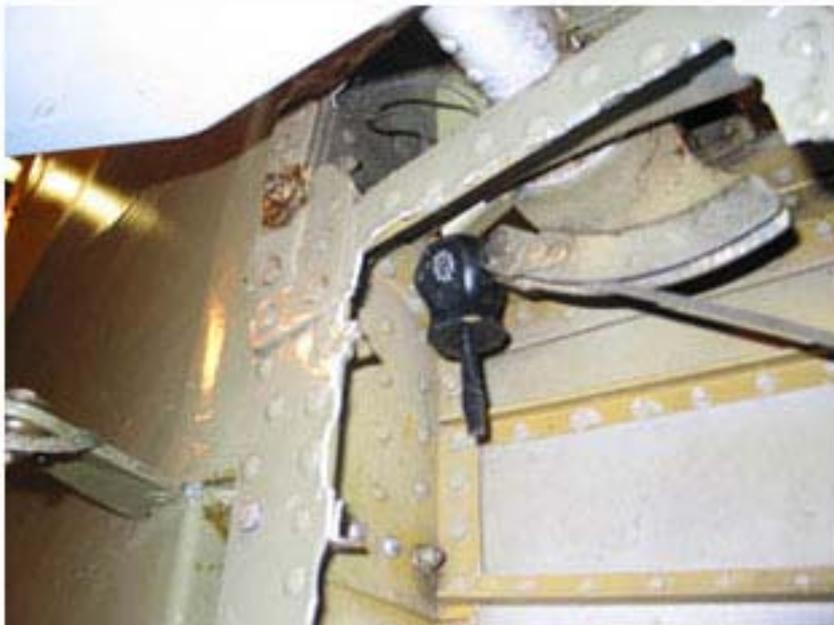
The restriction was discovered to be a small short-handled flat-bladed screwdriver, which had become impaled on the swaged end of the lower elevator cable at its attachment to the aft quadrant assembly (see Figure 2).

Figure 2: Screwdriver, as discovered, jammed on the aft elevator quadrant

The primary cause of the accident was a loose article, in the form of a screwdriver, jamming the aft elevator quadrant and preventing the elevator from being moved beyond neutral in the up direction. The elevator only became jammed during the stall turn aerobatic manoeuvre. If it had become jammed prior to the stall turn the aircraft would not have entered the climb required to begin the manoeuvre. It is probable that whilst the aircraft was in the climb towards the apex of the stall turn the screwdriver rested on the aft most section of the fuselage. When the elevator was moved towards the neutral position the quadrant 'scooped up' the screwdriver preventing the elevator from moving beyond neutral. This prevented the aircraft from pulling out of its dive.

The CAA should require the Yak-52, and aircraft of a similar design operating on the UK register, to have fitted a method of preventing loose articles migrating to a position where they could interfere with the operation or jam the flight controls.

(The maintenance organisation has already implemented the installation of a ceconite bulkhead, with a clear view panel, in the rear of all relevant aircraft. This bulkhead is being installed, on an opportunity basis, when aircraft are subject to routine maintenance by the organisation.)
