INCIDENT

Aircraft Type and Registration:	AS332 L2 Super Puma, G-REDO	
No & Type of Engines:	2 Turbomeca Makila 1A2 turboshaft engines	
Year of Manufacture:	2005	
Date & Time (UTC):	3 September 2007 at 1530 hrs	
Location:	Offshore in the Sumburgh area, Shetland Islands	
Type of Flight:	Aerial Work	
Persons on Board:	Crew - 4	Passengers - None
Injuries:	Crew - None	Passengers - N/A
Nature of Damage:	Winch cable failure during casualty recovery	
Commander's Licence:	Air Transport Pilot's Licence	
Commander's Age:	N/A	
Commander's Flying Experience:	N/A hours (of which n/k were on type) Last 90 days - N/A Last 28 days - N/A	
Information Source:	Accident report form submitted by the winchman and examination of cable by the AAIB

Synopsis

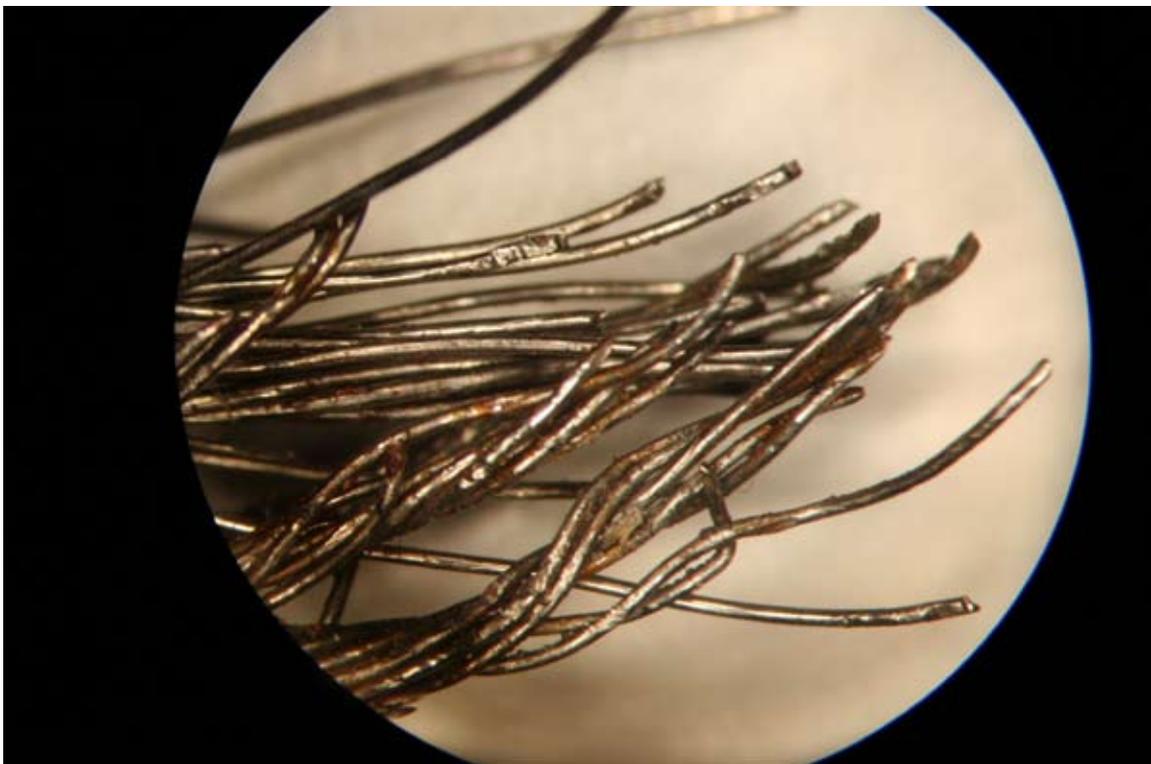
Figure 1

The broken cable was subsequently removed from the helicopter and sent to the AAIB for examination. Microscopic visual inspection showed clear evidence of mechanical damage to a large number of the cable

strands close to the failure, which included scoring and cutting, see Figure 1.

The majority of these strands had failed in the region of this damage, with fracture surfaces characteristic of relatively brittle tensile failure. The remaining strands, approximately 15% of the total, exhibited fracture surfaces associated with a degree of plastic deformation (necking) prior to failure in tensile overload. All of the fracture surfaces were free from corrosion and there was no evidence of prior cracking or fatigue.

The nature of the cable failure indicated that the primary cause was due to mechanical damage to the majority of the strands, possibly occasioned when the cable laid across the vessel's bow.

Failed cable strand ends mostly exhibiting evidence of mechanical damage at or close to the failures
