ACCIDENT

Aircraft Type and Registration:	Turbolet Let L 410 UVP-E, OK-RDA	
No & Type of Engines:	2 Walter 601-E turboprop engines	
Year of Manufacture:	1986	
Date & Time (UTC):	28 April 2008 at 1003 hrs	
Location:	En route from Belfast City to Ronaldsway, Isle of Man	
Type of Flight:	Commercial Air Transport (Passenger)	
Persons on Board:	Crew - 2	Passengers - 16
Injuries:	Crew - None	Passengers - None
Nature of Damage:	Damage to right nose baggage door	
Commander's Licence:	Airline Transport Pilot's Licence	
Commander's Age:	44 years	
Commander's Flying Experience:	7,452 hours (of which 4,440 were on type) Last 90 days - 130 hours Last 28 days - 53 hours	
Information Source:	Aircraft Accident Report Form submitted by the pilot

Synopsis

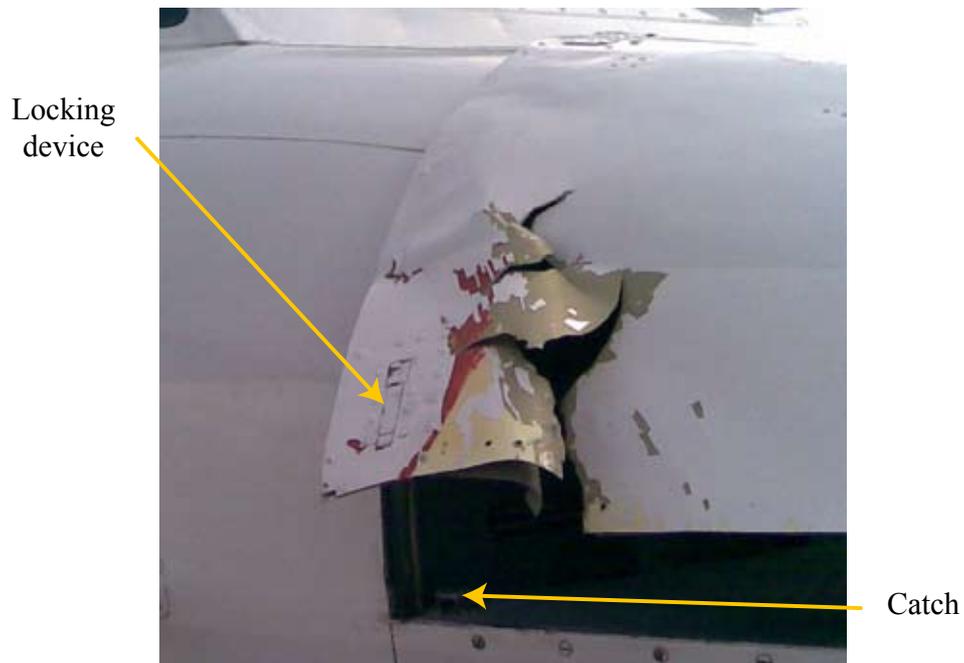
Figure 2
Door locking mechanism

The operator's maintenance engineer inspected the baggage door and reported that there were no defects with either the door or its locking device that would have prevented the door from locking. From photographs taken by the Airport Manager at Ronaldsway, it can be seen that whilst the locking device appeared to be locked from the outside, the hook on the mechanism had not engaged with the catch (Figure 2).

did not open during the outbound journey suggests that it was probably opened at Belfast City Airport. Whilst the door locking mechanism appeared from the outside to have been locked, it is apparent, from the lack of damage, that the hook did not engage in the catch when

the locking mechanism was closed. A modification is available to fit a physical indicator to the front door locking mechanism, but the modification had not been incorporated on this aircraft.
