Concorde Type 1 V102, G-BOAC

AAIB Bulletin No: 6/2004	Ref: EW/C2003/06/03	Category: 1.1
INCIDENT		
Aircraft Type and Registration:	Concorde Type 1 V102, G-BOAC	
No & Type of Engines:	4 Rolls-Royce Olympus 593 turbojets	
Year of Manufacture:	1975	
Date & Time (UTC):	13 June 2003, time unknown	
Location:	Transatlantic cruise	
Type of Flight:	Public Transport (Passenger)	
Persons on Board:	Crew - 9	Passengers - 98
Injuries:	Crew - None	Passengers - None
Nature of Damage:	Fire damage in under wing area	
Commander's Licence:	Airline Transport Pilot's Licence	
Commander's Age:	55 years	
Commander's Flying Experience:	17,000 hours (of which 2,200 were on type)	
	Last 90 days - 60 hours	
	Last 28 days - 20 hours	
Information Source:	AAIB Field Investigation

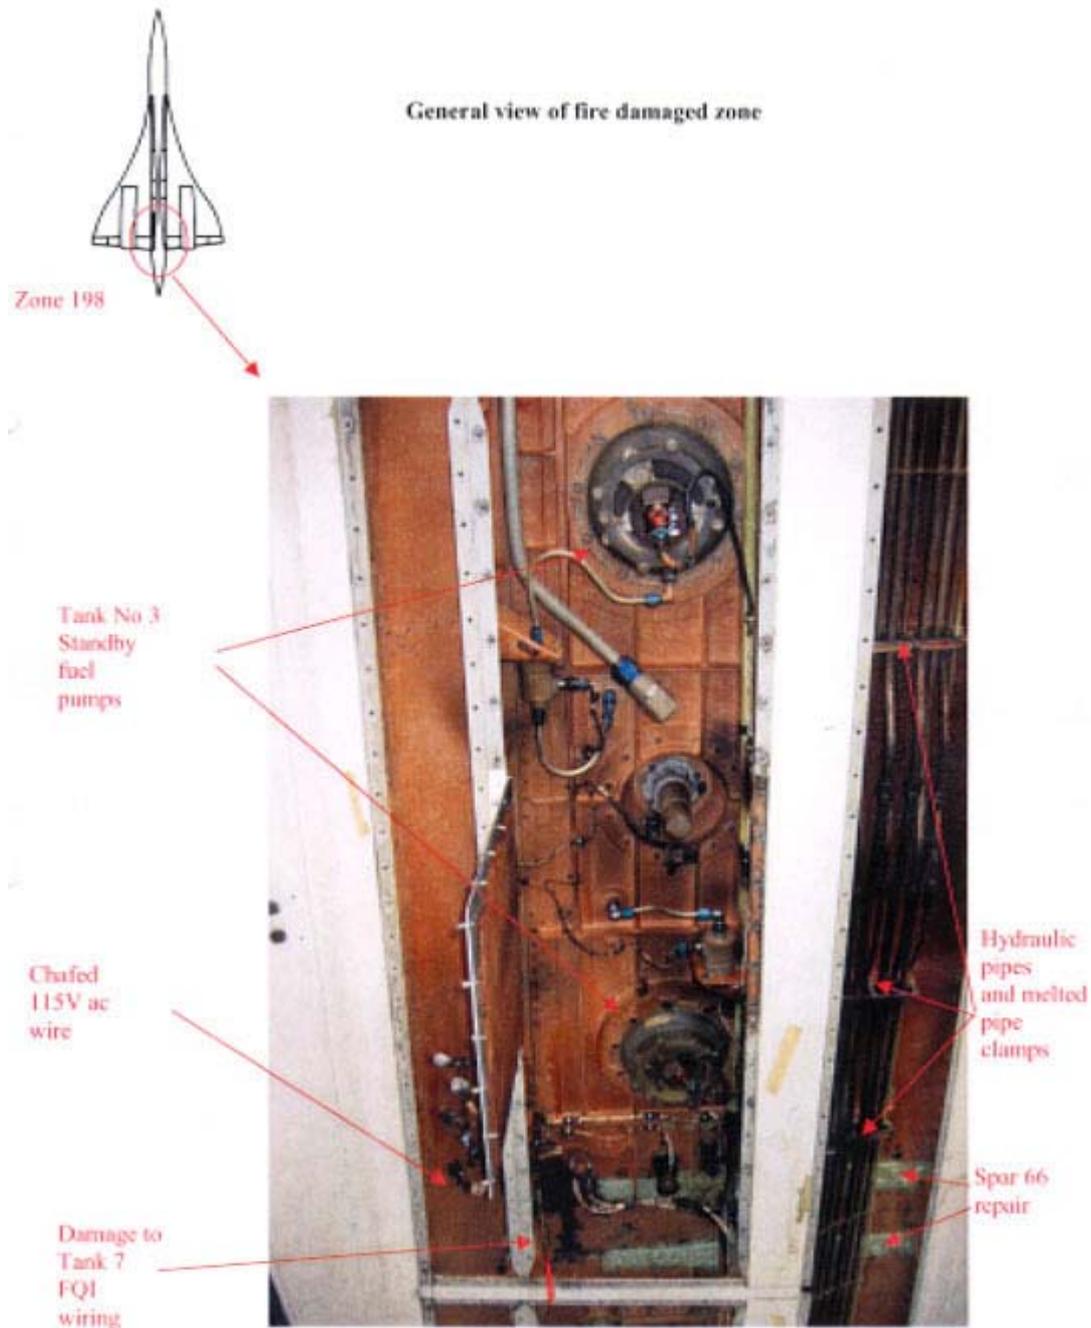
Figure 2: General view of fire damaged zone

The area damaged by the fire was contained within the wing/fuselage fairing area aft of the main landing gear, below and adjacent to tank No 3 (zone 198), Figure 2.

This area contains a number of hydraulic pipe runs, together with wiring for the fuel pumps and FQIs. There was little overall evidence of sooting, indicating that only a small quantity of fuel had been consumed. There was more localised evidence of sooting within a 'box' fairing support structure, and this also showed evidence of a ventilation airflow direction through the area, indicating that the fire was likely to have occurred during flight. Conductivity testing on the aluminium 'box' fairing structure showed this area had been heat affected. There was little damage to the paint and thus the

temperature of the fire was estimated to have been approximately 400°C. Tank No 3 115V AC main fuel pump wiring, from the rear fuselage, was found to be loose within its bundle in this zone and one wire had chafed on fairing panel 198AB, Figure 3.

The aircraft wiring in the area of the fire was installed at original manufacture in 1975. In 2001, routine inspection of the wing structure had detected cracks in the area of spar 66, Figure 2, and in order to complete the structural repair, it was necessary to disturb the wiring. It is likely that in reinstating the wiring the possibility for the chafe to occur was introduced. This area is not routinely inspected and, given the low number of hours flown by each aircraft, is unlikely to have been inspected within the period since the repair to spar 66. The operator carried out a visual inspection on the remaining aircraft to inspect for any similar wiring defects which could result in chafed wire, but none were identified. The operator also introduced a modification to introduce additional 0.25 inch diameter drain holes in the underside of the wing/fuselage fairing 'box' support structure aft of the

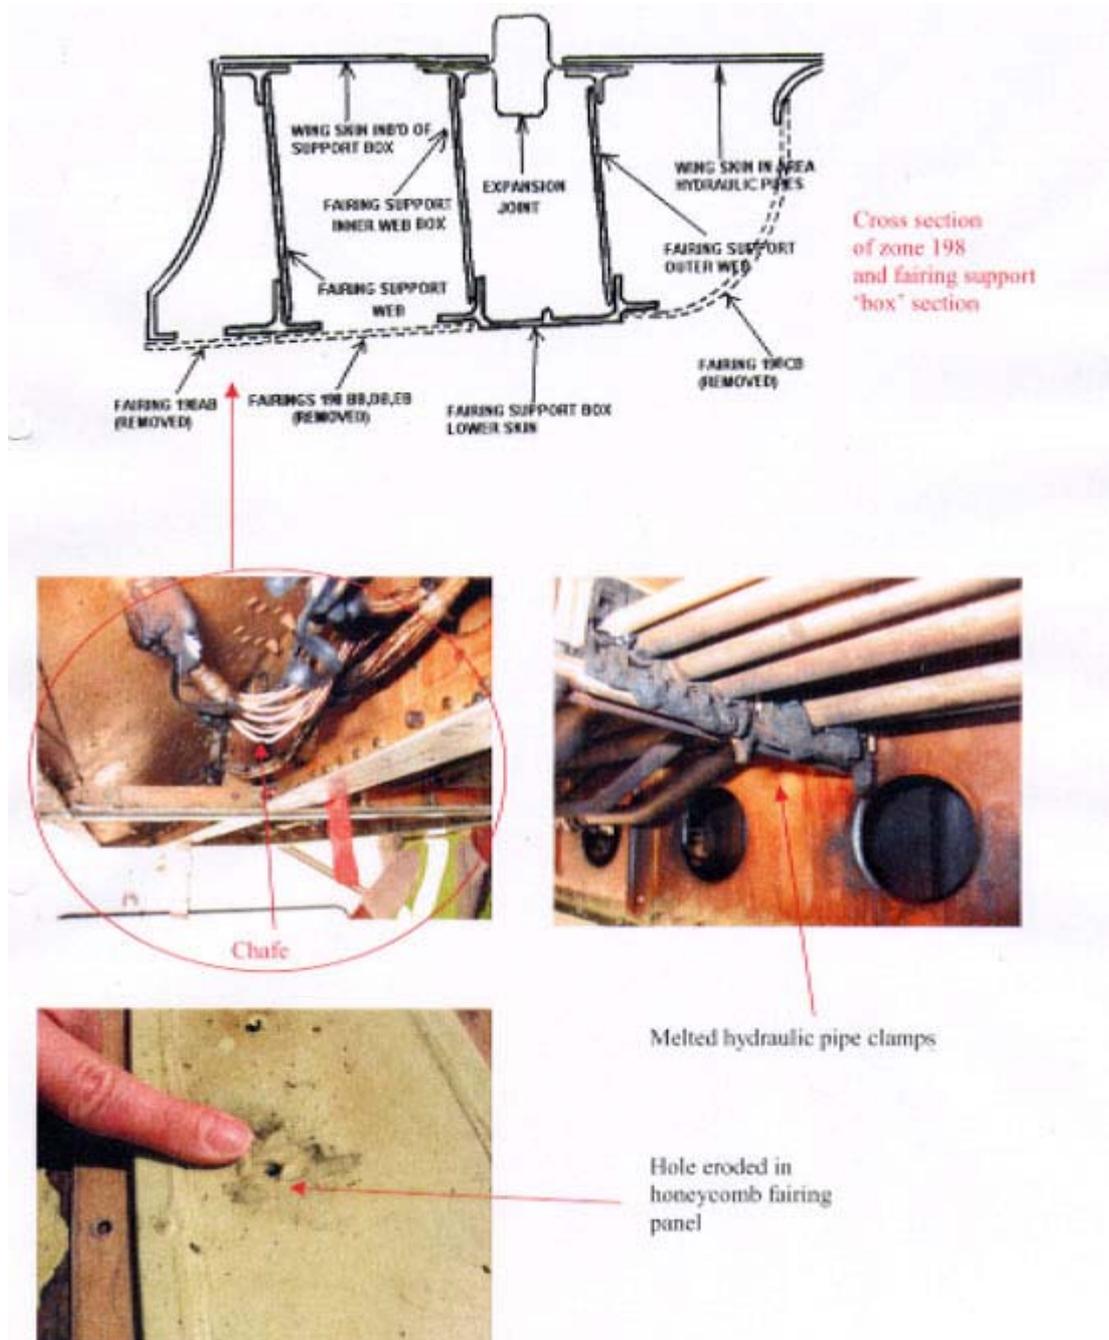
Figure 3: Cross section of Zone 198

The chaffing of the wire on the inner aluminium skin of the honeycomb filled panel eventually led to an electrical arc of a 115V AC supply, which ignited the fuel/air mixture. The fire had also caused damage to the FQI wiring, leading to the reported defects, initially on tank No 7 FQI system and then on other tank FQI systems and the CG computer. Although there was fire damage to the FQI and No 3 fuel pump wiring, there was no evidence of arc-tracking along the length of the wires. Arc tracking is not a feature associated with the Concorde PTFE wiring insulation.

The area under tank No 3 in the region of the fire, was cleaned and examined for fuel leaks. At the forward end of the expansion joint at wing spar 66, one drip of fuel occurred every 6 minutes and an additional drip every 1 minute 40 seconds from the area of the lower panel support structure, Figure 3. The bolts on a repair plate on spar 66 were damp but did not form droplets. There was also a drip every minute at the aft end of the expansion joint at spar 68. Zone 198, the region in which the fire occurred, is classed as 'zone two' for fuel leakage purposes and seepage only is permitted before repairs are required.
