ACCIDENT

Aircraft Type and Registration:	Piper PA-34-200T Seneca, G-BNEN	
No & Type of Engines:	2 Continental TSIO-360-EB piston engines	
Year of Manufacture:	1980	
Date & Time (UTC):	21 April 2005 at 1205 hrs	
Location:	Oxford Kidlington Airport, Oxfordshire	
Type of Flight:	Training	
Persons on Board:	Crew - 2	Passengers - None
Injuries:	Crew - None	Passengers - N/A
Nature of Damage:	Nose wheel, propellers and engines	
Commander's Licence:	Airline Transport Pilot's Licence	
Commander's Age:	71 years	
Commander's Flying Experience:	16,000 hours (of which 1,979 were on type) Last 90 days - 83 hours Last 28 days - 26 hours	
Information Source:	AAIB Field Investigation

Synopsis

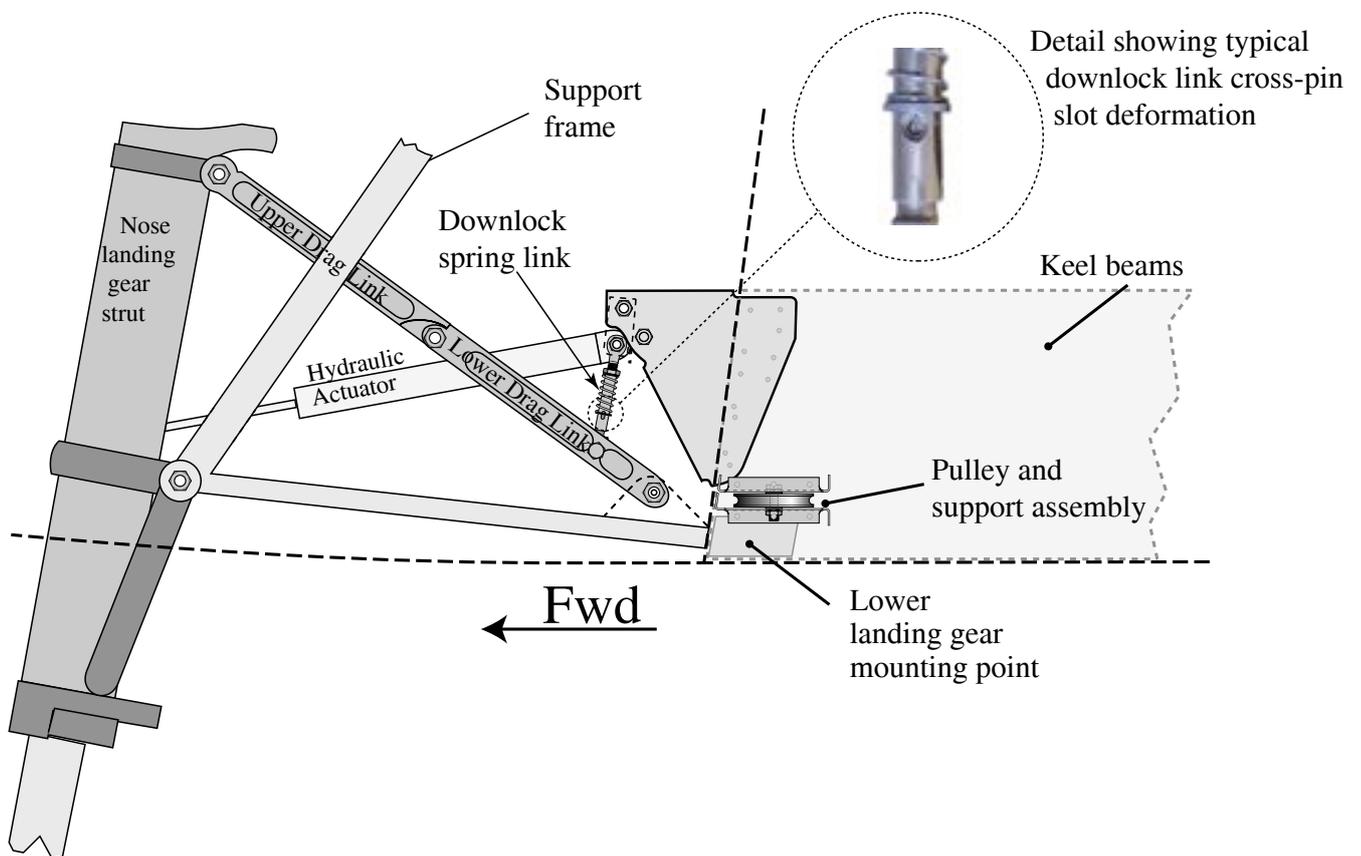
Figure 1

The nose landing gear upper and lower drag links together with the landing gear support frame, Figure 1, showed no signs of deformation or damage although the downlock link showed some deformation of its cross-pin

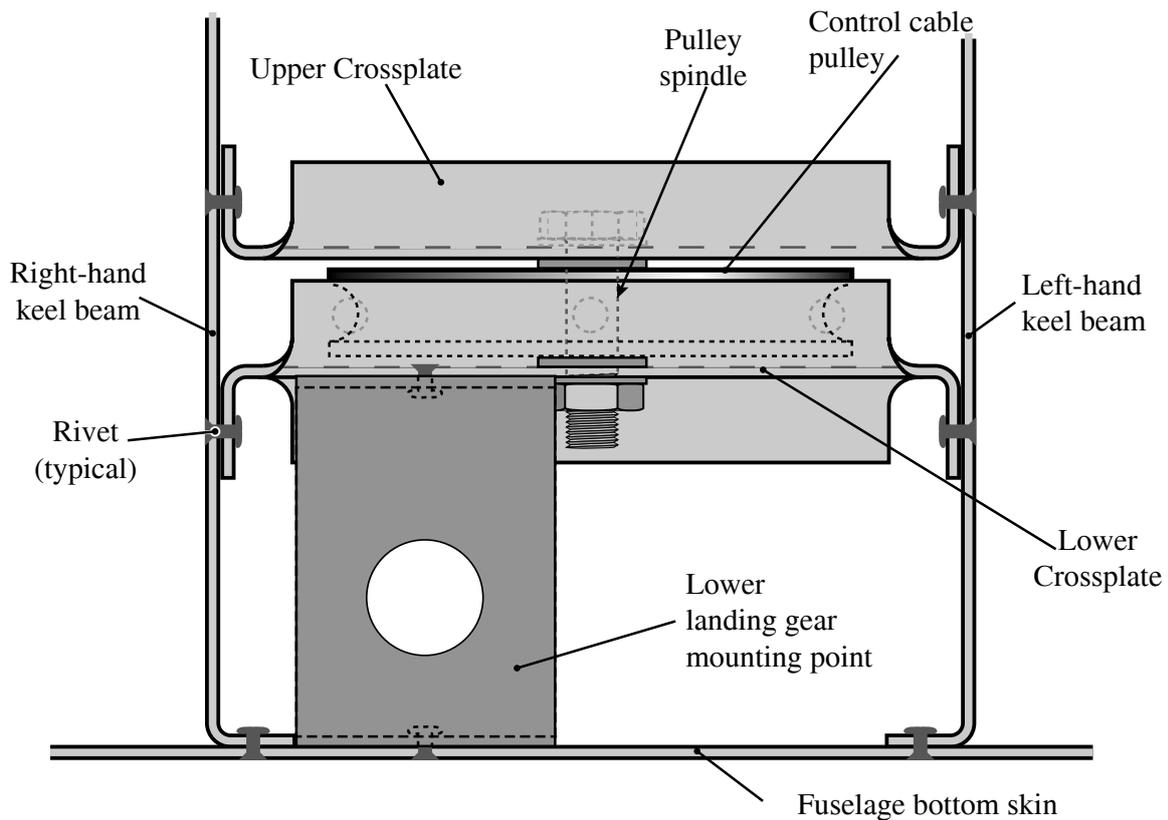
Figure 2

slot. The lower landing gear mount is secured by three rivets at its lower face to the inside of the fuselage skin and, on its upper face, by four rivets to the lower crossplate located between the left and right keel beams, Figure 2. All the rivet heads on the lower mount were found sheared off. The condition of the shank sections of the lower rivets associated with this mount indicated that these had failed during the landing gear collapse but discolouration of the remains of rivet shanks of the upper four rivets indicated that they had failed at some point prior to the collapse.

The cracking of the plate and the discolouration of the sheared rivet shanks at the upper surface of the landing gear lower mount, indicated that the damage to the mount and its supporting structure probably occurred as a result of the aircraft's previous landing gear collapse. Once the aircraft had been returned to service it is likely that the damage progressively increased, resulting in the overloading of further rivets and crack propagation in the upper crossplate and right keel beam lower edge.

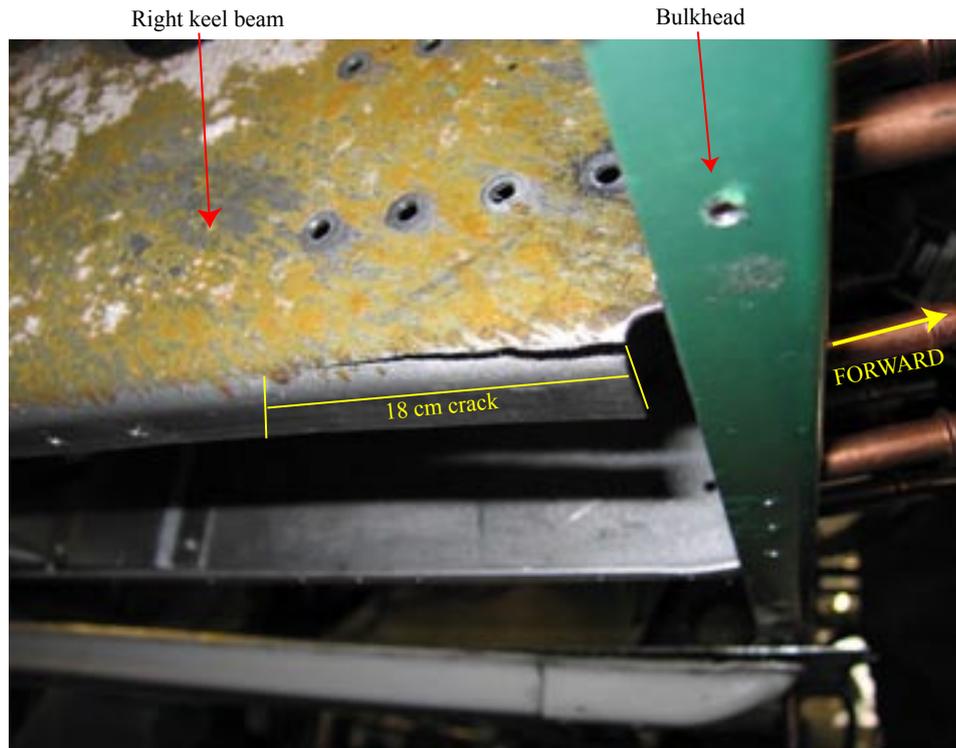
Examination of the upper crossplate revealed the presence of a crack extending through all four rivet holes, with the forward-most rivet holes showing signs of deformation. Also, the right side keel beam had cracked between the web and the lower flange, the crack extending aft from its forward edge over a distance of 18 cm (see Figure 3).

Figure 3
Right keel beam crack

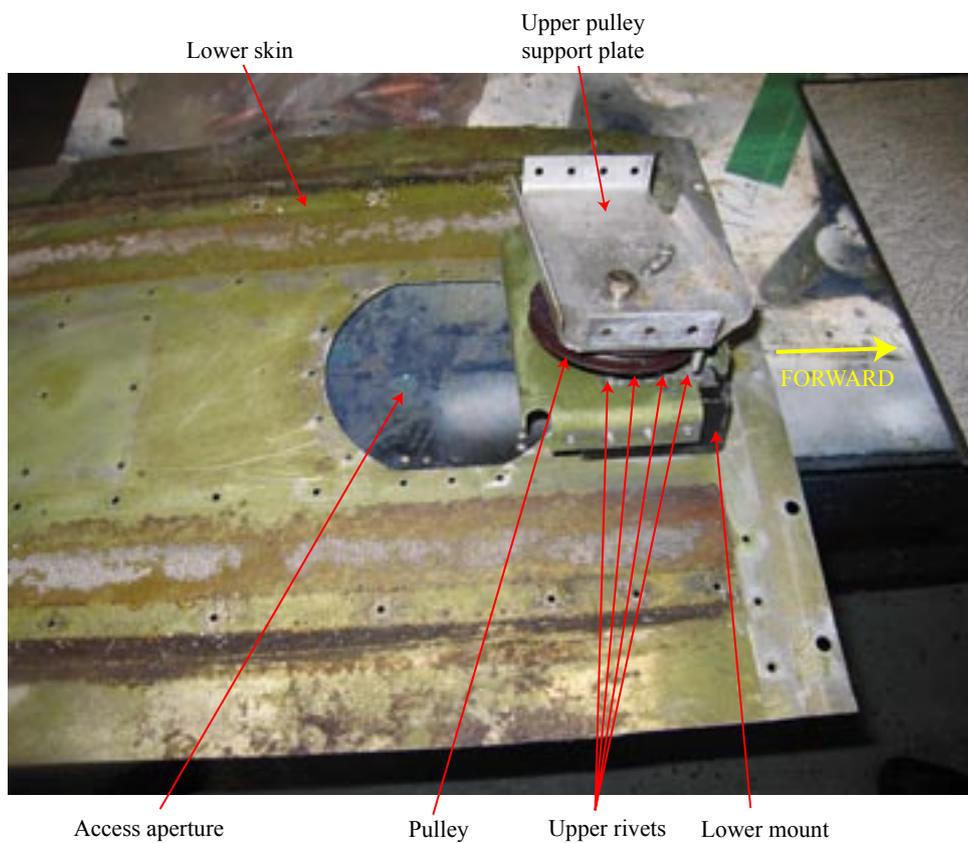
crossplate, support the pulley spindle, (see Figure 4). A 12 cm diameter access panel, located immediately aft of the pulley and mount assembly, provides access to this area. In order to determine if it would be possible to carry out a visual inspection of the lower mount and its fasteners in an assembled condition, tests were carried out on another aircraft using both standard and specialist inspection equipment. The results of these tests showed that, whilst the conditions of the mount's lower fasteners could be assessed, the upper fasteners could not be readily viewed through the access panel and, therefore, an assessment of their condition could not be made.

Figure 4
Lower mount with control pulley and support plates in position

In response to the findings of this investigation, New Piper Aircraft Incorporated have confirmed that they will publish amendments to all of the PA-34 Seneca series Aircraft Maintenance Manuals which will introduce in-situ inspection procedures to look for damage to the lower nose landing gear mount, surrounding structure and fasteners, following a nose gear collapse. In view of this response, it is not considered necessary to make any formal safety recommendations.
