ACCIDENT

Aircraft Type and Registration:	Evans VP-1 Volksplane, G-BFJJ	
No & Type of Engines:	1 Volkswagen 1800 piston engine	
Year of Manufacture:	1979	
Date & Time (UTC):	20 April 2008 at 1810 hrs	
Location:	Near Farley Farm Airfield, Winchester	
Type of Flight:	Private	
Persons on Board:	Crew - 1	Passengers - None
Injuries:	Crew - 1 (Minor)	Passengers - N/A
Nature of Damage:	Aircraft sustained substantial damage	
Commander's Licence:	Private Pilot's Licence	
Commander's Age:	50 years	
Commander's Flying Experience:	467 hours (of which 4 were on type) Last 90 days - 5 hours Last 28 days - 2 hours	
Information Source:	AAIB Field Investigation

Synopsis

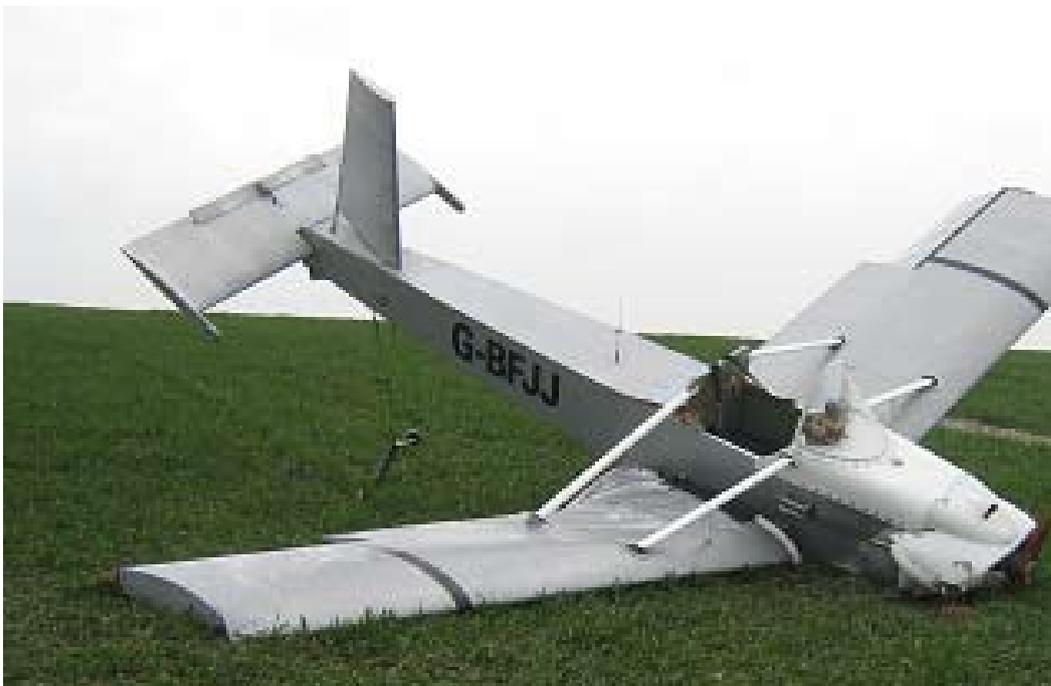
Figure 1

G-BFJJ is a single engine, low wing monoplane, with two steel bracing struts on each wing (Figure 1). One end of each strut is fixed to the structure of the wing and the other end is connected to the fuselage. The front two bracing struts are connected to a carry-through-structure, which goes through the front of the cockpit, and to which the instrument panel is attached. The rear two bracing struts are connected to an extended bulkhead containing a carry-through-structure, which forms the rear face of the cockpit compartment. The shoulder straps of the pilot's restraint harness are attached to the rear carry-through-structure at the top of this bulkhead.

Bracing strut orientation
