ACCIDENT

Aircraft Type and Registration:	Hunting Percival P56 Provost T1, G-AWVF	
No & Type of Engines:	1 Alvis Leonides 503/6A radial piston engine	
Year of Manufacture:	1955	
Date & Time (UTC):	8 July 2009 at 1334 hrs	
Location:	1.3 nm east of Bishop Norton, Lincolnshire	
Type of Flight:	Private	
Persons on Board:	Crew - 1	Passengers - None
Injuries:	Crew - 1 (Fatal)	Passengers - N/A
Nature of Damage:	Aircraft destroyed	
Commander's Licence:	Airline Transport Pilot's Licence	
Commander's Age:	74 years	
Commander's Flying Experience:	13,750 hours (of which 150 were on type) Last 90 days - 11 hours Last 28 days - 2 hours	
Information Source:	AAIB Field Investigation

Synopsis

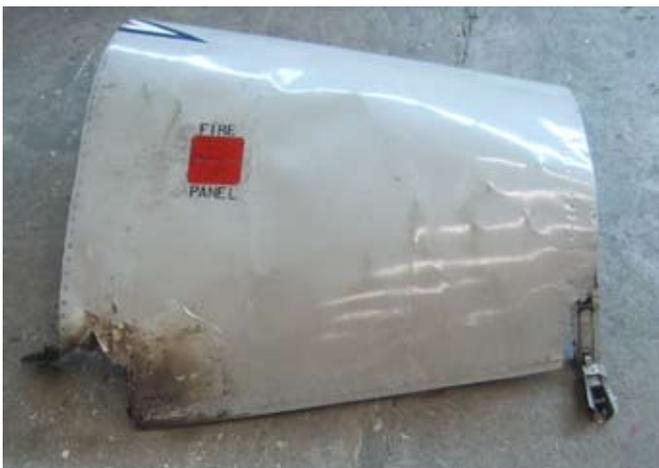
Figure 6

The latches securing the engine cowlings to the aircraft had failed in overload. The right engine cowling was missing a small portion of its rear lower corner and this area was surrounded by black burn marks and blistered paint (Figure 6). On the internal surface of the right engine cowling, in the lower forward section, there

Right engine cowling external surface – burnt area on lower aft corner

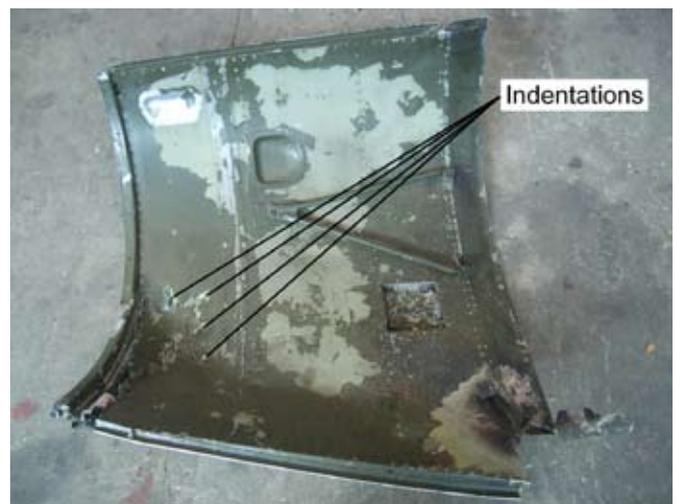
Figure 7

Right engine cowling inner surface – same burnt area visible on lower aft corner, and indentations near forward edge

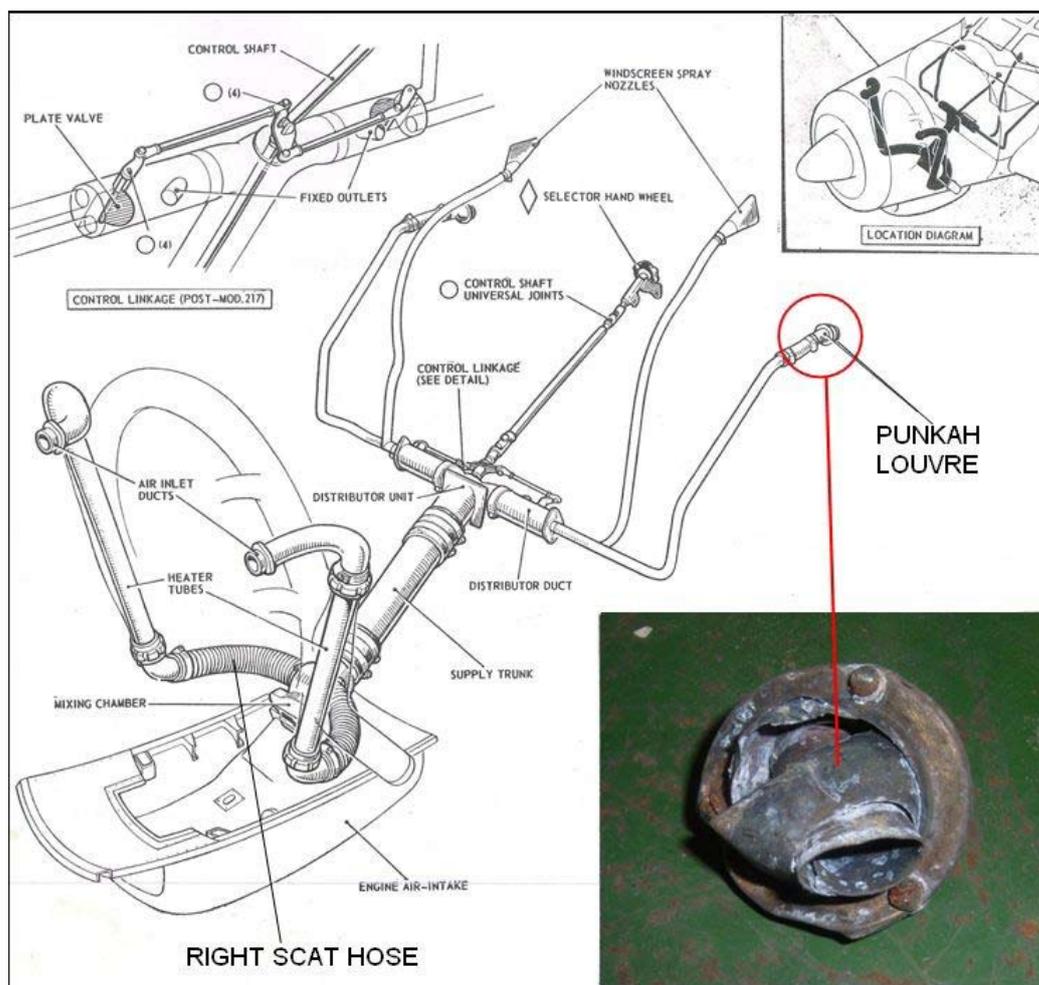
Figure 8

Ventilation system diagram showing location of right SCAT hose and punkah louvres. The burnt punkah louvre shown in the photograph was either from the left or right side of the instrument panel.

9. The fire in the engine bay probably burnt through the right SCAT hose that forms part of the ventilation system, permitting the fire to enter the cockpit via the punkha louvres. It is also possible that other entry points through the firewall were compromised, permitting the fire to enter the cockpit.
10. It is probable that the pilot lost consciousness due to the build-up of toxic fumes, and released the control stick.
11. The aircraft entered a steep dive due to the loss of engine power and the control stick being released, and then hit the ground.

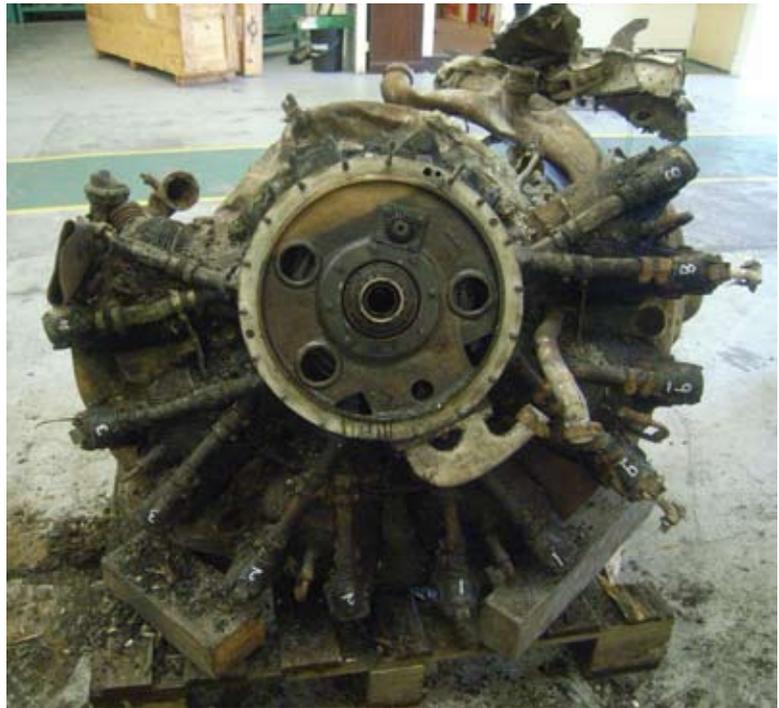
Figure 10

The engine had suffered from significant fire damage, and its No 5, 6 and 7 cylinders had detached (Figure 10). The cylinders had detached as a result of failure of some cylinder retaining bolts and the failure of engine casing material around the remaining cylinder retaining bolts. The master rod and all the articulating rods had failed near their roots. The section of master rod between the piston and root was missing. All the cylinders had damage of varying degrees to their skirt, consistent with impact from the connecting rods. The gudgeon pin from the No 6 piston, to which the master rod had been connected, had ‘sheared’ at its centre (Figure 11). The No 6 piston had suffered from multiple impact damage to its base and sidewalls, consistent with a flailing master rod. The No 5 and No 7 pistons were missing. Multiple sections of articulating rod material were also missing. The gudgeon pins from the remaining pistons (No 1, 2, 3, 4, 8, 9) were intact and still connected to sections of articulating

Front face of engine, positioned upside down, showing missing No 5, 6 and 7 cylinders (when the engine is installed, the No 1 cylinder sits at the ‘12 o’clock’ position)

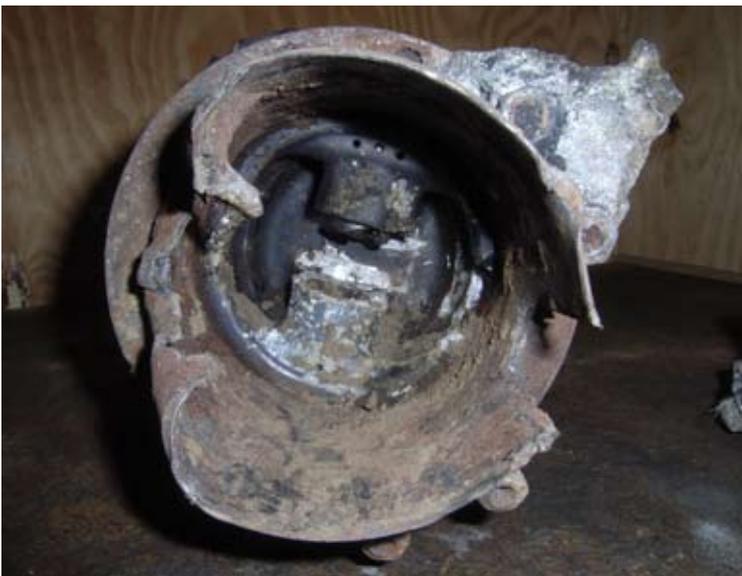
Figure 11

View inside No 6 cylinder showing damaged cylinder skirt, damaged piston and ‘sheared’ gudgeon pin

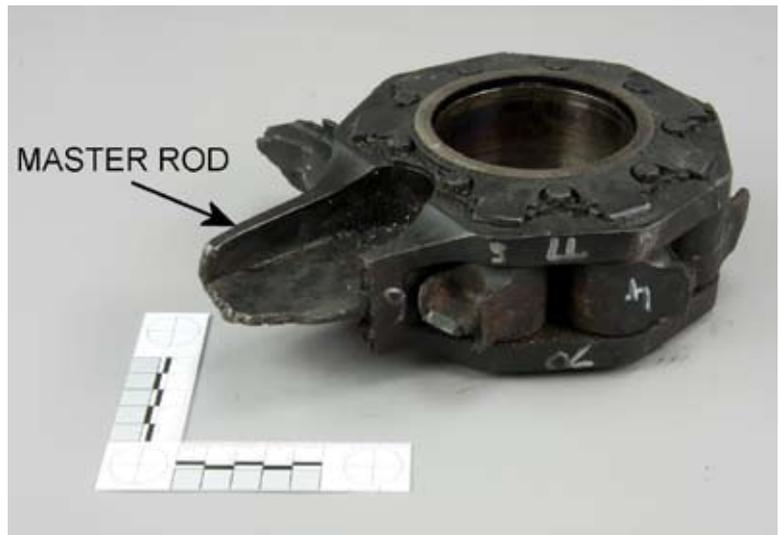
Figure 12

ends had been almost completely destroyed by post-failure mechanical damage (Figure 12). Areas which were not damaged exhibited dull, fibrous fractures and angled fracture surfaces which were characteristic of overload failure.

Remains of master rod and articulating rod ends

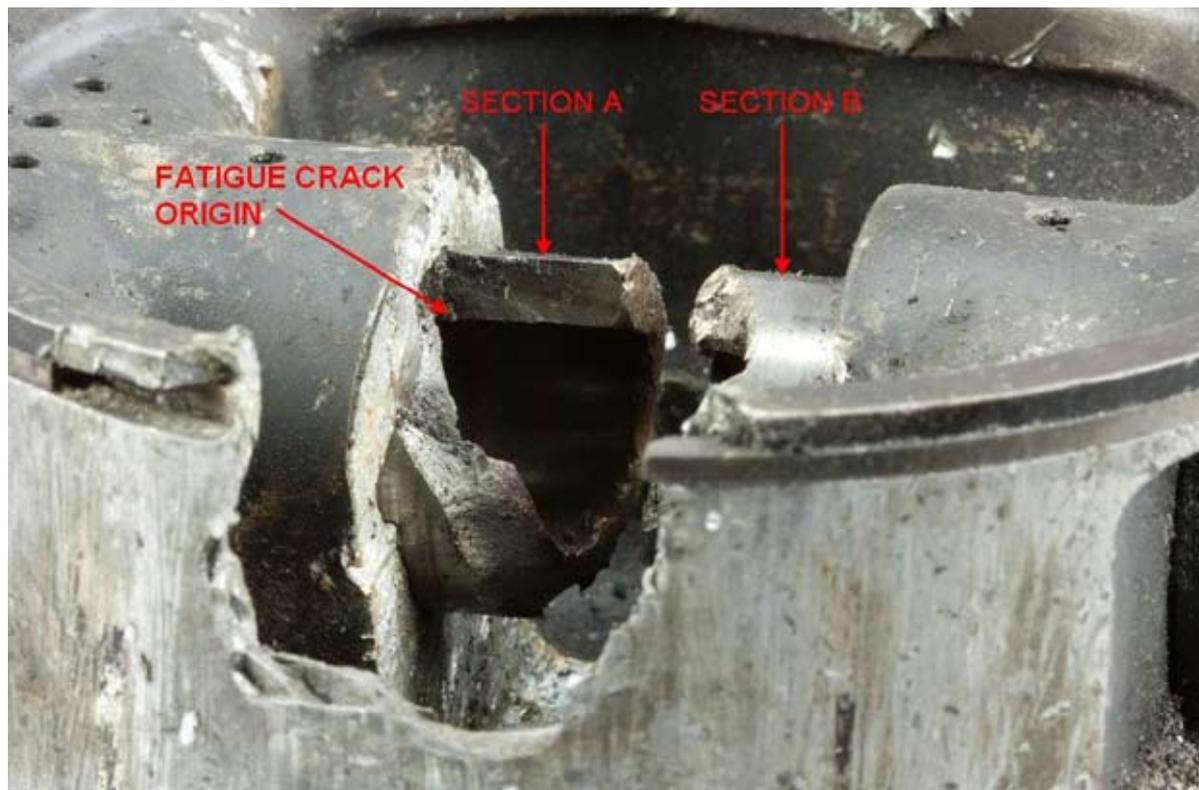
Figure 13

During the examination the sheared halves of the gudgeon pin from the No 6 piston were pushed inwards to their normal position (Figure 13). This revealed that between 5 and 20 mm of the pin was missing from its centre. The two portions of the pin (section A and section B) were removed from the piston and cleaned for more detailed examination and a close-up view of the two sections is shown in Figure 14. The fracture surface of section A was helical and had suffered from some post-failure mechanical damage. In the undamaged areas, the majority of the circumferential fracture surface was angled at 45° to the pin surface, which is characteristic of overload failure. However, the longitudinal fracture surface (annotated in Figure 14) was relatively flat and extended along a crack line to the end of the pin. This crack line also extended into the other half of the pin, section B.

No 6 piston. Both portions of the failed gudgeon pin have been pushed back into their original seating position (compare to Figure 11 for their post-failure position)

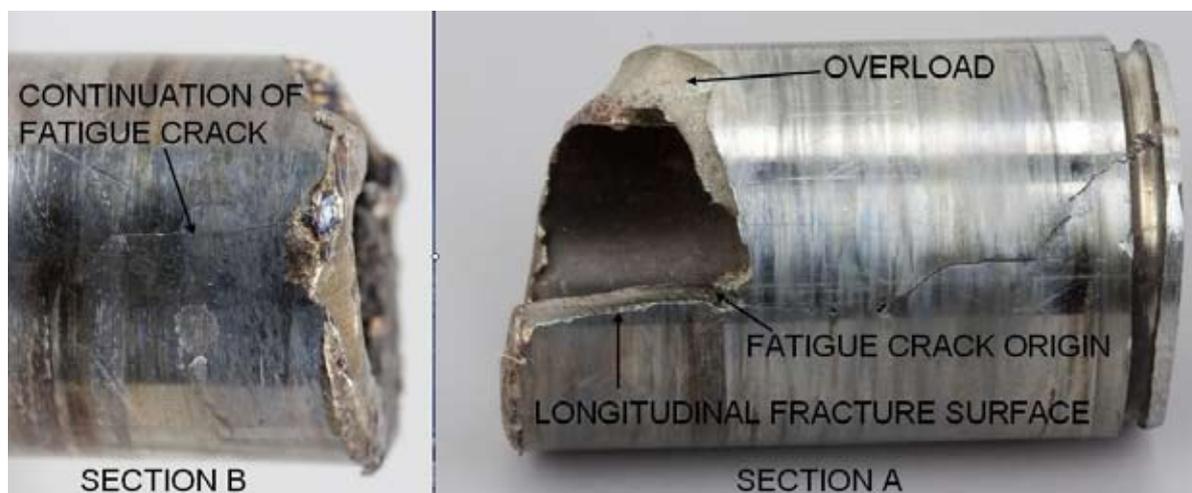
Figure 14

Both portions of No 6 gudgeon pin, showing fatigue crack origin

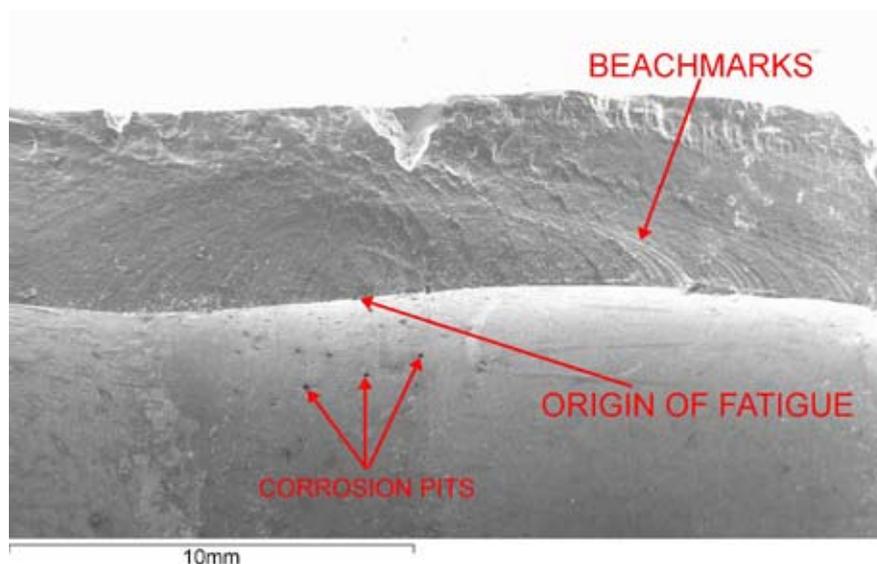
Figure 15

A more detailed SEM examination of the fatigue crack origin revealed that it had initiated at a corrosion pit approximately $150\ \mu\text{m}$ deep. There were a number of other corrosion pits on the inner surface of the pin in the vicinity of the fatigue crack origin; some of these are highlighted in Figure 15. Corrosion pits act as stress raisers and are a common initiation point for fatigue. The crack growth had not been caused by Stress Corrosion Cracking (SSC), as the striations were trans-granular, whereas SSC generates inter-granular failures.

Scanning Electron Microscope (SEM) image of longitudinal fracture surface from section A, showing fatigue crack origin, beachmarks and corrosion pits

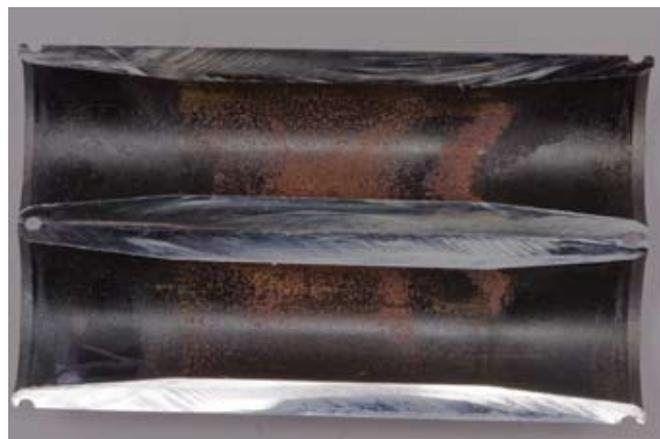
Figure 16

No 8 gudgeon pin sectioned, showing corrosion on internal surface
