Air Accidents Investigation Branch

**Report on the incident to
Airbus A320-214, registration G-BXKD
at Runway 09, Bristol Airport
on 15 November 2006**

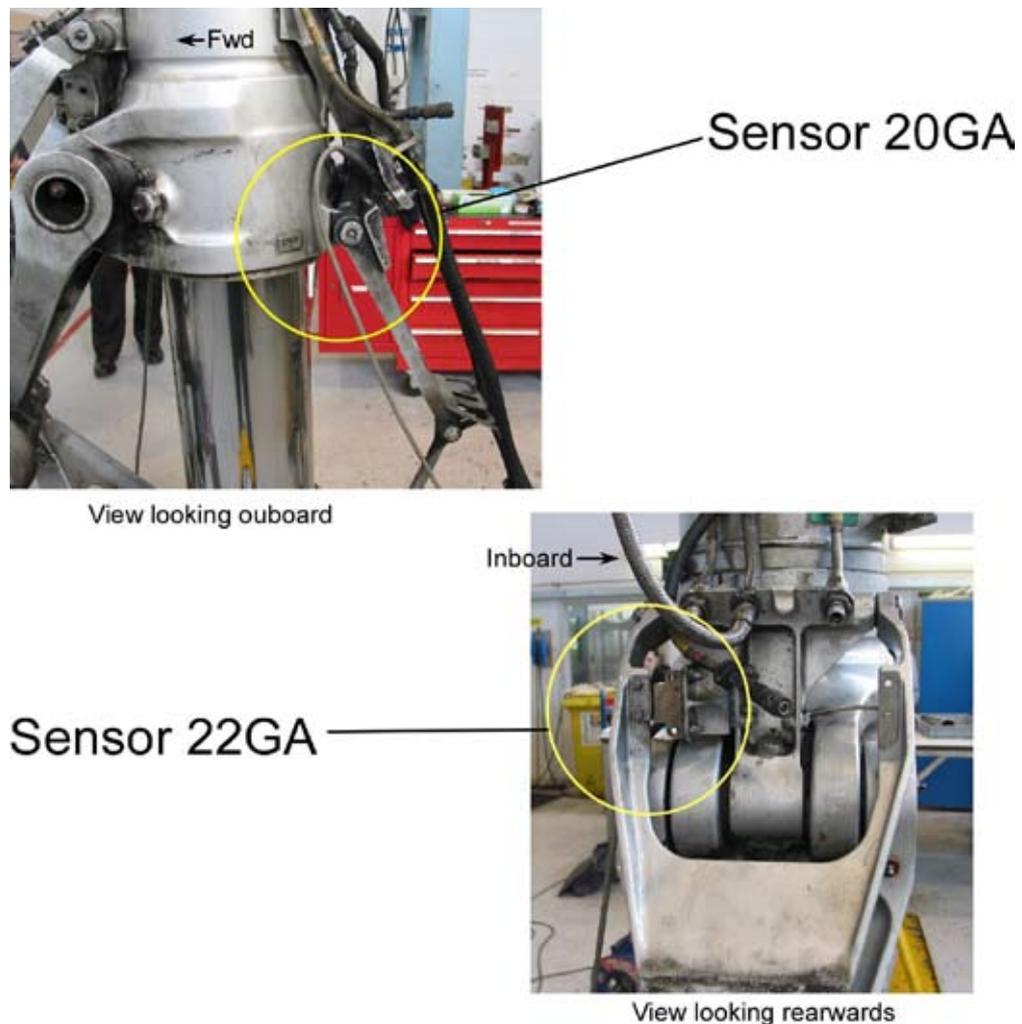
Sensor 20 GA and 22 GA location on right main gear

Whilst in the over-extended state, sensor 22GA remained in proximity, whilst 20GA moved out of proximity. An examination of the torque and slave links did not reveal any signs of distress. Prior to the strip an attempt was made to compress the oleo, but this was not possible.

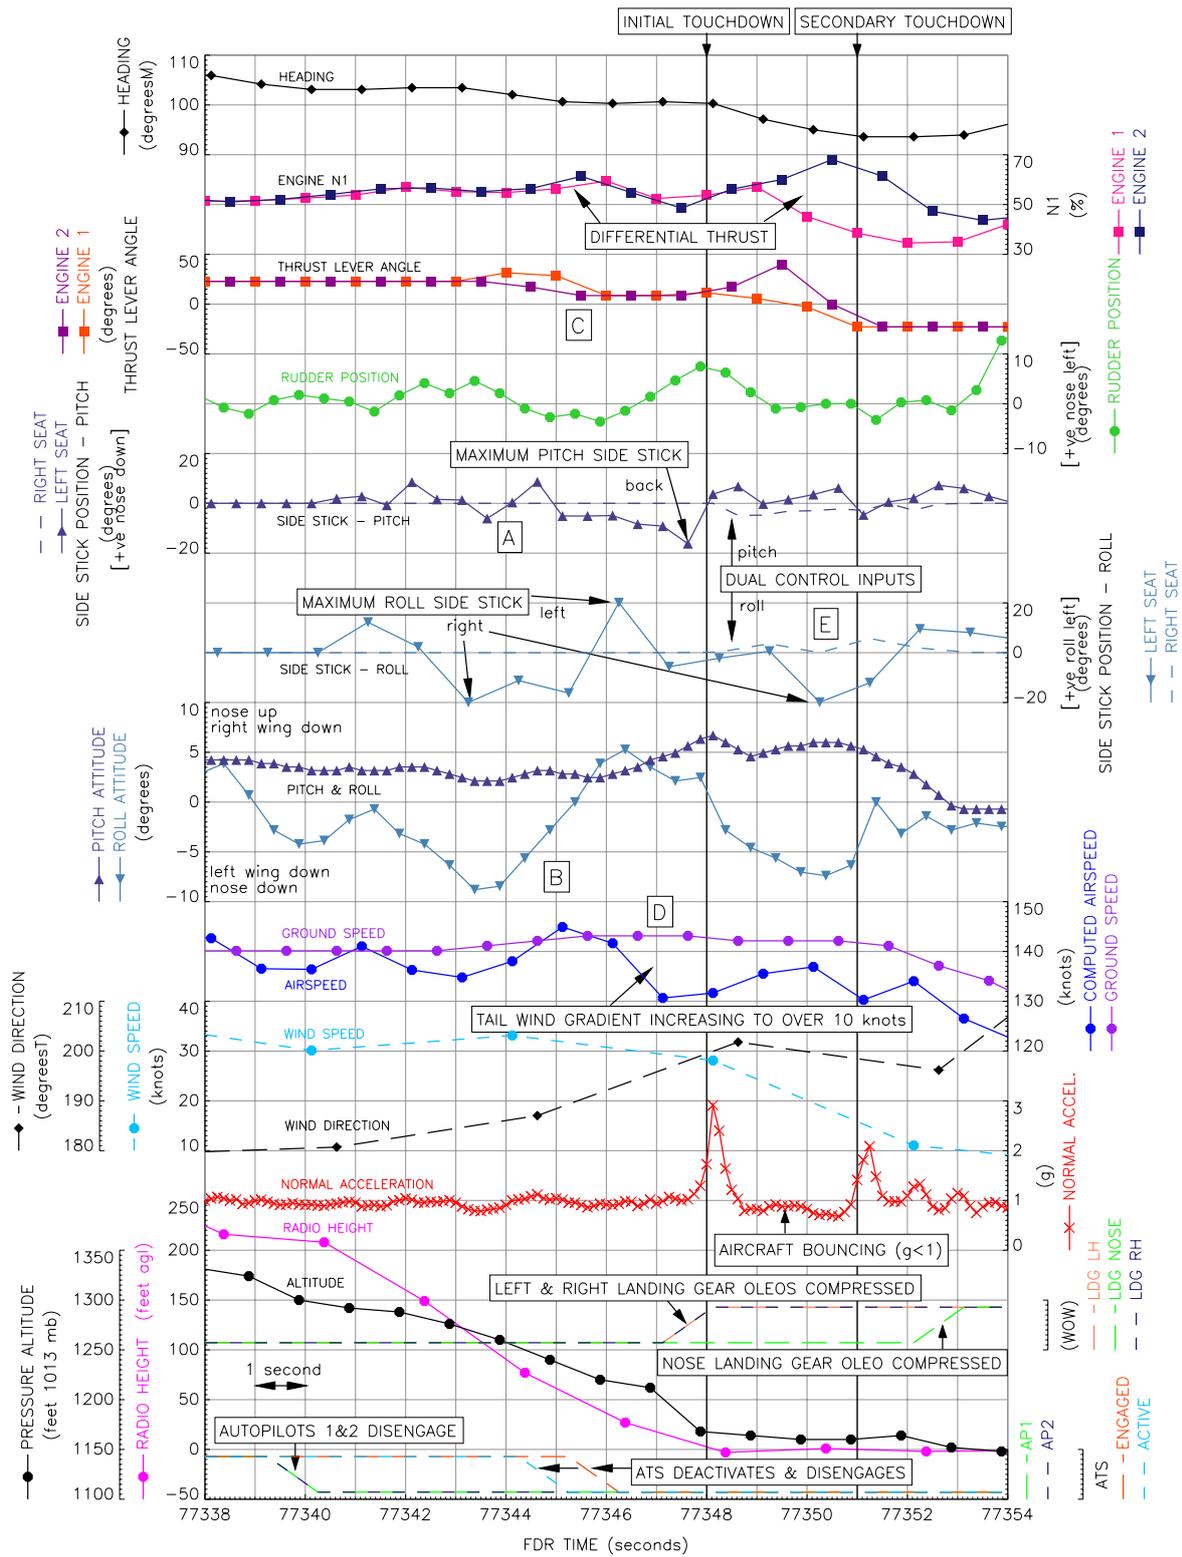
Figure 4
 Salient FDR Parameters
 (Incident to G-BXKD on 15 November 2006)

A maximum pitch attitude of 6.7° was recorded just after touchdown, together with a peak normal acceleration of 2.9g as both right and left main gear oleos compressed within a second of each other (right main first).

The commander disconnected the autopilots about 100 ft above the runway threshold, this was 5 seconds prior to initiating the flare and 8 seconds before touchdown. In the prevailing turbulent conditions this allowed insufficient time to separate the piloting tasks of taking control of the aircraft and flaring the aircraft to land. In addition, during the remaining flight to touchdown the pilot made a number of increasingly large control inputs, in both pitch and roll, in an attempt to maintain the required flight path. At the same time, changes to both the groundspeed and airspeed indicated the presence of an increasing headwind of about 6 kt. As a consequence of the successive pitch control inputs the rate of descent increased from 750 ft/min up to 1,000 ft/min and the aircraft descended below the glidepath. The PF initiated the flare 42 ft above the runway threshold with an increasing nose-up pitch input; the aircraft touched down at a pitch attitude of 5.5° and with full back stick applied. Just prior to touchdown the surface wind produced a tailwind of about 10 kt and a crosswind of about 30 kt. Therefore, the two main contributors to the heavy landing were the successive pitch control inputs which increased the rate of descent and the longitudinal wind gradient, with an increasing tailwind of about 15 kt just before touchdown.

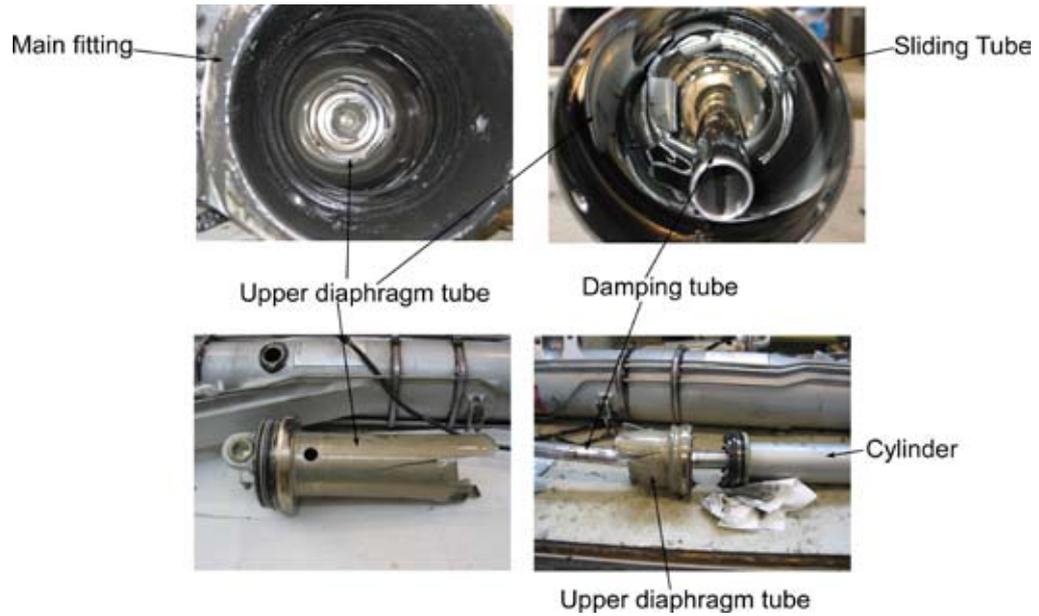
Figure 5
Damage to the main landing gear upper diaphragm tube

The right main landing gear internal upper diaphragm tube had ruptured allowing the inner sliding tube to over extend. There was no other damage to the aircraft.

The right main landing gear was removed from the aircraft and taken to the manufacturer for a detailed strip examination. Due to the damage, the sliding tube was allowed to over-extend to 675 mm between the centres of the torque link fittings; the manual states that this extension dimension should be 632.95 ± 3.85 mm.

The gear was then stripped down. After removal of the torque links, the main fitting was lifted from the sliding tube. This revealed a total rupture of the upper diaphragm tube (see Figure 5). The rupture had occurred in compression with the fracture around the orifice holes. The damping tube had also bent. There was no damage to the chambers or the gland seals, which is why the oil/air pressure was retained in the gear.

The significant damage to the right main landing gear upper diaphragm tube was caused by the initial heavy landing at Bristol. Although checks were carried out at Bristol, an opportunity to find this damage was missed. A second opportunity to discover the damage occurred at Manchester after its first arrival following the diversion. Again, this opportunity was missed. It was only after the second landing at Manchester that the damage was discovered.
