ACCIDENT

| Aircraft Type and Registration: | Piper J3C-65 Cub, G-NCUB | |
| Date & Time (UTC): | 8 October 2009 at 1430 hrs | |
| Location: | 4 miles NW of Ledbury, Herefordshire | |

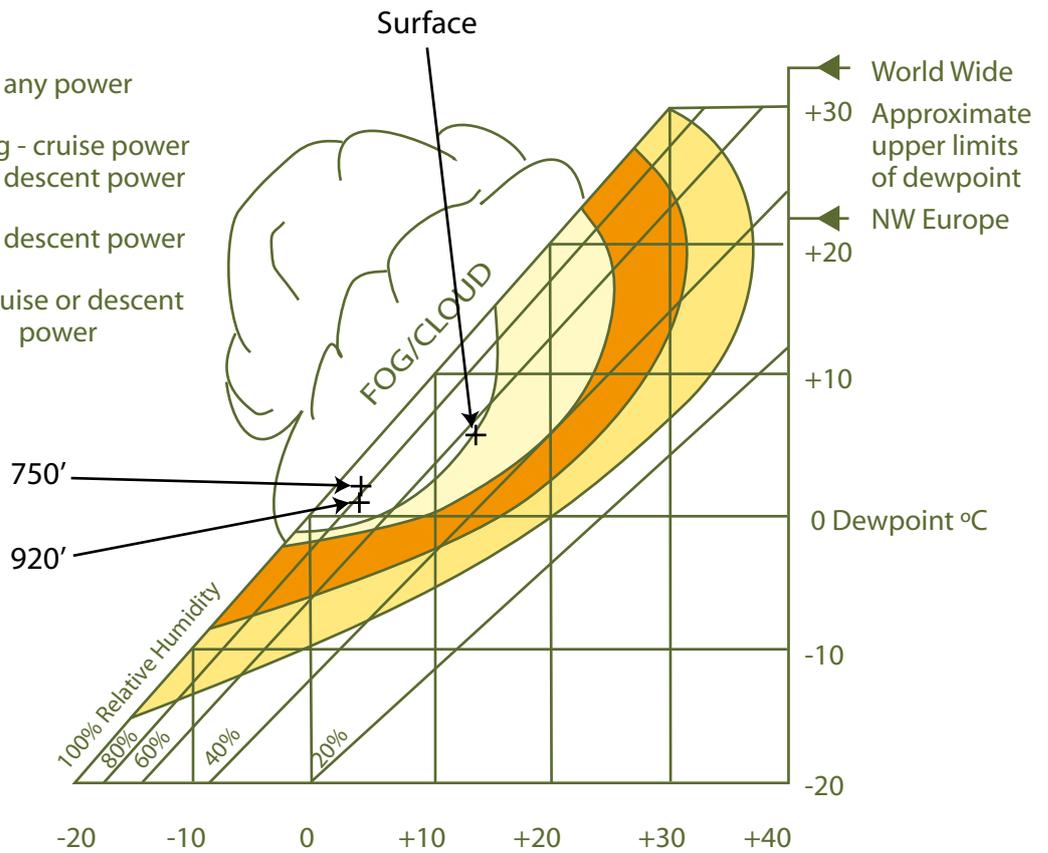
CARB ICING

No detailed examination of the engine or engine systems was carried out. An aftercast, for the Ledbury area on 8 October obtained from the Met Office, gave air temperature, dew point and humidity from the surface to 920 ft. When these figures were plotted on the Civil

Aviation Authority's Carburettor Icing Prediction Chart, published in Safety Sense Leaflet No 14, it gave a prognosis that serious carburettor icing could occur at any power setting between the surface and 920 ft above sea level (see Figure 1).
