Robinson R44 Clipper, G-KAZZ

AAIB Bulletin No: 1/2004	Ref: EW/C2003/07/02	Category: 2.3
INCIDENT		
Aircraft Type and Registration:	Robinson R44 Clipper, G-KAZZ	
No & Type of Engines:	1 Lycoming O-540-F1B5 piston engine	
Year of Manufacture:	2001	
Date & Time (UTC):	9 July 2003 at 0926 hrs	
Location:	Sywell Airfield, Northamptonshire	
Type of Flight:	Engineering Test Flight	
Persons on Board:	Crew - 2	Passengers - None
Injuries:	Crew - None	Passengers - N/A
Nature of Damage:	Tail rotor drive shaft failure. Tail cone, tail cone support frame, drive shaft flexible plate and engine clutch assembly damaged	
Commander's Licence:	Private Pilot's Licence	
Commander's Age:	49 years	
Commander's Flying Experience:	1,100 hours (of which 74 were on type)	
	Last 90 days - 25 hours	
	Last 28 days - 10 hours	
Information Source:	AAIB Field Investigation

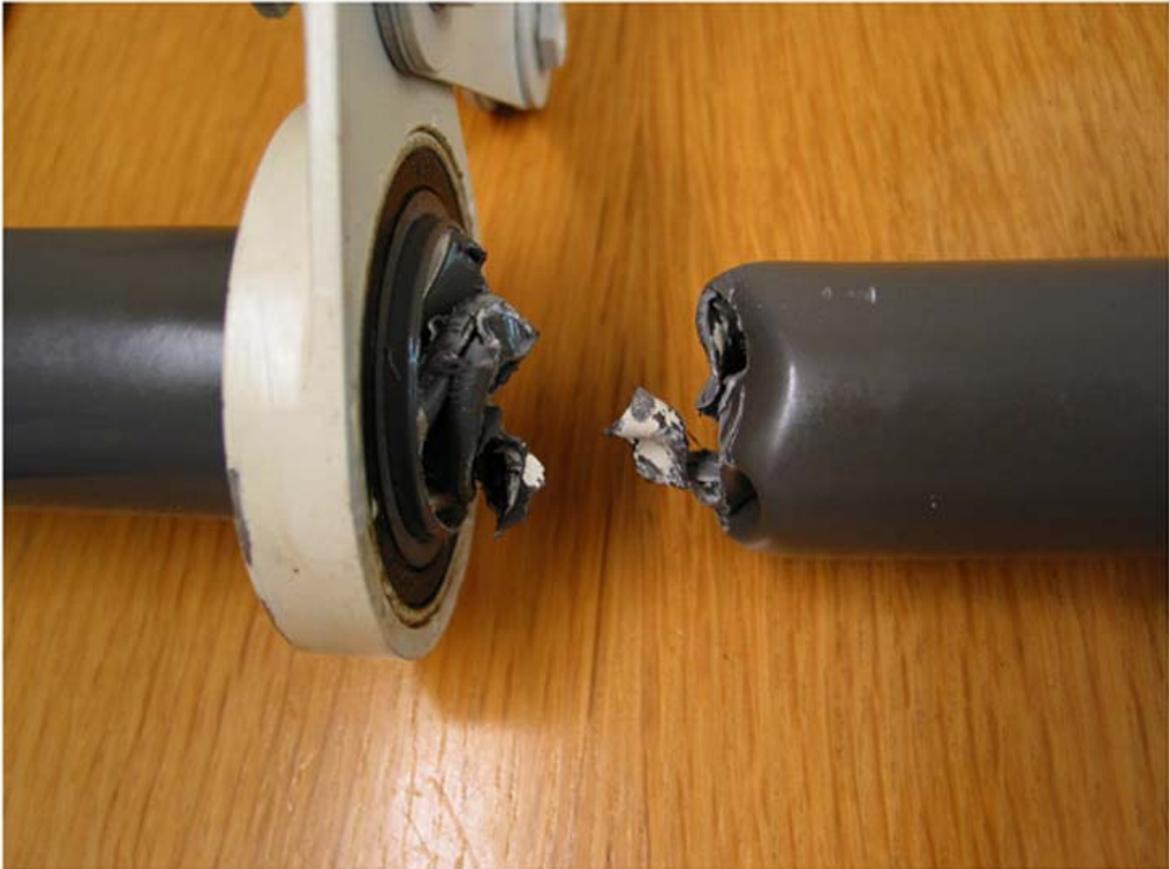
Inspection revealed that the tail rotor drive shaft had completely fractured at a point just aft of the damper bearing (see Figure 2 and Figure 3).

Tail rotor drive shaft failure

Following the failure the rear portion of the tail rotor drive shaft was unsupported and had flailed around causing contact damage to the frames of the tail cone and the drive shaft. The forward portion remained supported by the damper bearing.

Metallurgic examination of the tail rotor drive shaft revealed that the fracture, just aft of the 'whirl mode' bearing, was due to a torsional overload, consistent with stoppage of the aft section of the drive shaft while the forward section was still rotating. The fracture surfaces had 'shear type' failures consistent with overload in thin walled material.

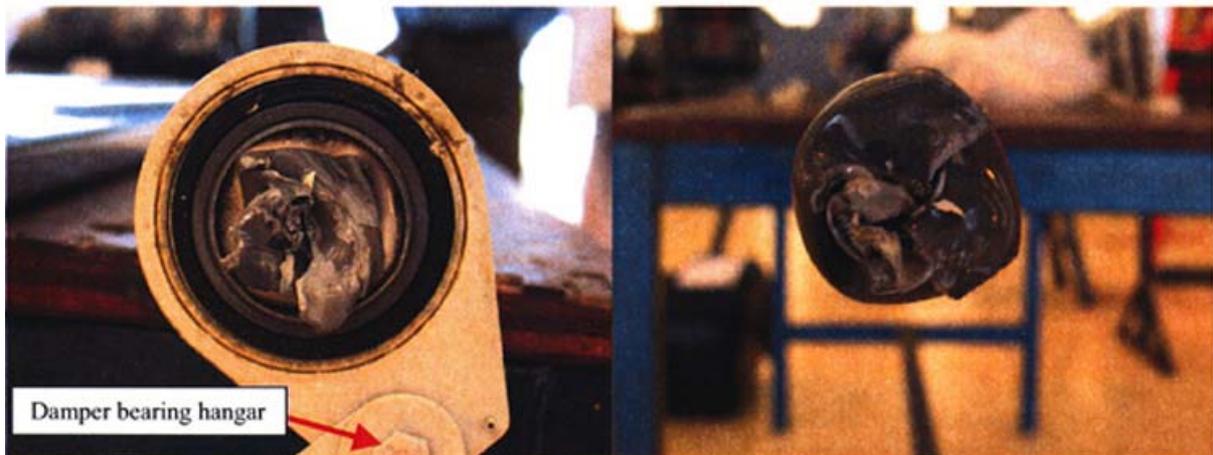
Figure 3

Drive shaft fracture faces

The physical evidence points to an 'over-torque' in the aft section of the tail rotor drive shaft. The failure, very localised in an area just aft of the whirl mode damper bearing, indicates that the rotation of the rear of the shaft had been stopped while the engine had still been driving the forward section.

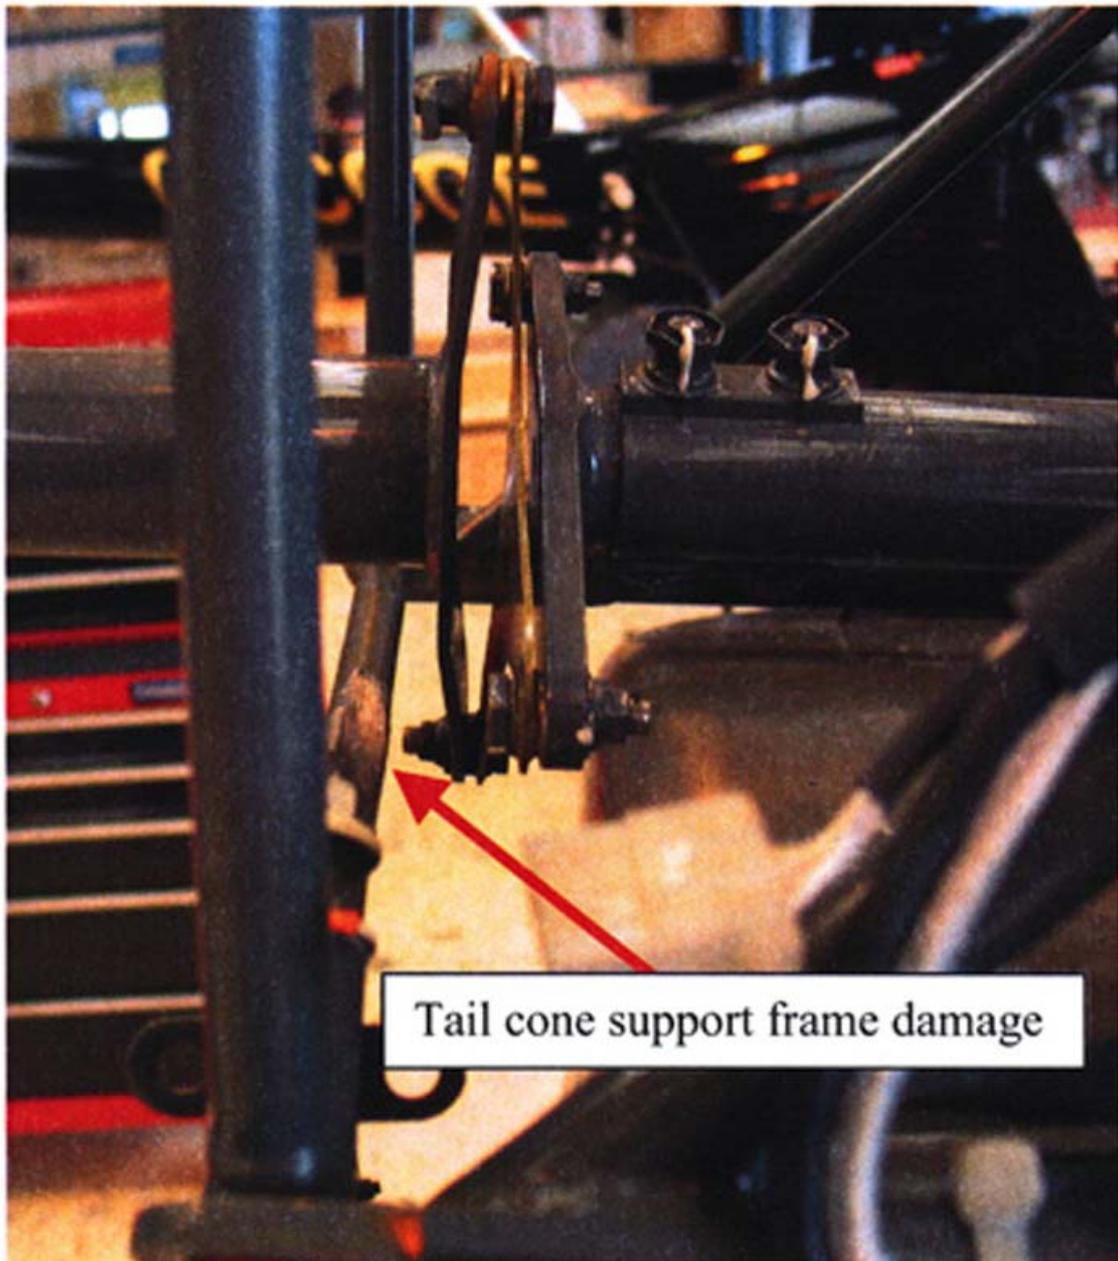
Figure 4

Additional damage was evident on the tail cone support frame where the flexible plate connecting the main engine drive shaft to the tail rotor drive shaft had come into contact with it on its lower section (see Figure 4).

Figure 4: Tail cone support frame damage

This was also evidenced by damage to the attaching nuts on the flexible plate. As the tail rotor shaft separated the flexible plate assembly had returned to its usual position with a clearance of approximately 0.4 inch. This was later confirmed to be similar to other Robinson R44 helicopters. Also the clutch actuator assembly had contacted the inner rim of the drum of the engine clutch and drive belt assembly. There was no other damage to the external tail cone assembly, vertical fins or the stinger. The tail rotor blades were also scanned for the presence of contact with organic material such as birds or grass, using UV light, but none was found.

This had caused the drive shaft to twist, plastically deform and shorten. The shortening of the shaft had been taken up by the flex plate of the flexible coupling situated near to the tail cone support frame. The coupling had been pulled rearwards bringing it into contact with the frame. When the shaft failed the flex plate returned to its pre-failure position suffering minimal plastic deformation.
