**ACCIDENT**

<b>Aircraft Type and Registration:</b>	Cessna F177RG Cardinal RG, G-BFPZ	
<b>No &amp; Type of Engines:</b>	1 Lycoming IO-360-A1B6D piston engine	
<b>Year of Manufacture:</b>	1973	
<b>Date &amp; Time (UTC):</b>	29 March 2009 at 1610 hrs	
<b>Location:</b>	Popham Airfield, Hampshire	
<b>Type of Flight:</b>	Private	
<b>Persons on Board:</b>	Crew - 1	Passengers - None
<b>Injuries:</b>	Crew - None	Passengers - N/A
<b>Nature of Damage:</b>	Damage to rear fuselage skin, stringers, stabilator tips and reinforcing strips	
<b>Commander's Licence:</b>	Private Pilot's Licence	
<b>Commander's Age:</b>	49 years	
<b>Commander's Flying Experience:</b>	294 hours (of which 4 were on type) Last 90 days - 5 hours Last 28 days - 1 hour	
<b>Information Source:</b>	AAIB Field Investigation

**Synopsis**

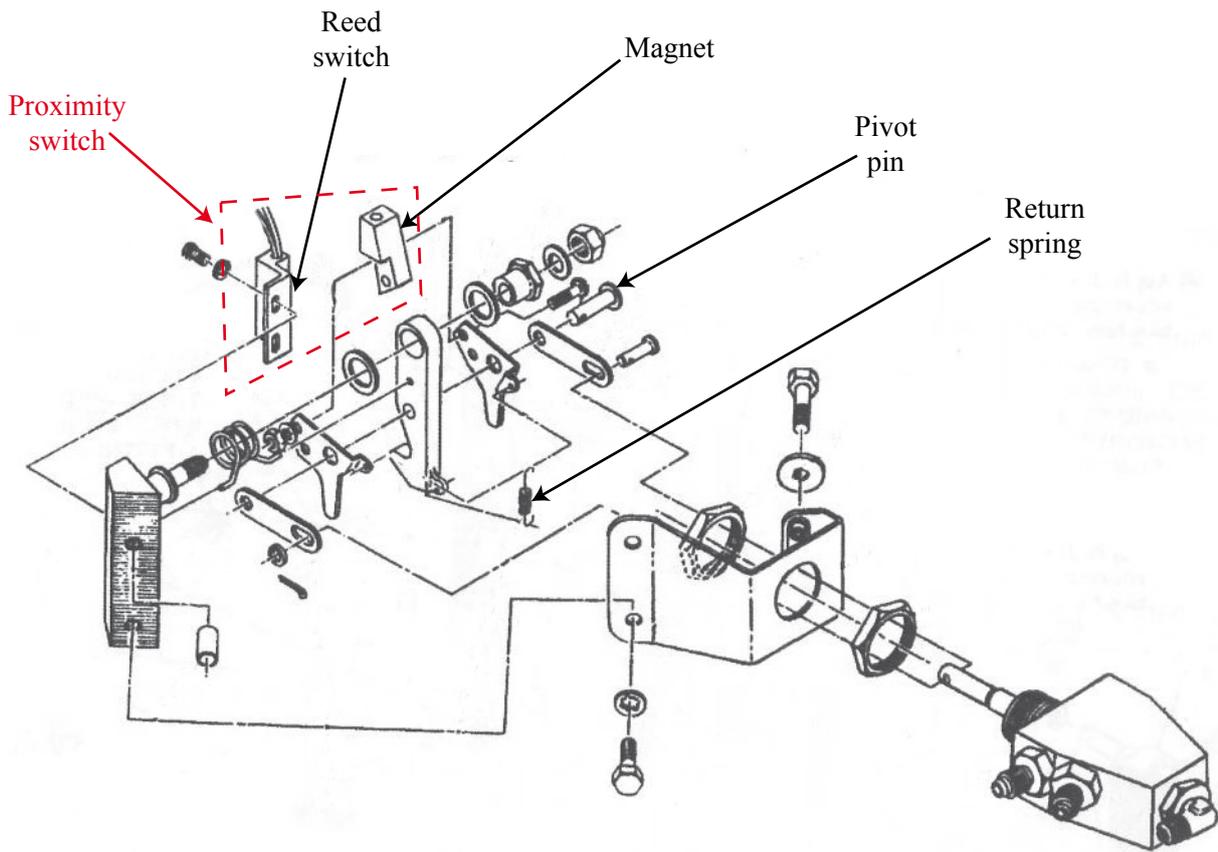
**Figure 1**

The main landing gear downlock proximity switches consist of a fixed 'reed' switch, part number 2070017, and a magnet, part number 2070026, that is attached to an actuator arm, part number 2041068. The actuator arm is mounted on a pivot, part number MS20392-3C15, and there is a small coil return spring, part number 2041064, attached at the opposite end to the magnet (Figure 1).

Main landing gear downlock mechanism

The engineering examination of G-BFPZ revealed that both main landing gear downlock proximity switches remained in the DOWN AND LOCKED position when the landing gear was retracted. Closer inspection found that the pivot points were dry, with no evidence of lubrication, and the return springs were weak.

It is recommended that the Cessna Aircraft Company introduce a specific maintenance requirement for F177RG aircraft to lubricate the main landing gear downlock proximity switch pivot (part number MS20392-3C15).

It is recommended that the Cessna Aircraft Company specify a calendar life for the main landing gear downlock proximity switch return spring (part number 2041064) fitted to F177RG aircraft.

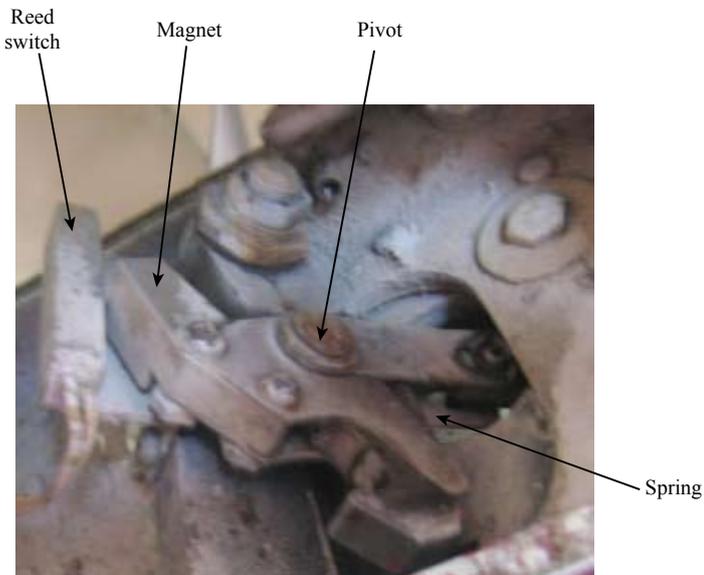
**Figure 2**

When the landing gears extend and enter the downlocks they mechanically move the lower ends of the actuator arms, causing them to pivot and swing the magnets towards the 'reed' switches. This extends the return springs (Figure 2).

Downlock proximity switch in the 'landing gear extended' position

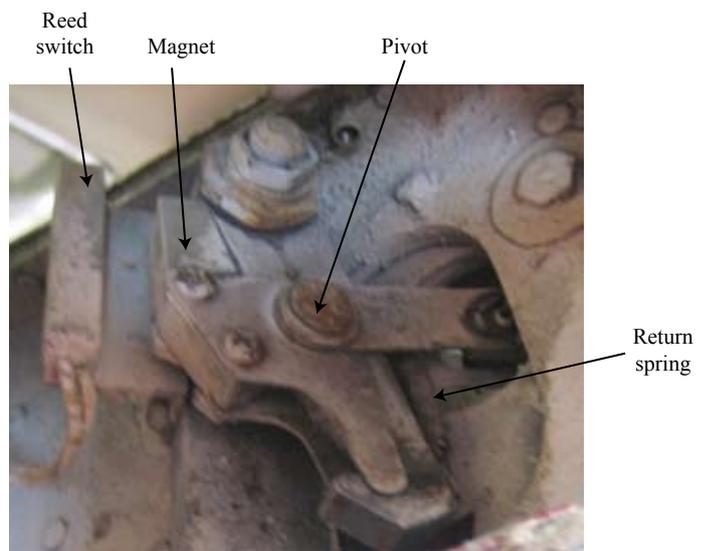
**Figure 3**

The two electrical contacts within the 'reed' switch are pulled together by the magnetic field of the magnet, completing the downlock electrical circuit. When the landing gear is retracted, the return spring pulls the magnet away from the 'reed' switch (Figure 3) allowing the contacts to separate, breaking the downlock electrical circuit.

Right landing gear downlock proximity switch in the 'landing gear retracted' position
