ACCIDENT

Aircraft Type and Registration:	Europa, G-TAGR	
No & type of Engines:	1 Rotax 912 ULS piston engine	
Year of Manufacture:	2004	
Date & Time (UTC):	21 July 2006 at 1305 hrs	
Location:	1.5 miles West of RAF Syerston, Nottinghamshire	
Type of Flight:	Private	
Persons on Board:	Crew 1	Passengers 1
Injuries:	Crew None	Passengers None
Nature of Damage:	Nose landing gear collapse and significant damage to lower fuselage and wing mounts	
Commander's Licence:	Private Pilot's Licence	
Commander's Age:	57 years	
Commander's Flying Experience:	394 hours (of which 29 were on type) Last 90 days - 5 hours Last 28 days - 1 hour	
Information Source:	Aircraft Accident Report Form submitted by the pilot/owner and subsequent testing

Synopsis

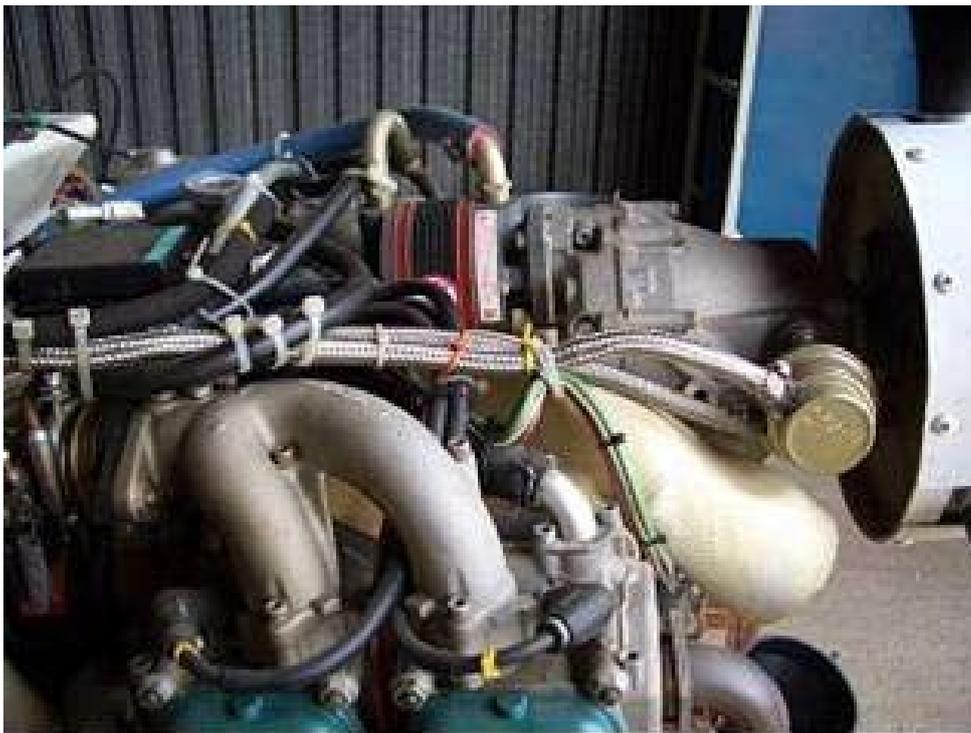
Figure 1

Photographs provided by the owner show that the fuel lines to and from the mechanical fuel pump were routed over the right inlet manifold, Figure 1; this complies with the recommended routing in the manufacturer's build manual. The manual also recommends that these lines are provided with an insulating sleeve to prevent heat transfer into the fuel. This recommendation was introduced¹ by the kit manufacturer as a result of several

cases of fuel vapour lock occurring during takeoff, which manifested itself as rough running and engine stoppage. The fuel lines fitted to G-TAGR were un-insulated and constructed with braided steel reinforcement.

Given the use of un-insulated fuel lines in an area of the engine bay which would be subject to significant heat

build up, and the high ambient temperature on the day, the possibility that the engine's rough running and power loss was caused by a vapour lock, which interrupted the flow of fuel to the engine, also could not be dismissed.
