**INCIDENT**

<b>Aircraft Type and Registration:</b>	Boeing 767-300 ER, V8-RBH	
<b>No &amp; Type of Engines:</b>	2 Pratt & Whitney 4060 turbofan engines	
<b>Year of Manufacture:</b>	1993	
<b>Date &amp; Time (UTC):</b>	3 March 2007 at 1630 hrs	
<b>Location:</b>	London Heathrow Airport	
<b>Type of Flight:</b>	Commercial Air Transport (Passenger)	
<b>Persons on Board:</b>	Crew - 11	Passengers - 189
<b>Injuries:</b>	Crew - None	Passengers - None
<b>Nature of Damage:</b>	Failure of No 1 wheel hub	
<b>Commander's Licence:</b>	Airline Transport Pilot's Licence	
<b>Commander's Age:</b>	56 years	
<b>Commander's Flying Experience:</b>	16,635 hours (of which 7,654 were on type) Last 90 days - 162 hours Last 28 days - 60 hours	
<b>Information Source:</b>	Aircraft Accident Report Form submitted by the pilot, and metallurgical examination of components

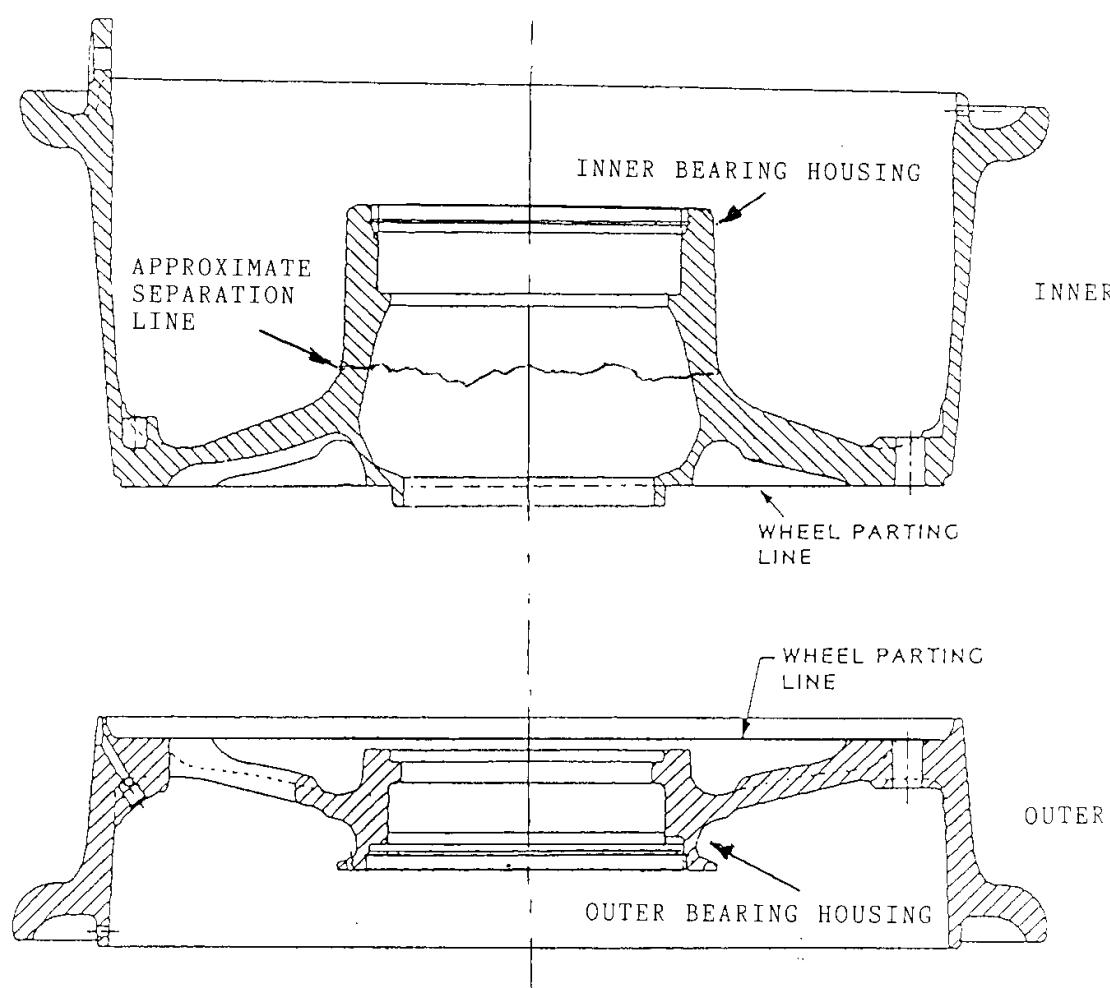
**Figure 1**

The wheel hub is in two parts. The outer hub houses the outer bearing and the inner hub, which is deeper, houses the inner bearing, (see Figure 1).

A large, almost-cylindrical section of the inner hub had become detached (see Figures 2, 3 and 4). The approximate location of the separation of the inner hub into two parts is also shown in Figure 1. The wheel was disassembled into its inner and outer hub parts and subjected to a detailed metallurgical examination. The conclusions from the examination were:

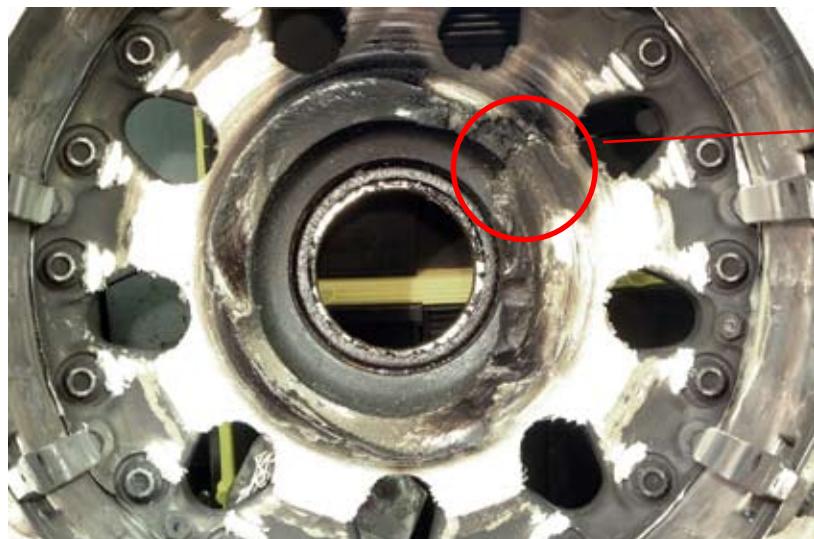
Figure 4

- a) the inner bearing housing had become detached and had severely overheated during contact with the main part of the inner hub. This was likely to have been the cause of the temperature warnings;
- b) the initial failure of the inner hub had taken place in the region shown by the in Figure 4;
- c) the likely cause of the failure was probably fatigue, or stress corrosion, or a combination of both;
- d) a precise assessment of the failure to the hub was impossible due to the extensive heat and

mechanical damage. The assessment was also made more difficult by the rapid cooling of the hub that occurred as a result of the water applied by the fire service;
