ACCIDENT

Aircraft Type and Registration:	Beech 76 Duchess, G-BMJT	
No & Type of Engines:	2 Lycoming (LO/O)-360-A1G6D piston engines	
Category:	1.3	
Year of Manufacture:	1981	
Date & Time (UTC):	10 April 2005 at 1649 hrs	
Location:	Adjacent to Belfast City Airport, Northern Ireland	
Type of Flight:	Private	
Persons on Board:	Crew - 1	Passengers - None
Injuries:	Crew - 1 (Serious)	Passengers - N/A
Nature of Damage:	Aircraft destroyed	
Commander's Licence:	Private Pilot's Licence	
Commander's Flying Experience:	Approximately 3,000 hours (of which approximately 2,400 were on type) Last 90 days - Not known Last 28 days - Not known	
Information Source:	AAIB Field Investigation

Summary

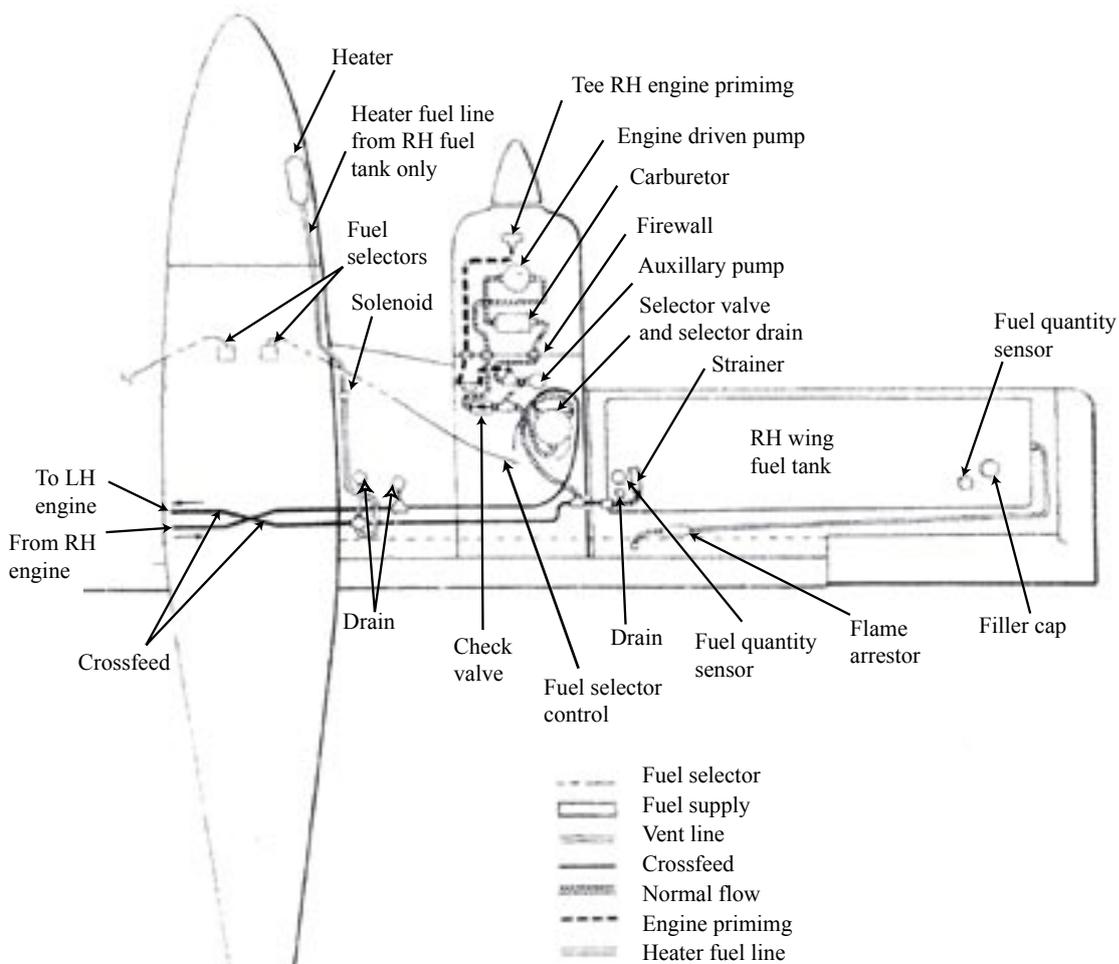
Figure 1
Fuel System Schematic

engine nacelles. This selector has three positions which are selectable from the cockpit, ON, CROSSFEED and OFF (see Figure 1). In the ON position the selector allows the engine to consume fuel from the fuel tank in the same wing, in the CROSSFEED position the fuel flow from the same wing is closed and fuel flows from the opposite wing tank via cross feed pipes. In the OFF position, both the cross feed and the normal fuel supplies are closed. During take off both fuel selector valves would normally be selected to the ON position. If the aircraft experienced an engine failure after take off then the Emergency Check List requires that the fuel selector for the inoperative engine is selected to the OFF position.

Examination of the remains of the fuel selector levers located on the cockpit floor showed that both levers were in the CROSSFEED position. There was a significant witness mark in the left fuel lever track at the CROSSFEED position which was likely to have been made by the fuel lever during the impact sequence; the left fuel lever was jammed in this position. The right fuel lever remained free to move and had not left any identifiable witness marks in its track and therefore its selected position at impact could not be confirmed.

Due to fire damage the aircraft fuel system could not be fully reconstructed; however, both the left and right fuel selectors were recovered and examined. The right engine selector remained within the engine nacelle together with its associated pipe work. When removed the valve was found to be in the ON position with the remains of the melted fuel filter bowl preventing any further movement of the valve plate. The left engine fuel selector was attached to the remains of the left wing by the selector cable, its locating structure having been destroyed in the fire. The valve was found to be in the CROSSFEED position; the remains of the fuel filter bowl prevented any movement of the valve plate.

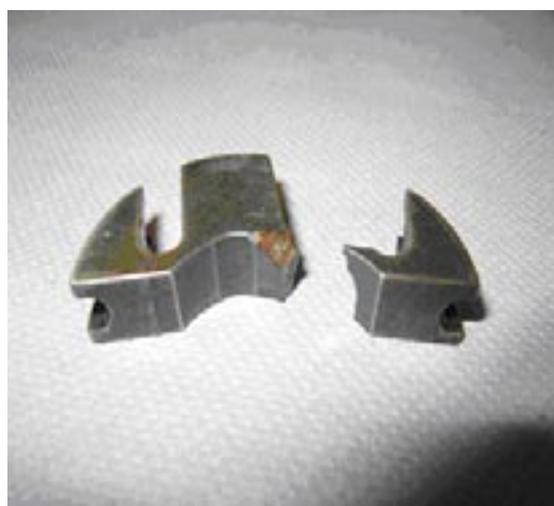
Figure 2

The propeller was then dismantled. The propeller cylinder was found to contain an appropriate quantity of apparently suitable oil, which was clean and bright in colour. The cylinder should be part filled with hydraulic oil to MIL-H-5606 specification. During removal of the feathering spring, the remains of one of the propeller pitch locks was found in the base of the propeller piston together with one of its retaining bolts. The remaining bolt had been partially pulled from its housing and had been distorted. The pitch lock was found in two pieces, having failed across an area of minimum wall thickness adjacent to one of the machined slots used to allow the lock to move under the influence of centrifugal forces in normal operation. (See Figure 2.)

The pitch lock was identified as being part number A-1590. This is an uncoated weight with an open design of slot. It is no longer available, having been replaced on an attrition basis with coated weights, part numbers B-317 and B-318 as appropriate for the propeller. These parts have a different slot design.

The presence of the broken pieces of pitch lock in the base of the cylinder, depending on its orientation, could have provided a mechanical restriction to the forward movement of the propeller piston preventing the propeller from moving to the fully fine position when the function test was carried out. This was the only plausible explanation for the observed restriction when the propeller was first tested.

Subsequent metallurgical examination of the fractured surface of the pitch lock showed it to be cracked by a fatigue mechanism which had then been finally fractured in overload. There was a distinct change in direction of the fracture at the final overload, which was over about 60% of the cross sectional area, indicative of a different loading mechanism. The fatigued portion of the surface was contaminated with corrosion deposits, including traces of sodium, chlorine and cadmium. The orientation of the fracture surface suggested that an element of torsion had occurred.

The shouldering and scoring present on the left propeller piston sleeve indicates that the pitch lock mechanism within the left propeller did not experience the same impact conditions as that of the right propeller. The existence of fatigue and the repetitive nature of the shouldering indicate that a problem existed before takeoff on the accident flight, although it is clear from the impact marks on the bolts that the final fracture of the lock was a result of ground impact.

It is possible that because of the corrosion found on the bolts, or for some other reason, the pitch locks had not opened and closed freely, resulting in contact with the sleeve and loads in the lock which may have generated the fatigue. During the ground impact the sleeve made heavy contact with the cracked but intact lock, causing the final overload failure. From the nature of the fatigue fracture of the pitch lock weight it appears this part had been subjected to an unusual, repetitive, and moderately high stress loading. This would be consistent with the lock not sliding properly due to contamination with the corrosion deposits found on the retaining bolts. The reason for the corrosion was not identified, however light corrosion of these bolts is reportedly sometimes found when propellers are overhauled. It is possible that the hydraulic oil absorbed moisture - the MIL-H-5606 oil specified is known to do this, and it is also possible that traces of salt (brine) were introduced when the propeller was charged with air or nitrogen. This would explain the traces of sodium and chlorine found on the fracture face.

Because the design of the lock, part A-1590 appears to be more susceptible to jamming than its later replacements, and because its design is more susceptible to cracking, the following safety recommendation is made:

It is recommended that the FAA, in collaboration with Hartzell, ensure that all Hartzell propellers in service that are fitted with part A-1590 pitch locks should have these replaced by part B-317 or B-318 pitch locks, as appropriate, at the next overhaul.
