**ACCIDENT**

<b>Aircraft Type and Registration:</b>	Diamond Aircraft Industries DA42 Twin Star, G-SLCT	
<b>No &amp; Type of Engines:</b>	2 Thielert TAE 125-01 piston engines	
<b>Year of Manufacture:</b>	2005	
<b>Date &amp; Time (UTC):</b>	3 June 2010 at 0900 hrs	
<b>Location:</b>	Stapleford Airfield, Essex	
<b>Type of Flight:</b>	Training	
<b>Persons on Board:</b>	Crew - 1	Passengers - 1
<b>Injuries:</b>	Crew - None	Passengers - None
<b>Nature of Damage:</b>	Aircraft extensively damaged	
<b>Commander's Licence:</b>	Airline Transport Pilot's Licence	
<b>Commander's Age:</b>	38 years	
<b>Commander's Flying Experience:</b>	2,276 hours (of which 58 were on type) Last 90 days - 107 hours Last 28 days - 40 hours	
<b>Information Source:</b>	Aircraft Accident Report Form submitted by the pilot and AAIB investigation

**Synopsis**

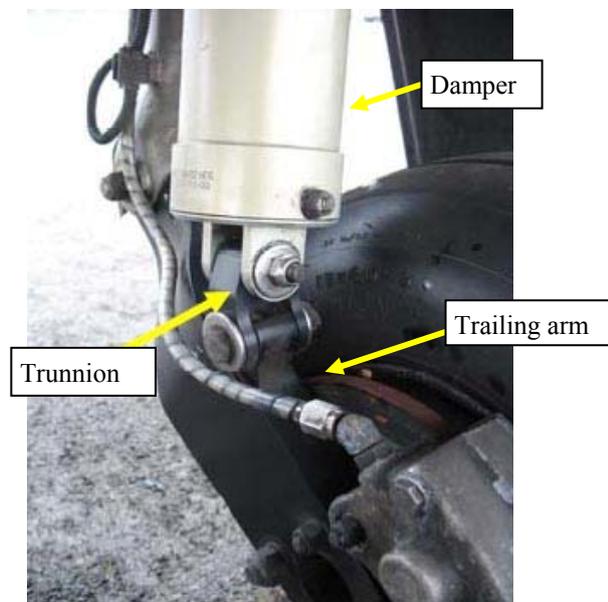
**Figure 1**

The aircraft was recovered and examined by the operator's maintenance organisation who advised the AAIB that the trunnion (Part No D60-3217-23-51) that connected the landing gear damper to the wheel trailing arm on the right landing gear leg had failed, Figure 1. This allowed the trailing arm to hang lower than normal, causing the landing gear to foul on the inside of the wheel well and prevented it from extending.

Location of failed trunnion on right landing gear

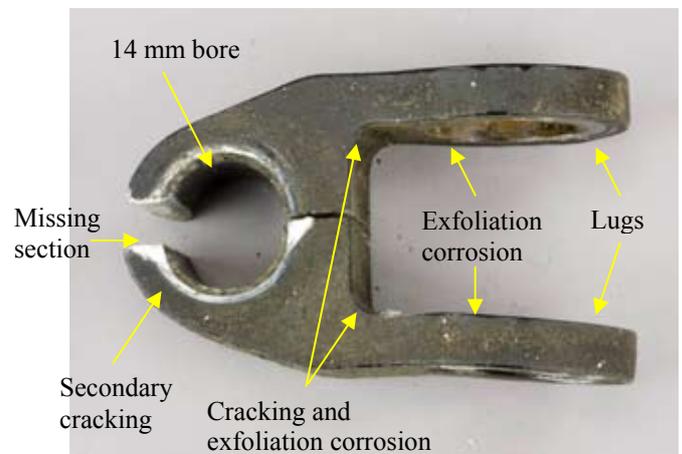
**Figure 2**

Failure of the right trunnion had occurred as a result of a fracture running along the 14 mm bore through which the attachment bolt that connects the trunnion to the damper was fitted. A section from this part of the trunnion, approximately 5 mm wide, had broken away and was not recovered from the accident site, Figure 2.

Damage to right trunnion

There was also evidence of secondary cracking and corrosion pits on the inside of the bore, with one corrosion pit located on the fracture face of the bore. The secondary cracking which was associated with damage to the anodised layer, had progressed along the exposed grain boundaries to depths of approximately 2.5 mm and was indicative of SCC.

The metallurgist concluded that the failure of the right trunnion was as a result of SCC, which started in the 14 mm bore where the protective anodising had been damaged. Movement of the attachment bolt in the bore might have resulted in surface damage which compromised the anodised layer and accelerated the onset of SCC. The metallurgist also commented that the material from which the trunnion was manufactured is known to be susceptible to SCC, particularly when, as in this case, the component has been machined from plate stock or a forging resulting in exposed grain boundaries.

It is recommended that Diamond Aircraft Industries consider issuing a Mandatory Service Bulletin for the trunnions (Part No D60-3217-23-51) on the main landing gear fitted to DA42 and DA42M aircraft to be removed, disassembled and inspected for corrosion and cracking.

It is recommended that Diamond Aircraft Industries review their instructions for the inspection and lubrication of the trunnions (Part No D60-3217-23-51) on the main landing gear fitted to DA42 and DA42M aircraft with a view to reducing their susceptibility to corrosion and stress corrosion cracking.

It is recommended that Diamond Aircraft Industries review the design of the trunnions (Part No D60-3217-23-51) on the main landing gear fitted to DA42 and DA42M aircraft with a view to making the components less susceptible to stress corrosion cracking.

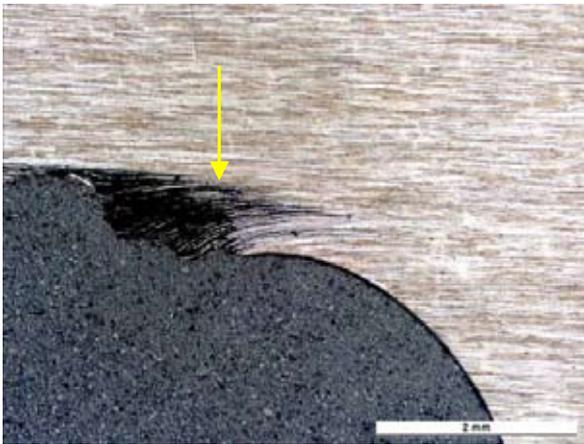
The trunnion had suffered extensively from exfoliation corrosion on the inner and outer faces of both lugs, Figure 3, to a depth of 4.8 mm. Cracking and exfoliation corrosion to a depth of 1.6 mm was also found along the inner radius at the base of both lugs, Figure 4.

**Figure 3**  
Exfoliation corrosion

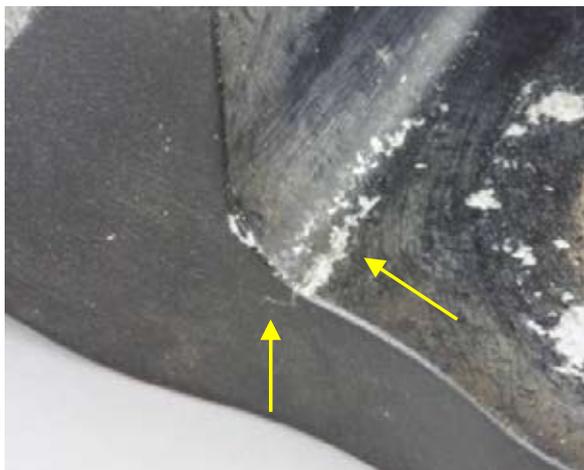
**Figure 4**  
Cracking at base of lugs

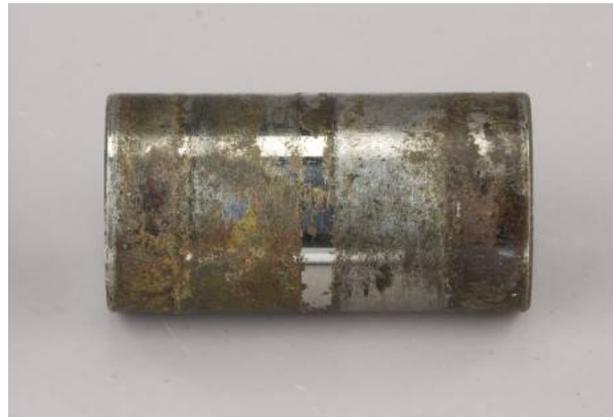
The bush (Part No BU1-18-10-0342) that fits into the lugs and the fitting on the landing gear trailing arm, Figure 5, had suffered from corrosion damage which appeared to be confined to the surface and did not penetrate the section, or show any evidence of pitting. There was no evidence of wear or gross loss of material. The bolt, which is fitted in the bush, was assessed as being in relatively good condition with no evidence of corrosion or damage.

**Figure 5**  
Condition of bush
