Rans S-6ES Coyote II, G-BYPT

AAIB Bulletin No: 4/2004	Ref: EW/G2003/08/42	Category: 1.4
Aircraft Type and Registration:	Rans S-6ES Coyote II, G-BYPT	
No & Type of Engines:	1 Jabiru 2200A piston engine	
Year of Manufacture:	1999	
Date & Time (UTC):	24 August 2003 at 1750 hrs	
Location:	Compton Abbas Airfield, Wiltshire	
Type of Flight:	Private	
Persons on Board:	Crew - 1	Passengers - 1
Injuries:	Crew - None	Passengers - None
Nature of Damage:	Nose leg collapsed, damaged propeller, engine shock loaded and damage to underside of engine cowling	
Commander's Licence:	Private Pilot's Licence	
Commander's Age:	51 years	
Commander's Flying Experience:	130 hours (of which 68 were on type)	
	Last 90 days - 18 hours	
	Last 28 days - 11 hours	
Information Source:	Aircraft Accident Report Form submitted by the pilot and further enquiries by the AAIB

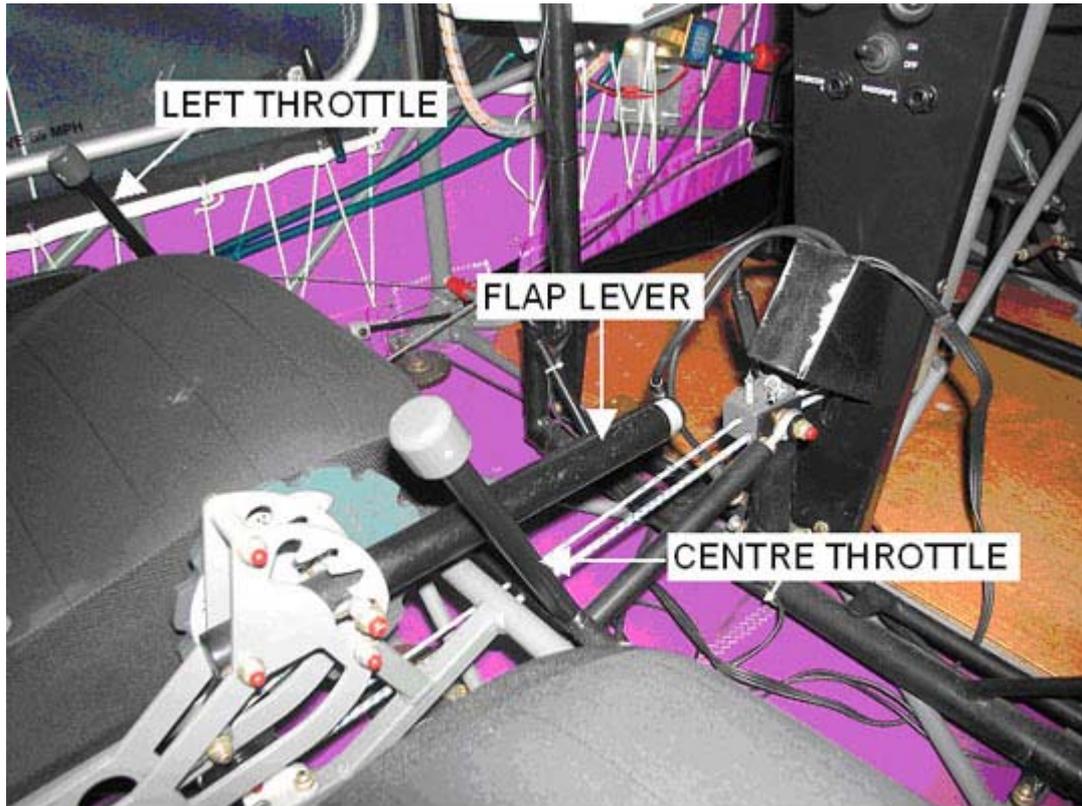
the two seats, which rotated fore and aft. One throttle lever was located on the left side of the left seat and the other throttle lever was located in the centre, between the two seats (see Figures 1 and 2). The centre throttle was on the right side of the flap lever. The pilot's previous aircraft, a Rans S6-XL, was a similar aircraft with two throttle levers but it did not have a flap lever. From flying the S6-XL the pilot was used to controlling the aircraft with his left hand on the left throttle and his right hand on the control stick.

Figure 1: Flap lever in flaps 'UP' position and throttle in IDLE position

Figure 1 - Flap lever in flaps UP position and throttle in IDLE position

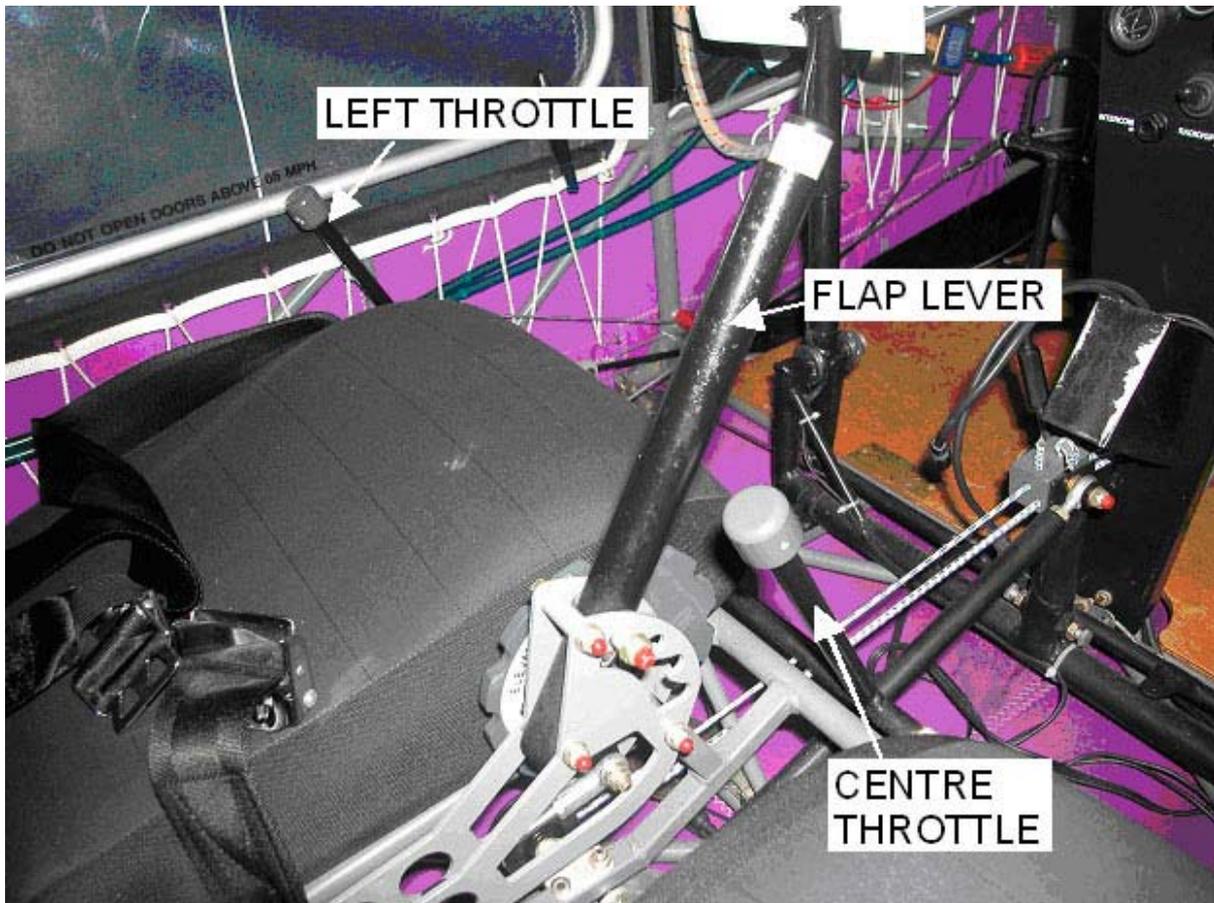
Figure 2: Flap lever in flaps full down position and throttle in idle position

Figure 2 - Flap lever in flaps FULL DOWN position and throttle in IDLE position

When the throttle is closed (as one would expect at touchdown) the flap handle is sufficiently far forward of the throttle handle that it is unlikely that the throttle could be accidentally nudged while actuating the flap. However, a pilot unfamiliar with the location of the flap lever might accidentally grab the throttle lever by mistake and nudge it forwards. Regardless of the cause of this accident, the ergonomics of the throttle lever positions are poor. If a pilot in the left seat decides to control the aircraft with his right hand, his left hand will control the throttle on his left side. In order to actuate the flap the pilot must then either swap hands on the control stick or release the control stick completely to actuate the flap with his right hand. Some pilots reportedly use both throttle levers depending upon the situation. The new Rans S-6ES kit comes equipped with a single central console mounted push-pull throttle although the old twin fore and aft throttles can still be purchased as an option.
