# Jabiru UL-450, G-JUDD

<b>AAIB Bulletin No:</b> 10/2002	<b>Ref:</b> EW/G2002/04/14	<b>Category:</b> 1.3
<b>Aircraft Type and Registration:</b>	Jabiru UL-450, G-JUDD	
<b>No &amp; Type of Engines:</b>	1 Jabiru Aircraft PTY 2200A piston engine	
<b>Year of Manufacture:</b>	2000	
<b>Date &amp; Time (UTC):</b>	19 April 2002 at 0815 hrs	
<b>Location:</b>	Lark Engine Farm House, Ely, Cambridgeshire	
<b>Type of Flight:</b>	Private	
<b>Persons on Board:</b>	Crew - 1	Passengers - 1
<b>Injuries:</b>	Crew - None	Passengers - None
<b>Nature of Damage:</b>	Damage to propeller, wing tip and landing gear	
<b>Commander's Licence:</b>	Private Pilots Licence (Microlights)	
<b>Commander's Age:</b>	51 years	
<b>Commander's Flying Experience:</b>	689 hours (of which 200 were on type)	
	Last 90 days - 45 hours	
	Last 28 days - 26 hours	
<b>Information Source:</b>	Aircraft Accident Report Form submitted by the pilot, metallurgical examination of landing gear bolts and other enquiries by AAIB

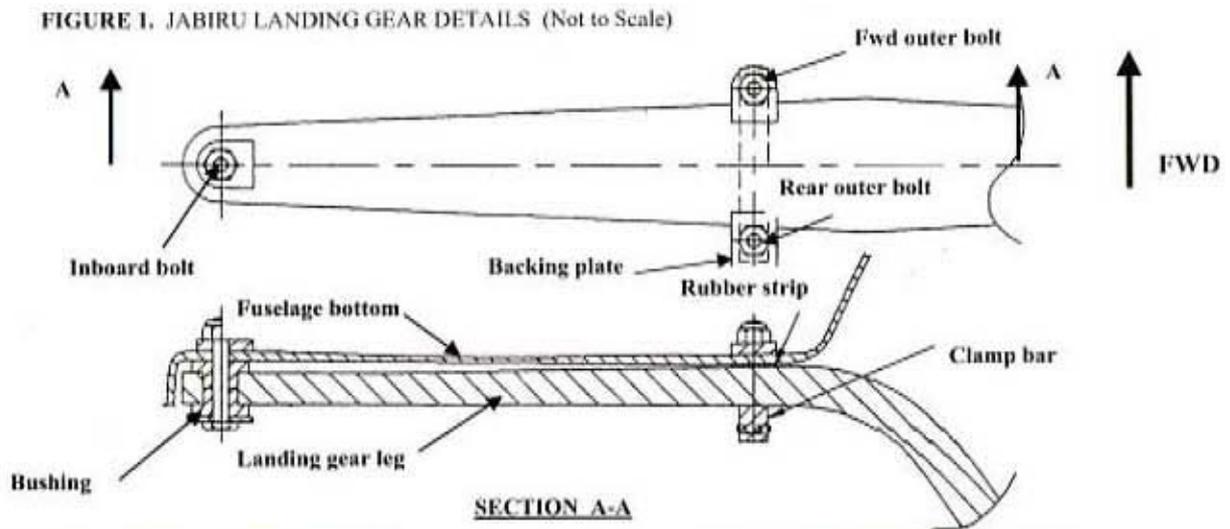
**Figure 1: Jabiru landing gear details.**

The main landing gear legs on this type of aircraft are of composite construction, and they are attached to the underside of the glassfibre fuselage by means of three bolts. Figure 1 below shows the general layout. It can be seen that the inboard bolt passes through a bushing. The outboard bolts are unbushed, and pass through a protective rubber strip and a clamp bar, located respectively on the upper and lower side of the leg. The diagram shows the bolts to be all the same length (AN5-24A), although a separate parts list within the assembly manual calls up three different bolts. In

The airworthiness aspects of this aircraft are the responsibility of the Popular Flying Association (PFA). They are currently considering a modification that introduces bushings in the outboard clamp assembly, similar to the inboard bolt installation. This would assist in achieving and maintaining satisfactory assembly torque within the clamp.

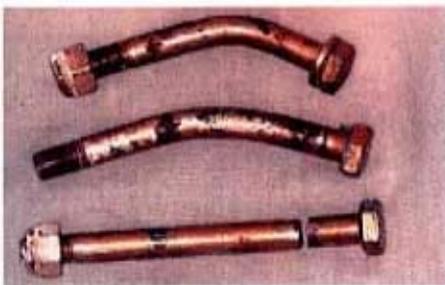
*(Photo: H T Consultants)*  
**FIGURE 1a. Bolts as received**

The three bolts from the left main landing gear were submitted to the AAIB for examination. One had failed approximately 20 mm from the underside of the head and the remaining two were intact but bent. One of the bent bolts was slightly shorter than the other two. The geometry of the landing gear is such that the landing shock loads tend to deflect the legs forwards; this imparts the greatest stress on the rearmost of the outboard bolts and it was this one that failed in the case of G-JUDD. The bolts were unlabelled on receipt at the AAIB, although it was assumed that the one of the same length as the failed item had been in the forward outer position.

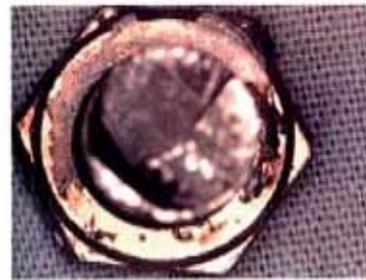
*(Photo: H T Consultants)*  
**FIGURE 1b. Underside of fractured bolt head showing lack of damage to plating. Thrust face of associated nut showed similar lack of damage**

The examination revealed that the bolt failure had occurred as a result of a simple bending fatigue mechanism, with multiple initiation sites. There was evidence, in the form of a relative lack of

smearing of the cadmium plating on the thrust face of the nut and the underside of the bolt head, which suggested that the assembly had not been fully tightened. This would have reduced the bolt's fatigue resistance. The condition of the forward outer bolt was the same, although the inboard bolt appeared to have been adequately tightened. It was noted that the threaded end of the inboard bolt contained at least three fatigue cracks in the thread roots. The UK agent for the aircraft kit manufacturer examined the aircraft and formed the opinion that one or more of the bolts may have been insufficiently tight, allowing movement of the gear leg within the clamp. He additionally noted that the failed bolt had been installed upside down, although it seems unlikely that this had any influence on the failure. The owner stated that he had tightened the bolts approximately 20 flying hours before the accident, and previously at the renewal of the annual Permit to Fly.
