Aircraft type and registration:	Slingsby T67M Firefly G-SFTY (light single engine fixed wing aircraft)	
Year of manufacture:	1983	
Date and time (GMT):	30 January 1984 at about 1205 hrs	
Location:	Torquhan, near Galashiels, Scotland	
Type of flight:	Navigation training	
Persons on board:	Crew — 1	Passengers — Nil
Injuries:	Crew — 1 (fatal)	Passengers — N/A
Nature of damage:	Aircraft destroyed	
Commander's Licence:	Private Pilot's Licence	
Commander's Age:	23 years	
Commander's total flying experience:	80 hours (of which 10 hours were on type)

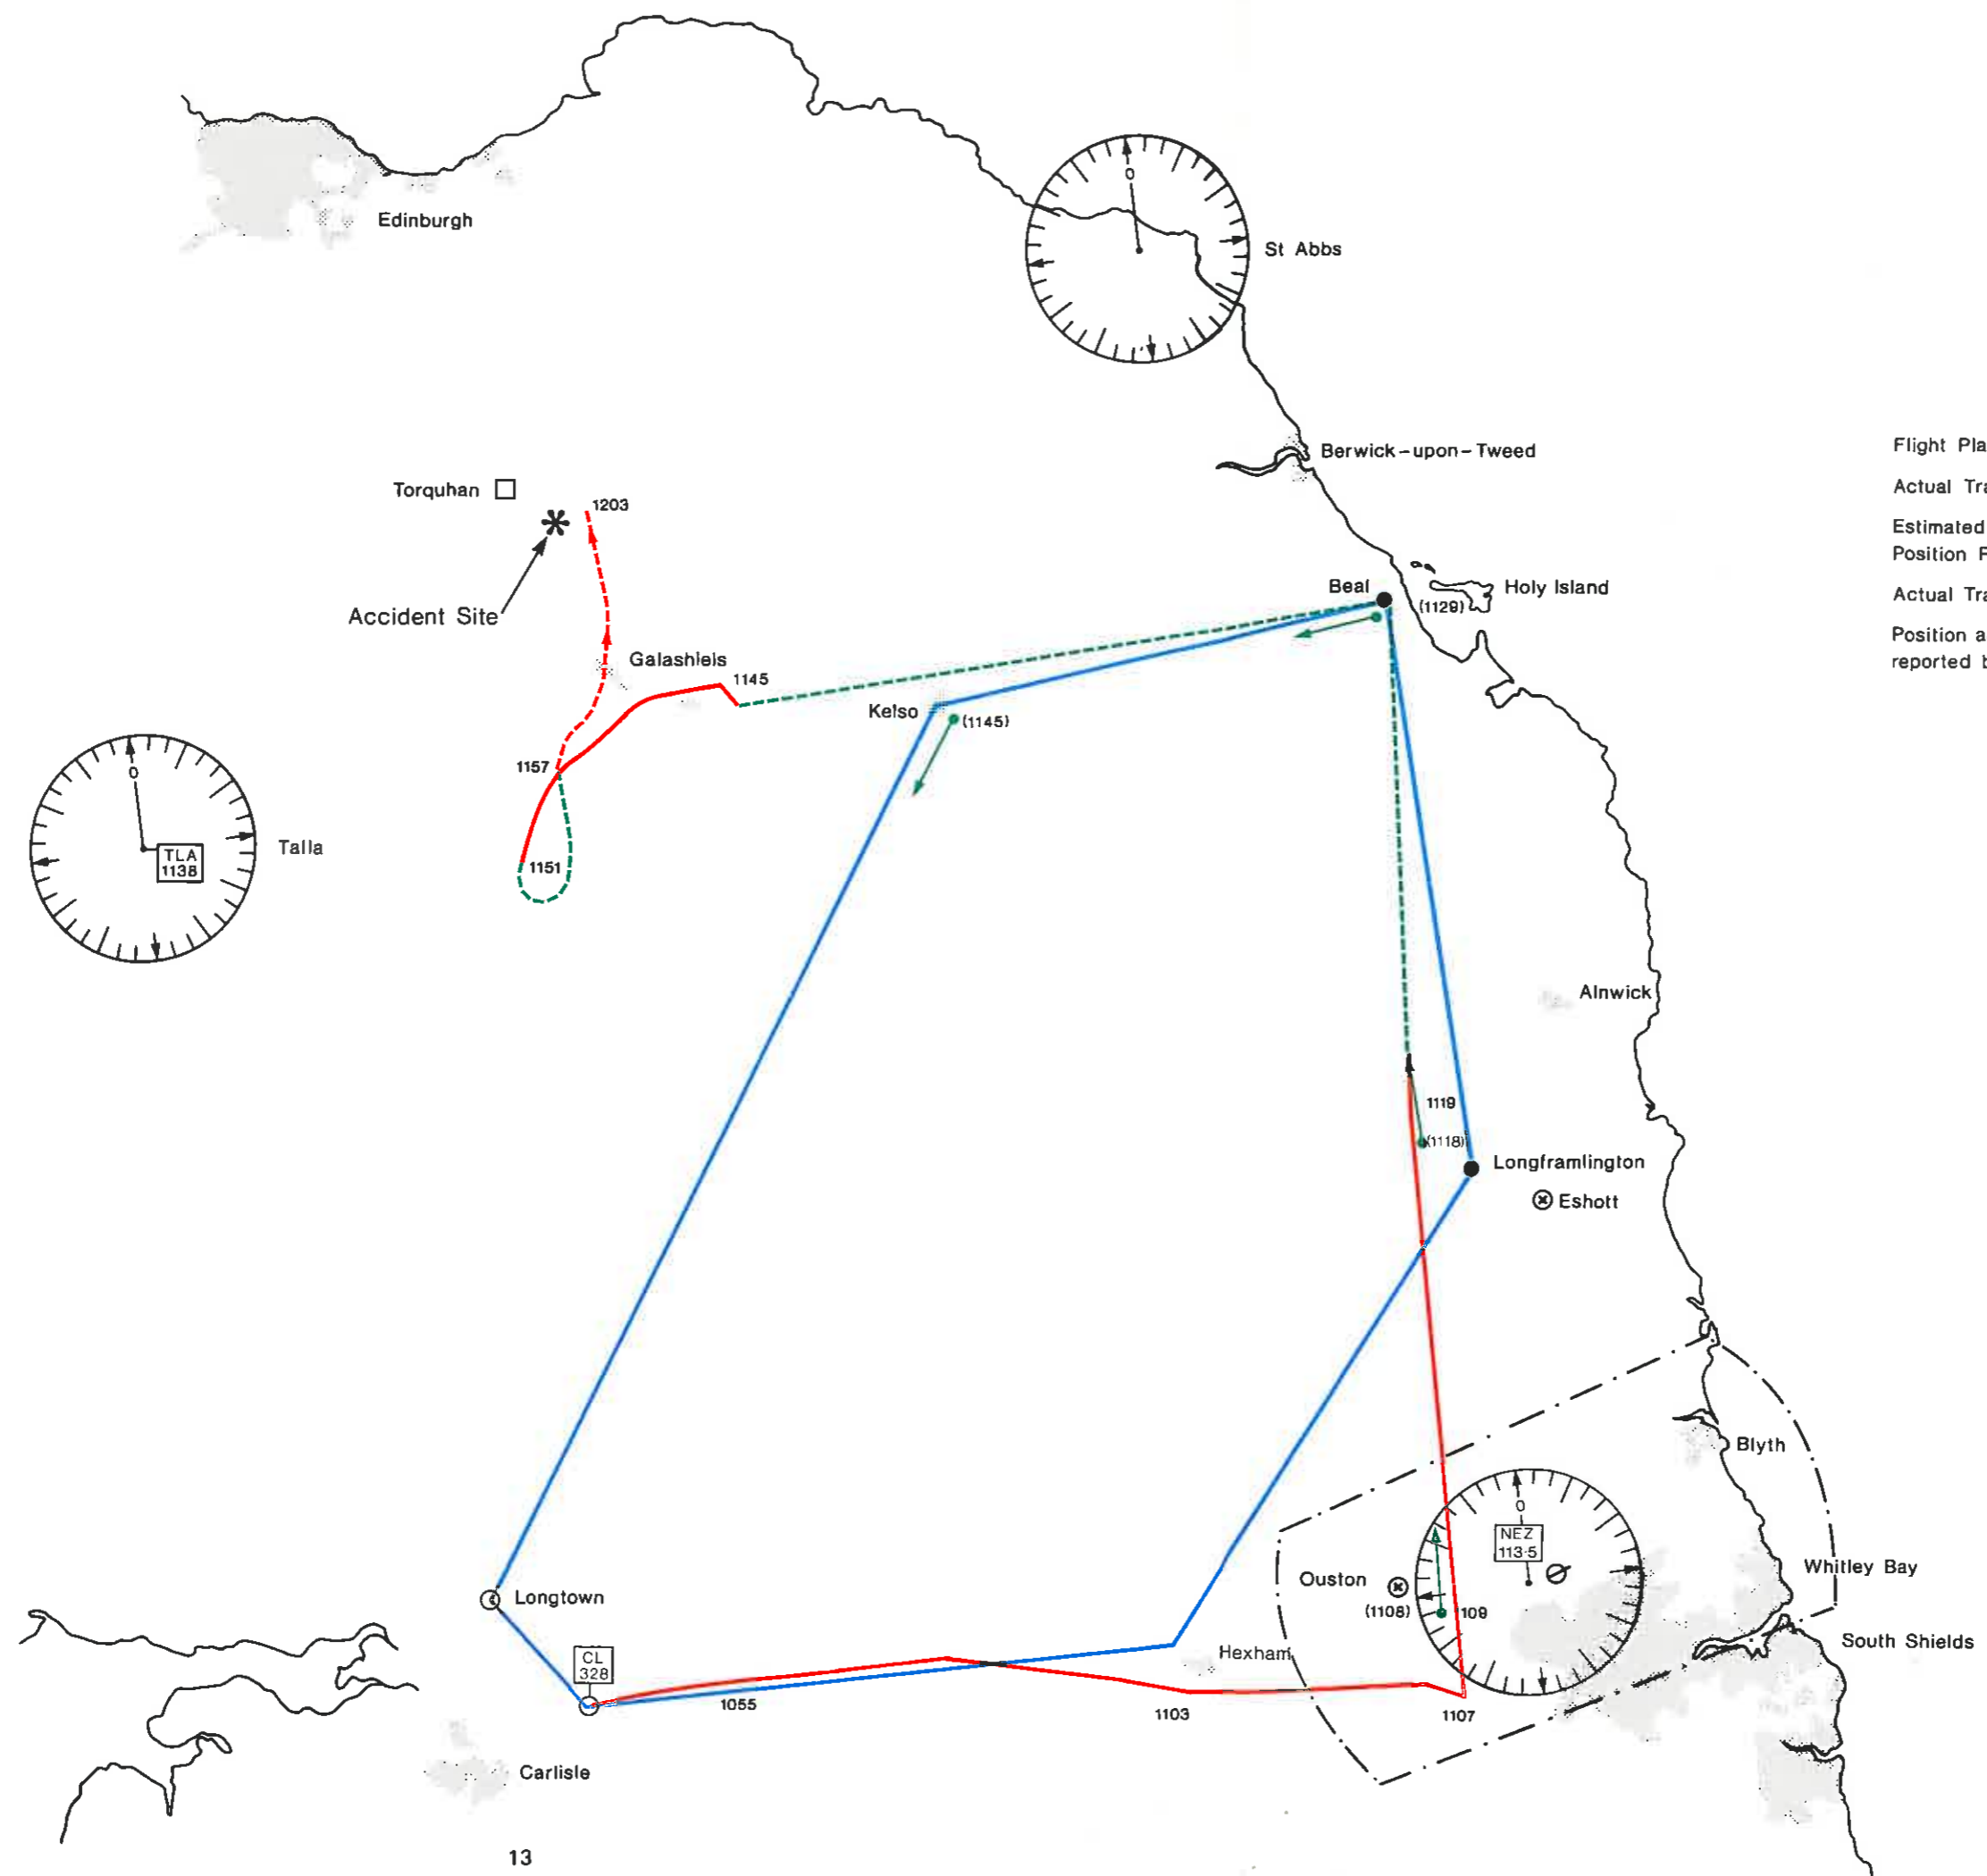
From an analysis of radar recording and the transcripts of RTF messages throughout the flight, it has been possible to establish a reasonably accurate assessment of the actual track flown by the pilot; this is included in the diagram at the end of this bulletin.
