AAIB Bulletin S5/2009

SPECIAL

ACCIDENT

Aircraft Type and Registration:	Eurocopter AS332L2 Super Puma, G-REDL	
No & Type of Engines:	2 Turbomeca Makila 1A2 turboshaft engines	
Year of Manufacture:	2004	
Date & Time (UTC):	1 April 2009 at 1255 hrs	
Location:	In the sea approximately 11 miles north-east of Peterhead, Scotland	
Type of Flight:	Commercial Air Transport (Passenger)	
Persons on Board:	Crew - 2	Passengers - 14
Injuries:	Crew - 2 (Fatal)	Passengers - 14 (Fatal)
Nature of Damage:	Helicopter destroyed	
Commander's Licence:	Airline Transport Pilot's Licence (H)	
Commander's Age:	31 years	
Commander's Flying Experience:	2,575 hours (of which 1,870 were on type) Last 90 days - 96 hours Last 28 days - 37 hours	
Information Source:	AAIB Field Investigation

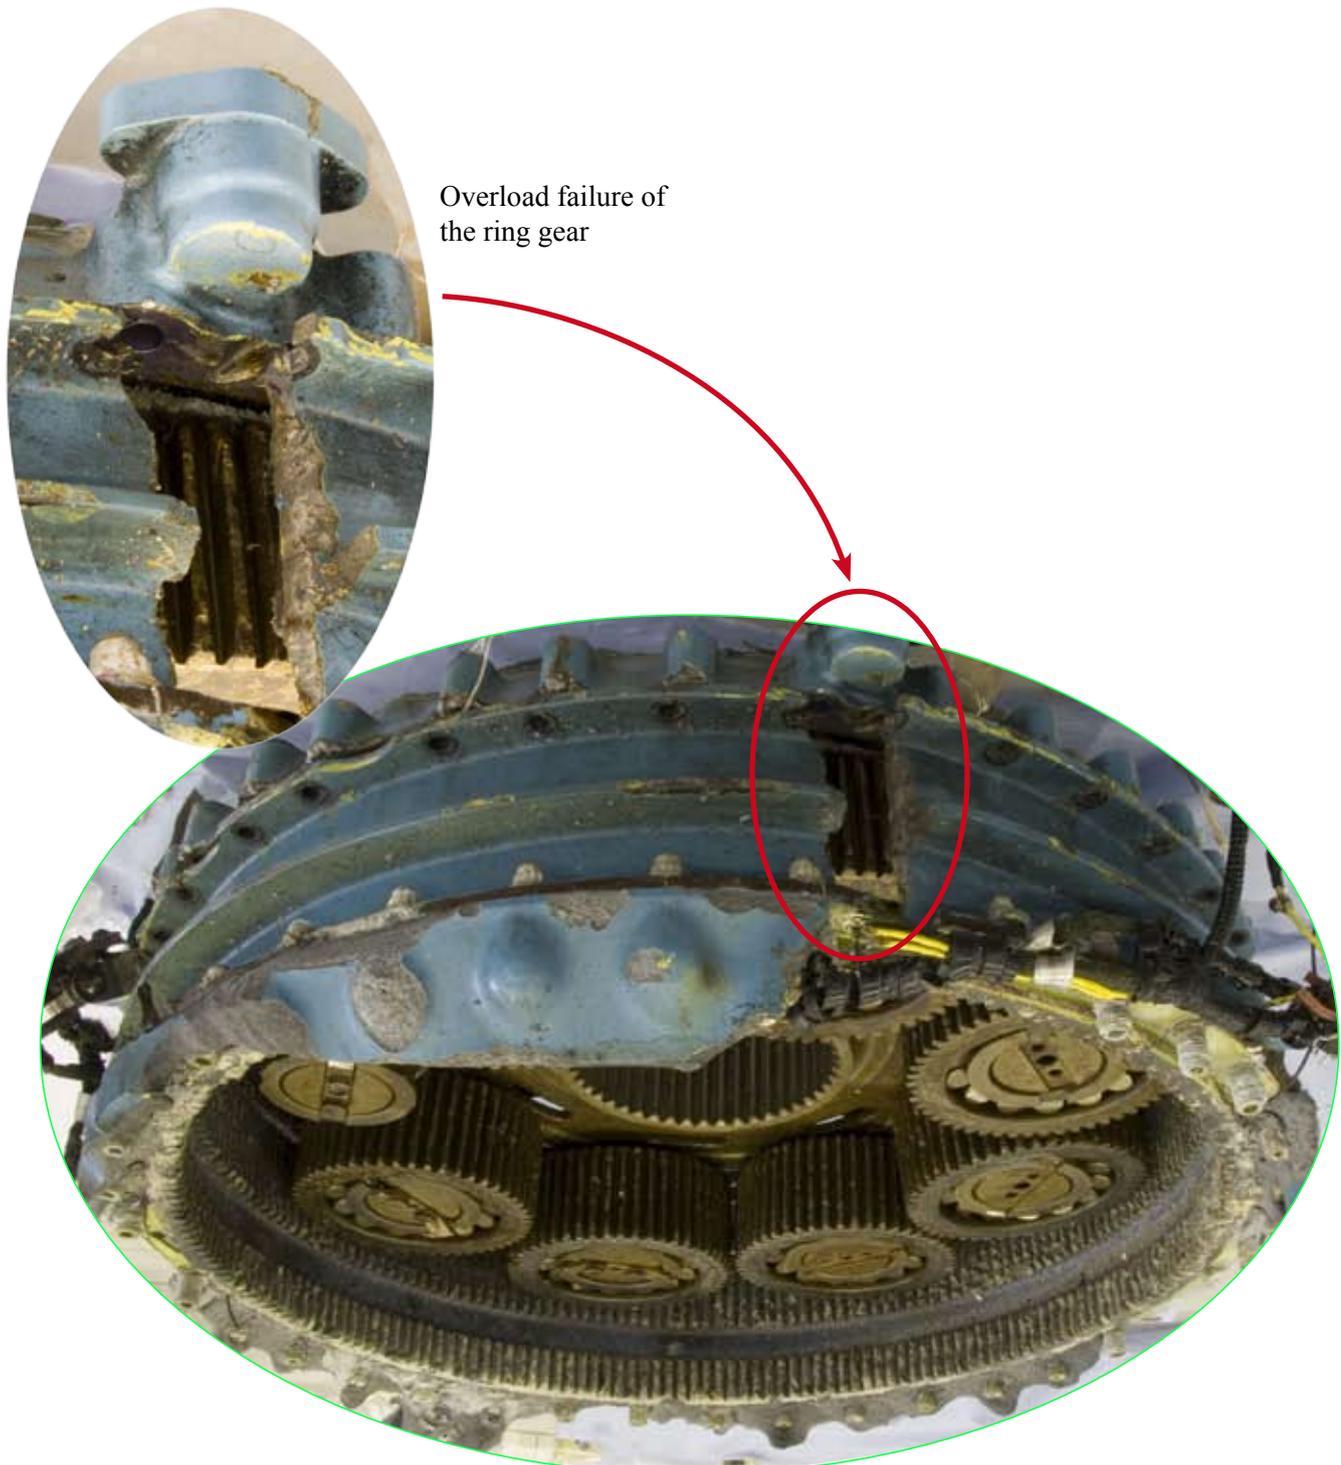
Figure 4

It is considered that a section of the failed second stage planet gear became jammed between the ring gear and a planet gear, precipitating the ring gear failure, (Figure 4). There is evidence on all gear teeth of damage caused by debris being present, consistent with the gearbox running in an abnormal condition prior to the separation of the main rotor head. However, no evidence has indicated that the flight crew were aware of any problem with the MRG until shortly before the accident, when the loss of MRG oil pressure occurred, and a noise became evident on the CVR. This was likely to have been at the time the ring gear burst open.

Failed ring gear details with second epicyclic stage reinstalled - viewed from below.
