No: 5/89

Ref: EW/C1101

and Registration: Britten-Norman B2T Islander, G-OTVS

Location: Lashenden (Headcorn) Kent

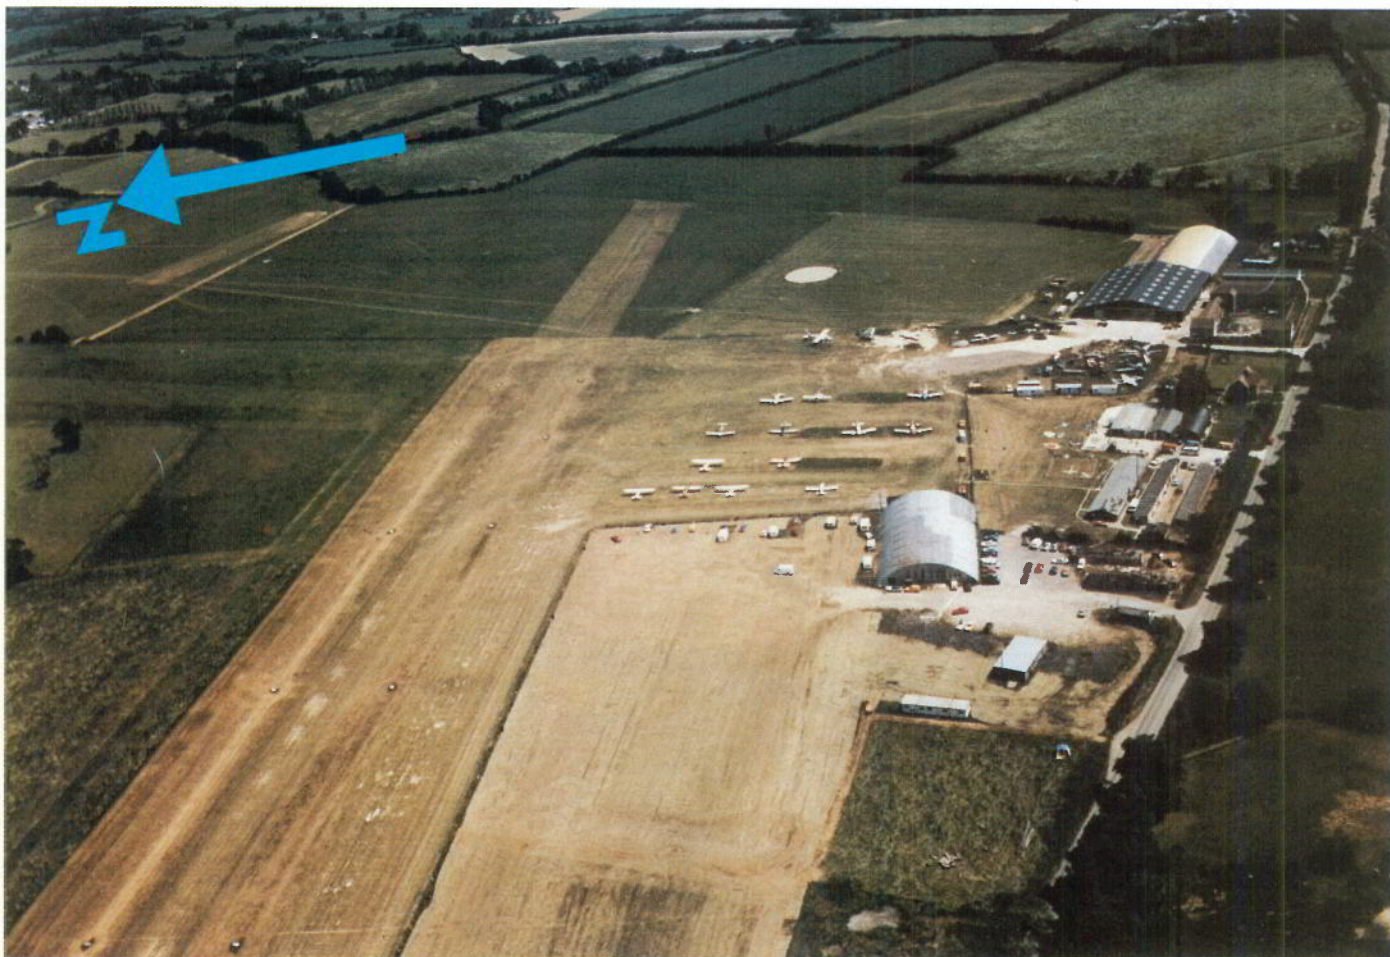
The Dropping Zone (DZ) was a small field on the south eastern edge of the airfield, in the middle of which was a circle containing gravel, which was approximately 20 metres in diameter and known as the "pit". This was the target area for experienced parachutists permitted to use this DZ and is shown on the upper right centre of the photograph. Students and inexperienced parachutists use the area to the north east of runway 29 where there are a number of suitable fields available for use as a DZ.

The licensed grass runway 11/29 is delineated by the white markers and has a take-off run, and landing distance available of 796 metres. The runway has been extended 200 metres to the east from the runway 29 threshold end, but this section is unlicensed. The aircraft was certificated in the private category and as the flight was not for the purposes of public transport, or flying instruction, the commander was entitled to land on this 200 metre strip if he judged it to be a suitable surface.

- 1 The DZ for all parachutists is moved to the North of Headcorn Airfield and the use of the DZ to the south east be discontinued.
2. An approved parachute instructor be positioned by the runway with appropriate RTF equipment, to monitor the air/ground frequency and act as Aircraft Controller.
3. All student parachutists (less than 50 jumps) to be equipped with radio receivers in order that they can be instructed or advised by an instructor on the ground on a discrete frequency.
4. Use of the unlicensed runway extension by aircraft be prohibited while parachuting is in progress.

5. Student parachutists to be marshalled across the runway 29 extension by the Aircraft Controller.
