Aircraft Type and Registration:	Socata TBM 700B, N30LT	
No & Type of Engines:	1 Pratt & Whitney PT6A-64 turboprop engine	
Year of Manufacture:	2001	
Date & Time (UTC):	6 December 2003 at 1124 hrs	
Location:	180 metres west of Runway 01 threshold at Oxford (Kidlington) Airport, Oxfordshire	
Type of Flight:	Declared as Private (see text)	
Persons on Board:	Crew - 1	Passengers - 2
Injuries:	Crew - 1 (Fatal)	Passengers - 2 (Fatal)
Nature of Damage:	Aircraft destroyed	
Commander's Licence:	FAA Commercial Pilot's Licence	
Commander's Age:	46 years	
Commander's Flying Experience:	More than 1,573 hours (of which approximately 500 hours were on type) Last 90 days - not known (see text) Last 28 days - not known (see text)	
Information Source:	AAIB Field Investigation

Synopsis

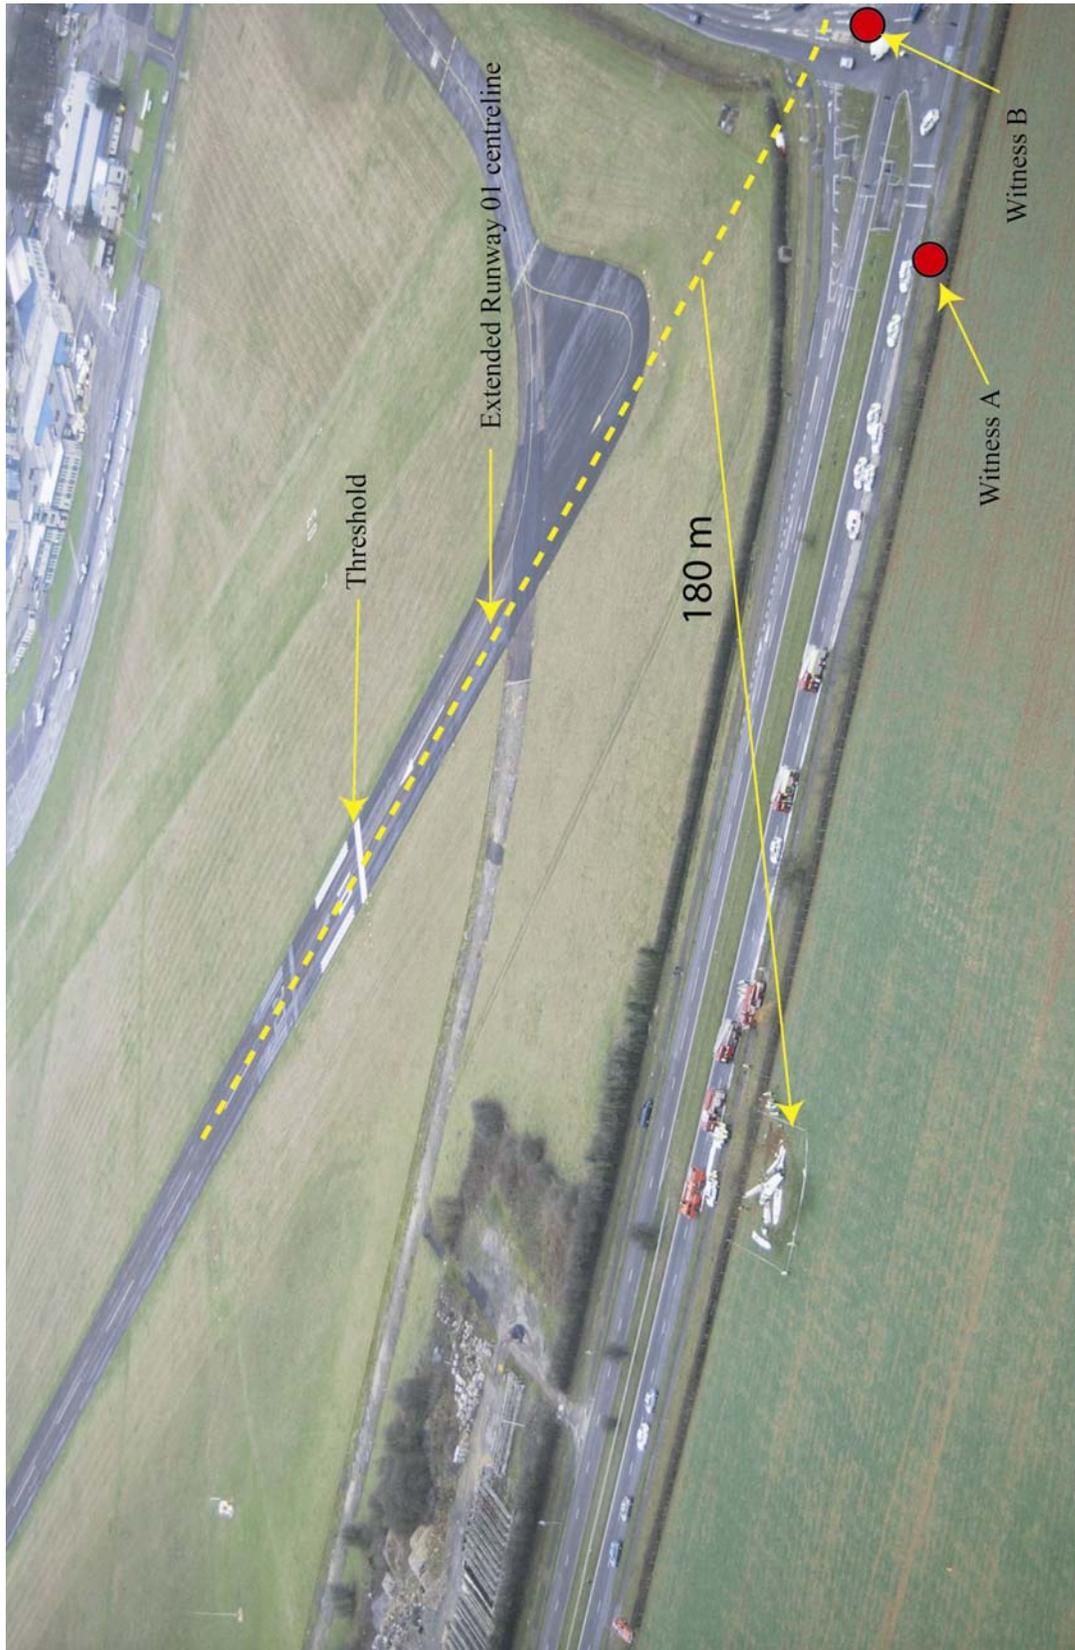
Figure 1

The aircraft had struck the ground in a field alongside the A44 on the south side of the Oxford Airport boundary. The aircraft wreckage was located 180 metres to the west of the Runway 01 threshold as shown in Figure 1. The initial impact marks and wreckage distribution were consistent with the aircraft having struck the ground upright in a nose low attitude, with a slight left bank and with a steep flight path angle. The marks and damage to the aircraft also indicated that the aircraft was in a sideslip to the left. After striking the ground on its nose and left side, the aircraft bounced, broke up into large sections and then immediately came to rest. The approximate final ground track of the aircraft, based on the wreckage distribution, was 320°(M).

N30LT - Accident Site Location

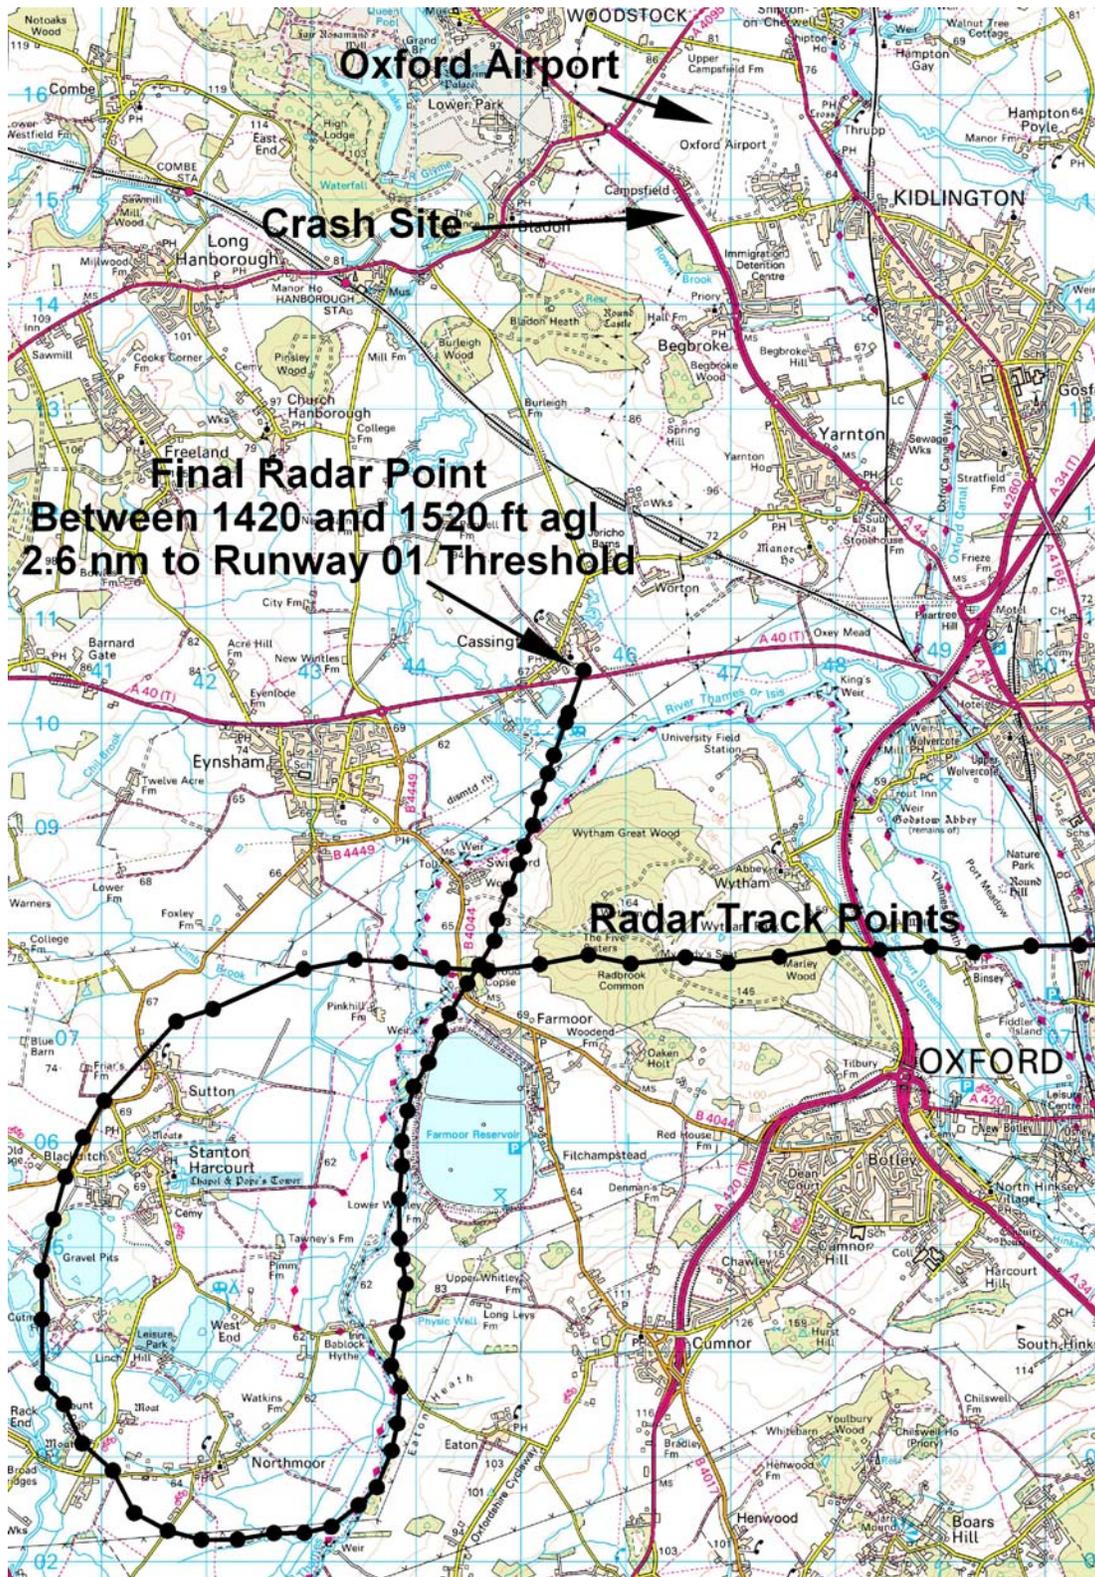
National Air Traffic Services Limited provided secondary radar information on N30LT from two radar sources at Heathrow. Some of this information has been included in the history of flight. The final radar contact was at 1122:29 hrs, at a height between 1,420 and 1,520 feet agl with the aircraft approximately 2.6 nm from the threshold of Runway 01. The accident occurred at 1124:10 hrs. Therefore the time from the last radar contact to the runway was 1 minute and 41 seconds, giving an average ground speed of about 93 kt and an average descent rate of approximately 870 feet per minute. Figure 2 details the radar track for the last part of the flight.

Final radar track of N30LT

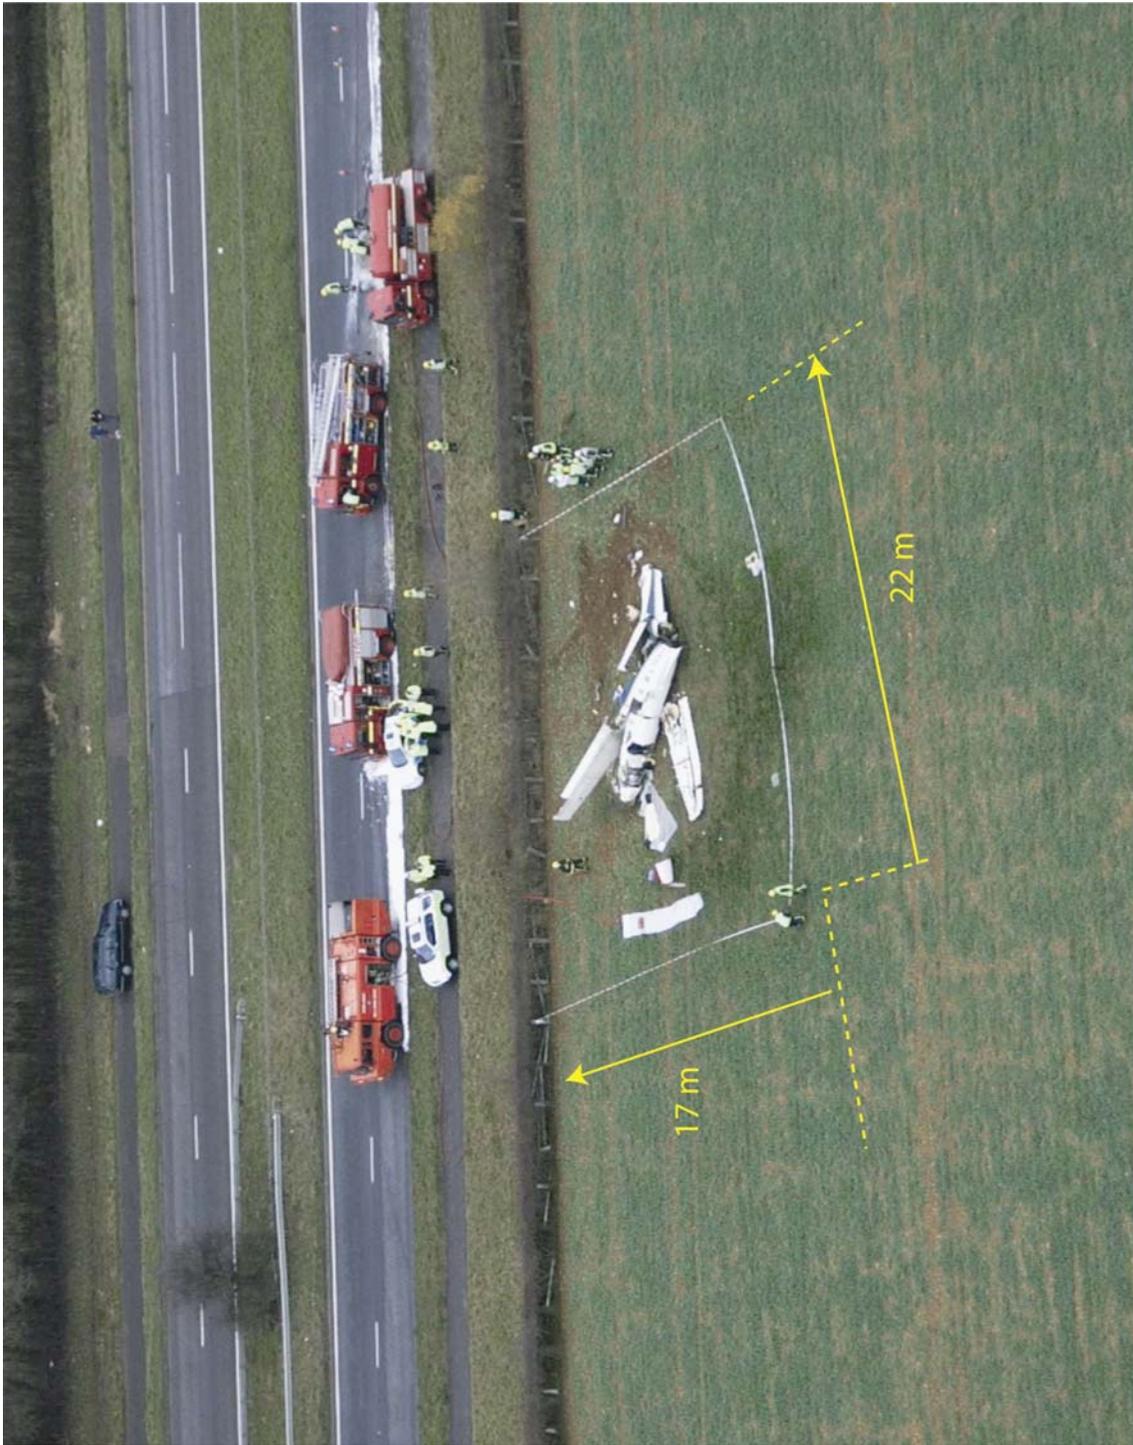
Figure 3

All the aircraft wreckage and impact marks were located in a small 17 by 22 metre area, Figure 3, and this, together with the nature of the wreckage, indicated that the aircraft had a very low forward speed at impact.

N30LT - Accident Site Details
