**ACCIDENT**

<b>Aircraft Type and Registration:</b>	Zenair CH 601UL Zodiac, G-CBAP	
<b>No &amp; Type of Engines:</b>	1 Rotax 912-S piston engine	
<b>Year of Manufacture:</b>	2001 (Serial no: PFA 162A-13656)	
<b>Date &amp; Time (UTC):</b>	17 February 2013 at 1435 hours	
<b>Location:</b>	Near Cumnock, East Ayrshire	
<b>Type of Flight:</b>	Private	
<b>Persons on Board:</b>	Crew - 1	Passengers - None
<b>Injuries:</b>	Crew - None	Passengers - N/A
<b>Nature of Damage:</b>	Damaged beyond economic repair	
<b>Commander's Licence:</b>	Private Pilot's Licence	
<b>Commander's Age:</b>	65 years	
<b>Commander's Flying Experience:</b>	304 (of which 174 were on type) Last 90 days - 6 hours Last 28 days - 1 hour	
<b>Information Source:</b>	Aircraft Accident Report Form submitted by the pilot

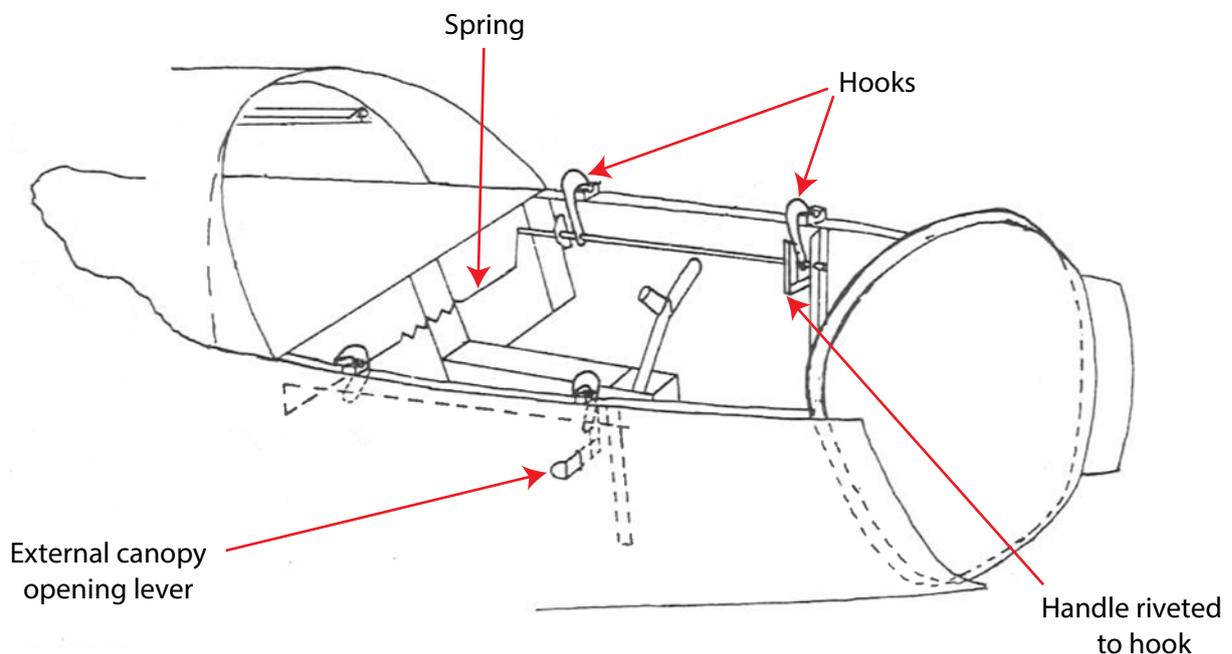
**Figure 1**

On this model of the CH601 Zodiac the one-piece canopy is hinged sideways, as opposed to later models which are hinged from the front. Longitudinal tubes on the sides of the canopy frame are secured by two hooks on each cockpit sill (Figure 1). The hooks are

spring-biased towards the locked position by a light duty helical spring stretched across the rear of the cockpit. Handles attached to the left and right rear hooks allowed one side or the other of the canopy to be unlocked and opened; the hooks on the other side then acted as hinges. Note that, although Figure 1 is taken from the builder's manual for G-CBAP, the unlatch handles were attached to the rear hooks and not the front as depicted and only the left handle could be operated externally. In addition, and also not shown, two sliding bolts were attached to the left and right cockpit sidewalls which engaged into holes in the front hooks to keep them in the closed position. Opening the canopy from the inside thus required two operations: firstly, disengaging the bolt and then operating the release handle.

Sketch from builder's manual showing principle of the canopy locking mechanism.  
Description of how G-CBAP differed from this is in the text

Canopy latching mechanism

The pilot subsequently stated that he was aware of the left rear canopy hook unlatching first, moments before the canopy detached. Examination showed the right side of the canopy had torn away, leaving the longitudinal tube retained by the hooks on that side. On the right side, the longitudinal tube was missing (presumably still attached to the canopy), even though both hooks on that side were closed and the front hook locked by the pin.

The Light Aircraft Association is investigating the various possibilities for this scenario including a foreign object becoming trapped by a rear hook or wear causing an apparently locked mechanism to fail to retain the canopy.
